I-195 Washington Bridge (700)

Forensic Evaluation and Procedural Audit Related to PT Tie-Down Failures

I-195 SB Washington Bridge over Seekonk River
Providence, RI

DRAFT REPORT

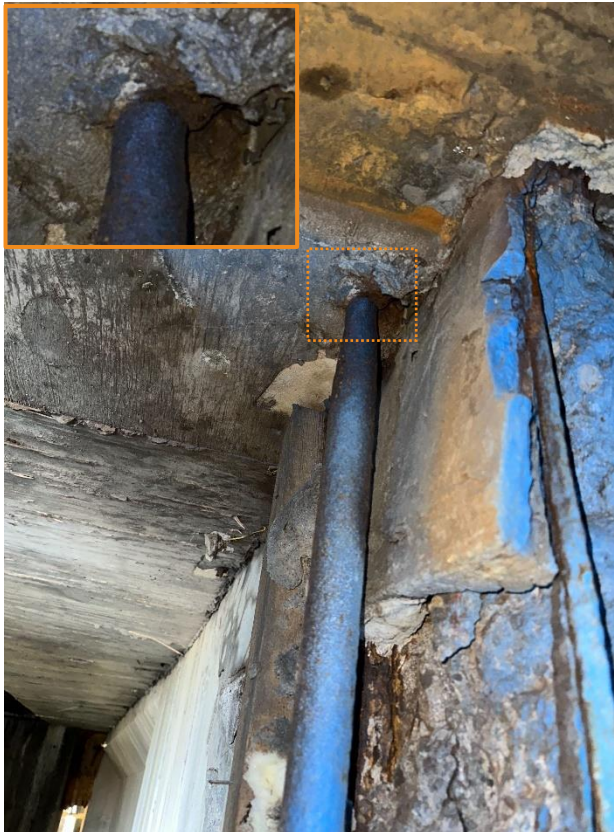
WJE personnel Michael Brown and John Cocca visited the bridge on December 16, 2023. During the site visit the fractured bars and the configuration and condition of the cantilever beams and structural walls at Piers 6 and 7 that the post-tensioned (PT) rods were designed to connect were observed. WJE observed fractured rods at two of four corners of Span 7, at Cantilever A and Cantilever F at Pier 7. At the time, a third rod, Cantilever A at Pier 6, was suspected of also being fractured due to observed movement of the cantilever/rod, but a fracture could not be visibly confirmed. A report noted bouncing of cantilevers and gaps at bearings of adjacent girder lines at the Pier 6 and Pier 7 connections.¹ Photos of the fractured bars taken by WJE on December 16, 2023 are shown in Figures 1 and 2. The bars were corroded on the exterior perimeter and the cross-section was reduced/tapered in the regions around the fractures.

Figure 1. Pier 7 Cantilever A fractured tie-down rod

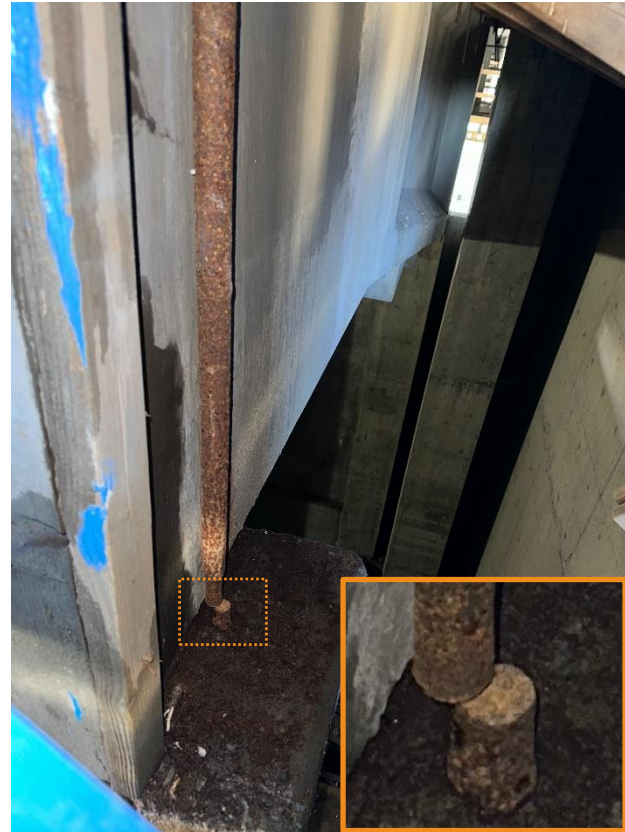
Figure 2. Pier 7 Cantilever F fractured tie-down rod

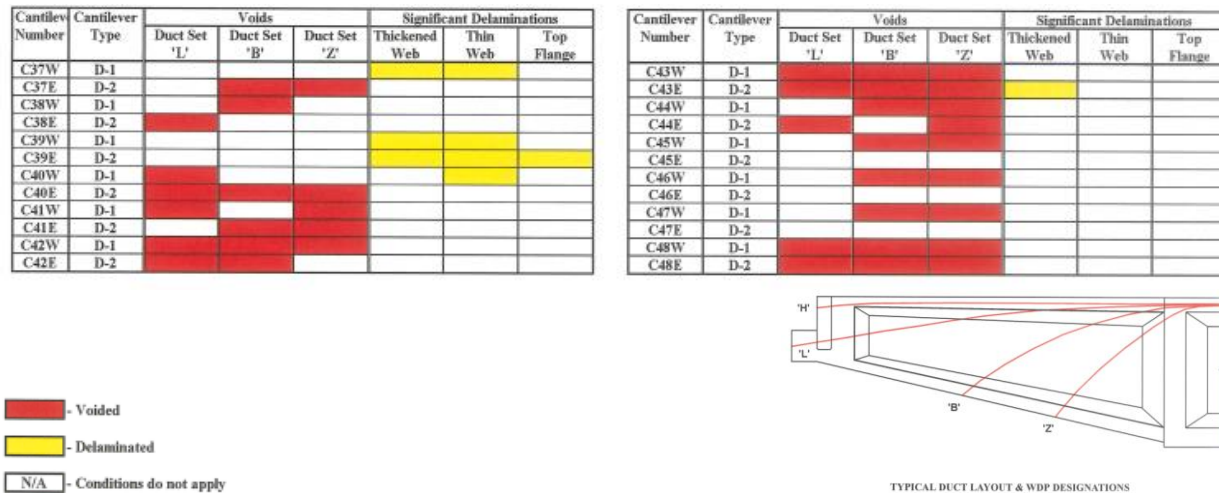
condition of post-tensioning anchorages and the tendons. Whitlock, Dalrymple, and Poston (WDP) were engaged to perform impact echo testing of the cantilever beam webs to investigate suspected voids. Over a series of NDE inspections, WDP identified 81 out of 170 beams (47.6%) containing 139 out of 644 PT ducts (21.6%) with indications of voids or voids and delaminations (Figure 13). The cantilevers at Piers 6 & 7 in Span 7 contained the highest frequency of voids and delamination with indications in 42 out of 120 (35%) ducts (Figure 14). Note Duct "H" in each beam could not be evaluated due to the thicker section and reinforcement configuration.

Figure 14. Summary of Type D cantilever impact echo findings compiled from WDP report.⁹

Special provisions have been retained for the impact echo testing and retrofit grouting.¹⁰ A series of change orders were issued during the contract to address the required NDE testing, additional repairs to ends of cantilevers, additional repairs to address cantilever beam delaminations and the retrofit grouting to address voids detected in the cantilever beam post-tensioned ducts.^{11,12,13} The WDP summary report indicates voids in ducts of most cantilever spans. However, it is unclear from available documents whether retrofit grouting was applied to cantilevers in all spans or primarily to the Pier 6 and 7 cantilevers. Project records and change order documents indicate 125 one-square-foot tendon openings (with cost unit "each") were made to enable retrofit grouting during the project.¹³ It is not clear how many cumulative linear feet of tendon were retrofit grouted.

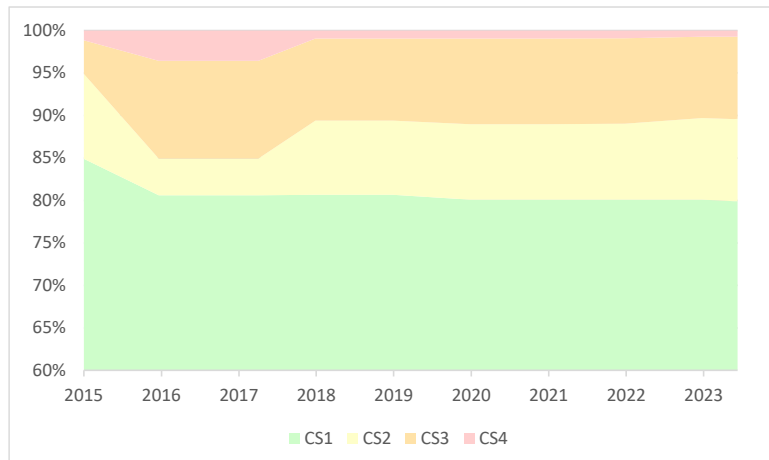
Figure 15. Element 109 Condition State History (2015 to 2023)

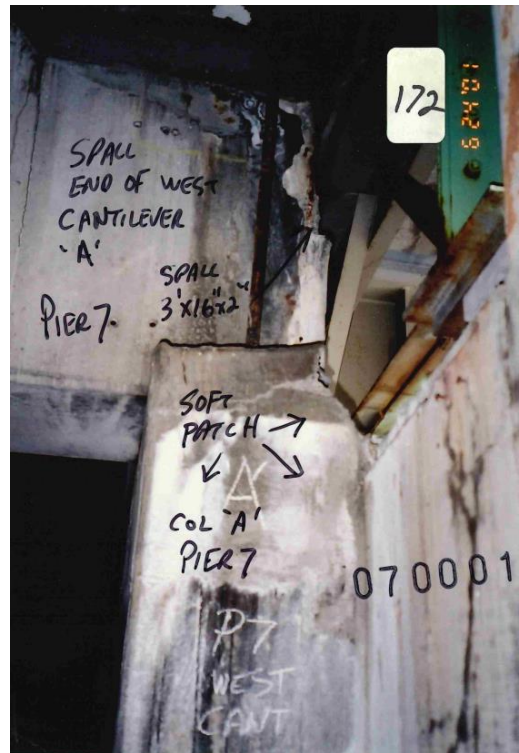
Figure 26. Inspection photo of exterior tie-down rod for cantilever beam A at Pier 7 taken June 2001 (RIDOT).

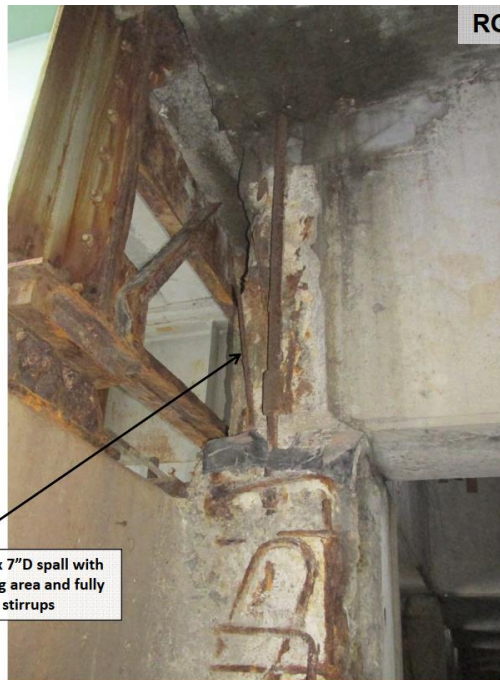
PHOTO #114

FH x 9"W (EF) x 16"W (NF) x 7"D spall with 9"x10"x6"D reduced bearing area and fully exposed and broken stirrups

Span 7 Beam A – N. Face Cant. End at Pier 6
(LOOKING SOUTH)

Figure 27. Inspection photo of exterior tie-down rod for cantilever beam A at Pier 6 taken July 2015 (AECOM).

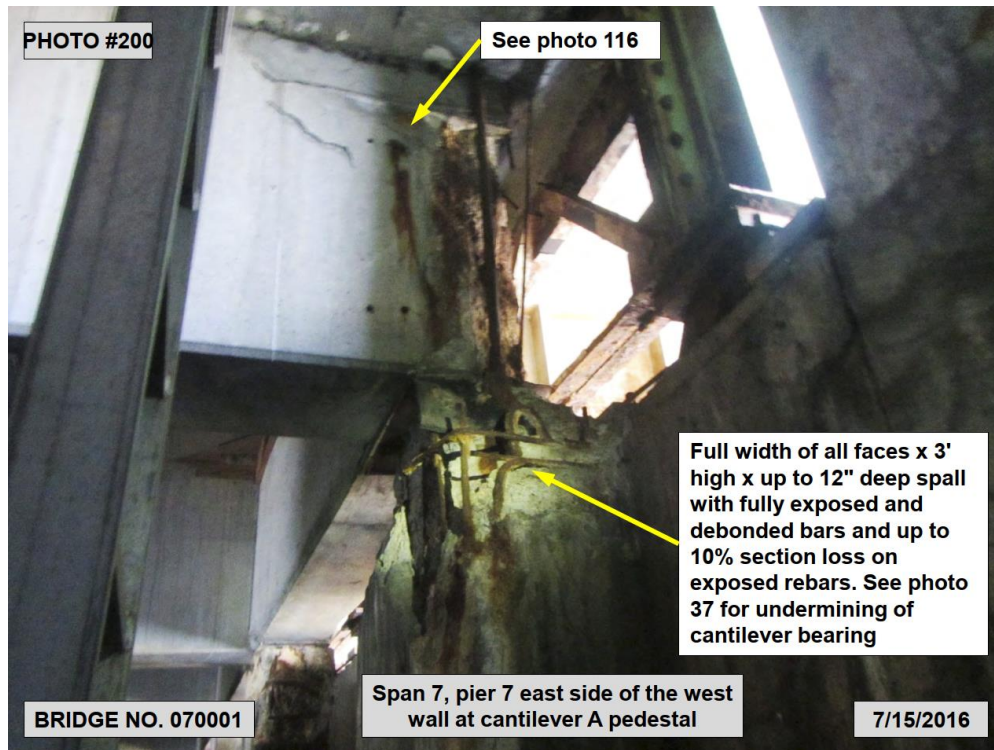
Figure 28. Inspection photo of exterior tie-down rod for cantilever beam A at Pier 7 taken July 2016 (TranSystems).

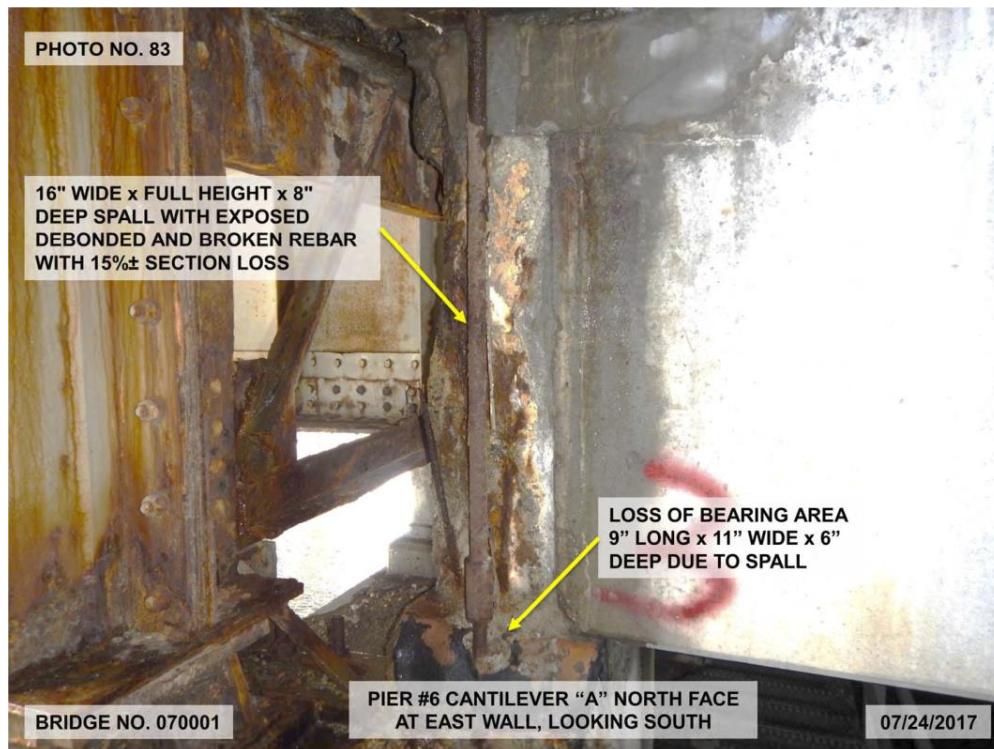
Figure 29. Inspection photo of exterior tie-down rod for cantilever beam A at Pier 6 taken July 2017 (Collins).

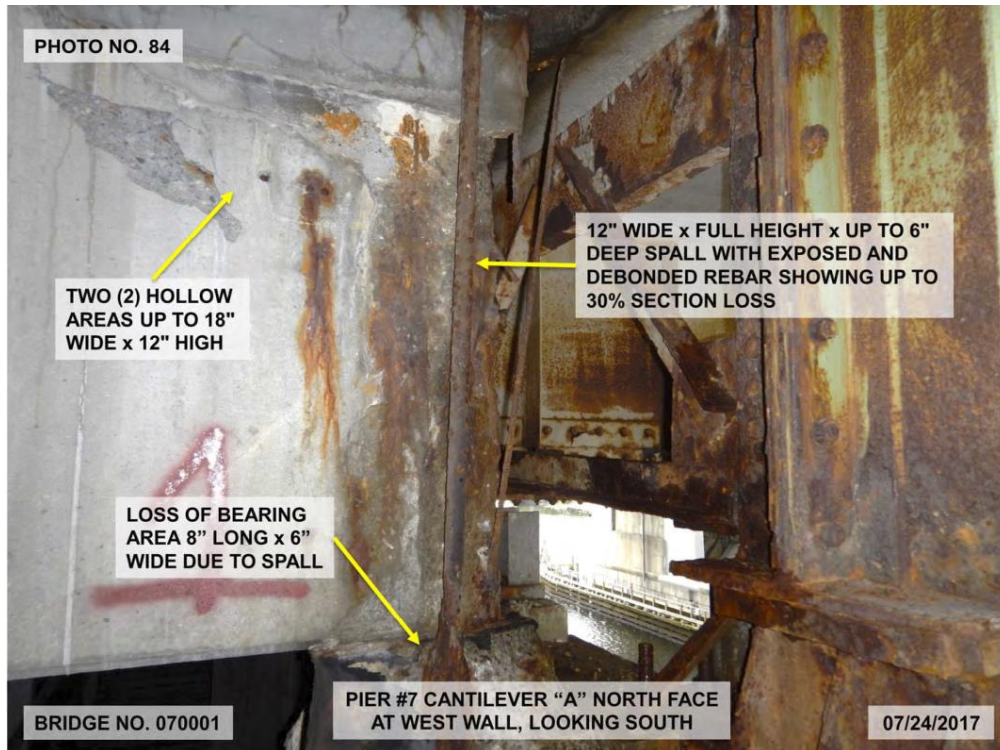
Figure 30. Inspection photo of exterior tie-down rod for cantilever beam A at Pier 7 taken July 2017 (Collins).

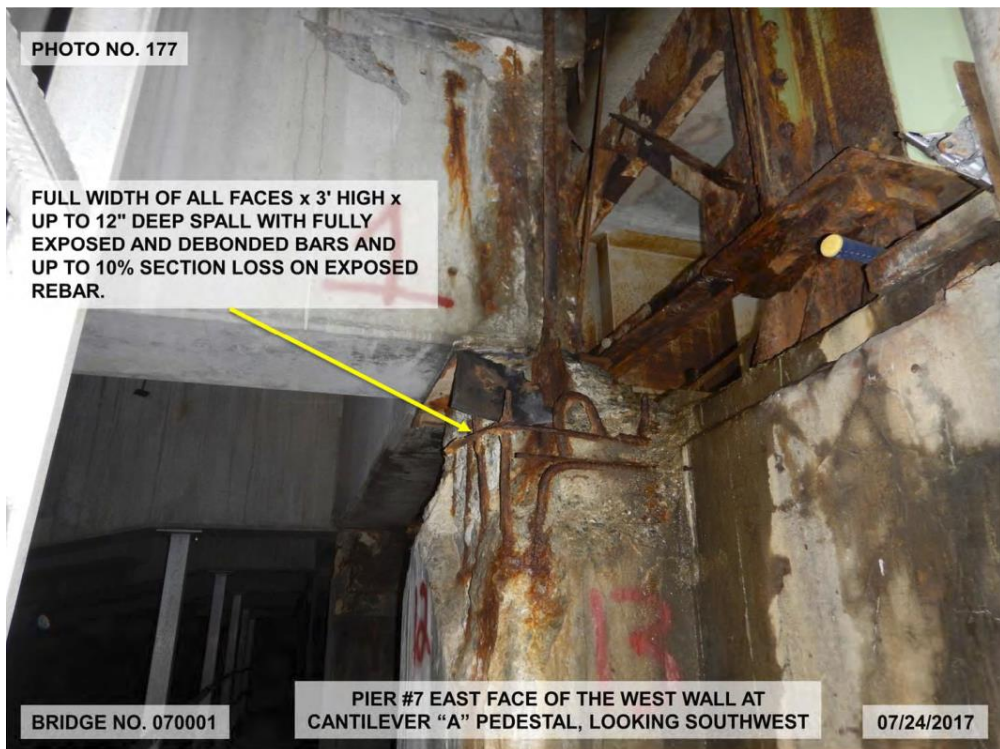
Figure 31. Inspection photo of exterior tie-down rod for cantilever beam A at Pier 7 taken July 2017 (Collins).

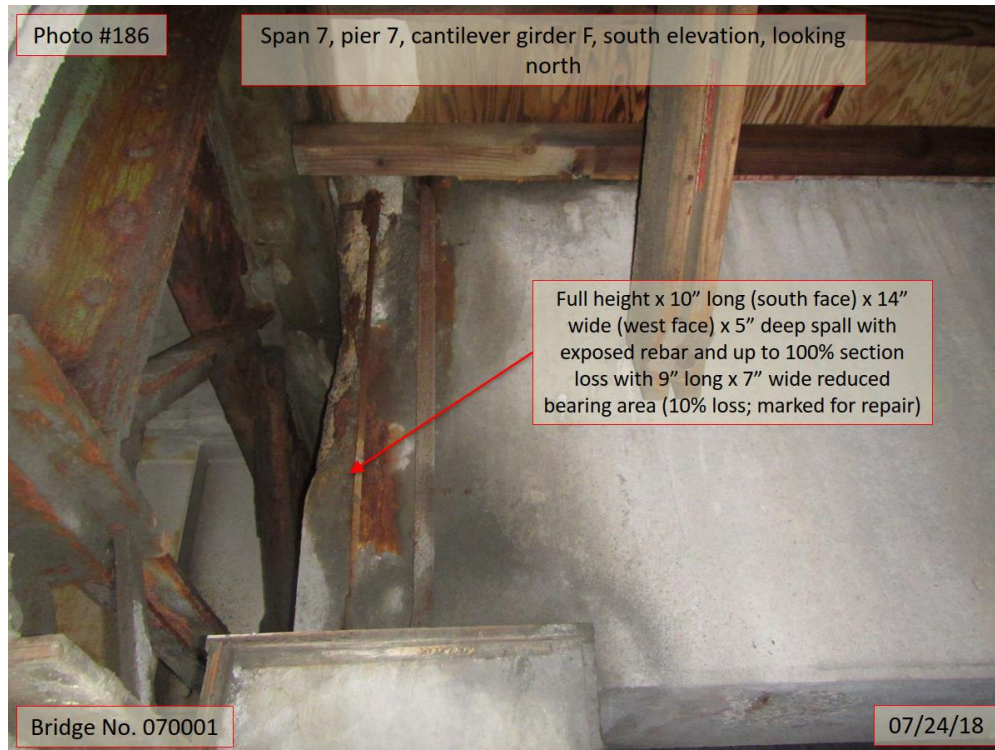
Figure 32. Inspection photo of exterior tie-down rod for cantilever beam F at Pier 7 taken July 2018 (Michael Baker).

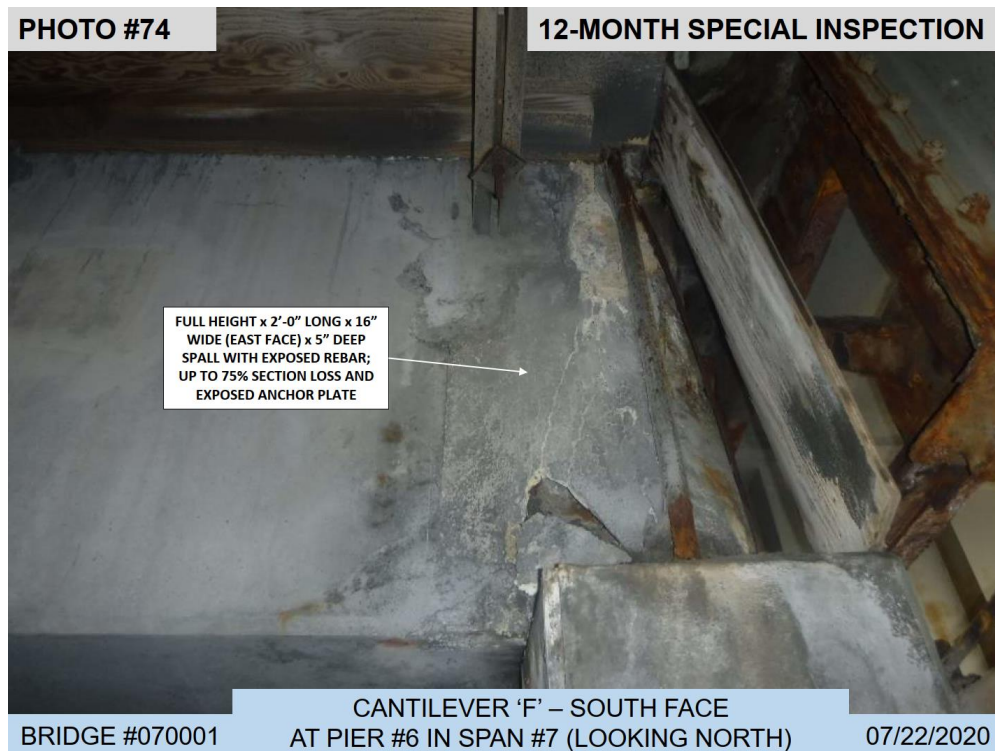
Figure 33. Inspection photo of exterior tie-down rod for cantilever beam F at Pier 6 taken July 2020 (AECOM).

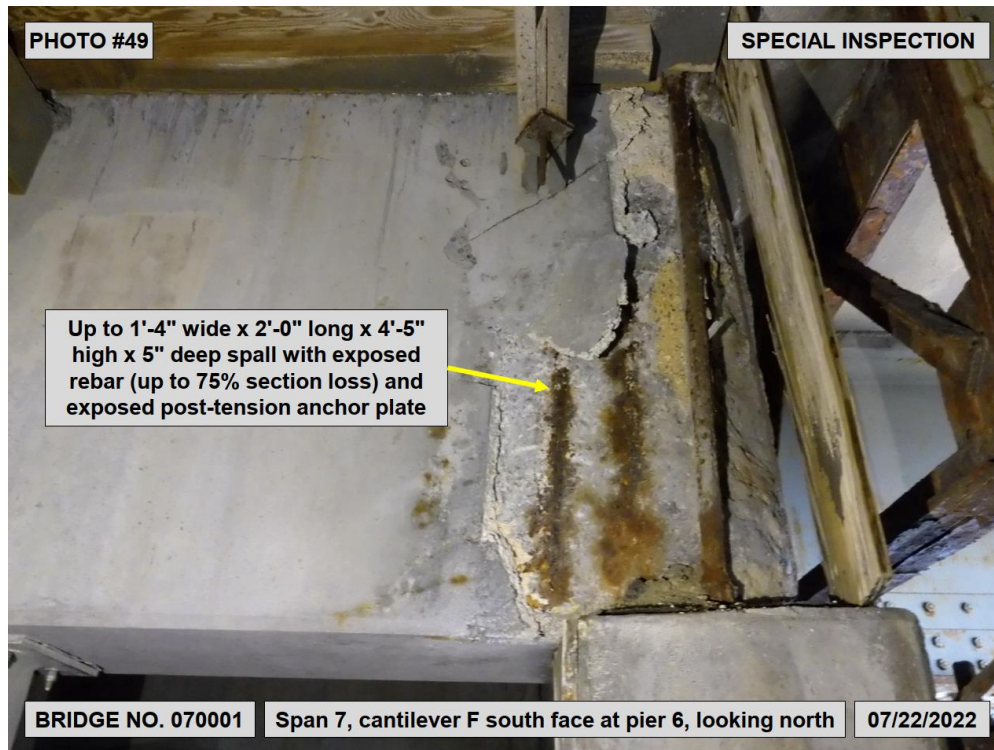
Figure 34. Inspection photo of exterior tie-down rod for cantilever beam F at Pier 6 taken July 2022 (TranSystems).

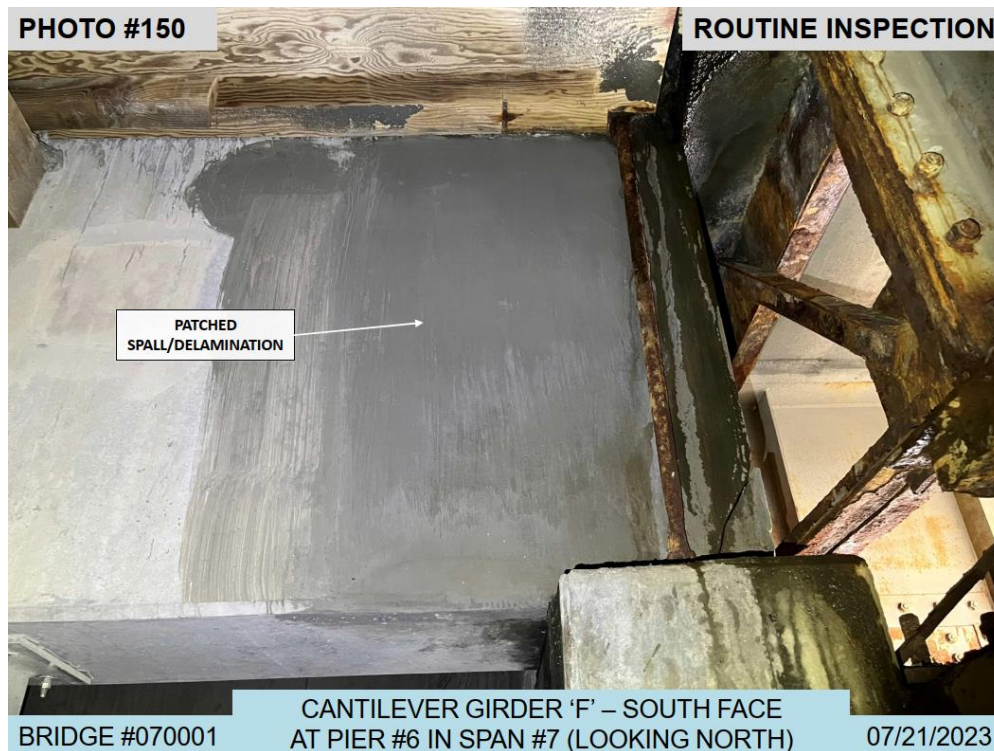
Figure 35. Inspection photo of exterior tie-down rod for cantilever beam F at Pier 6 taken July 2023 (AECOM).

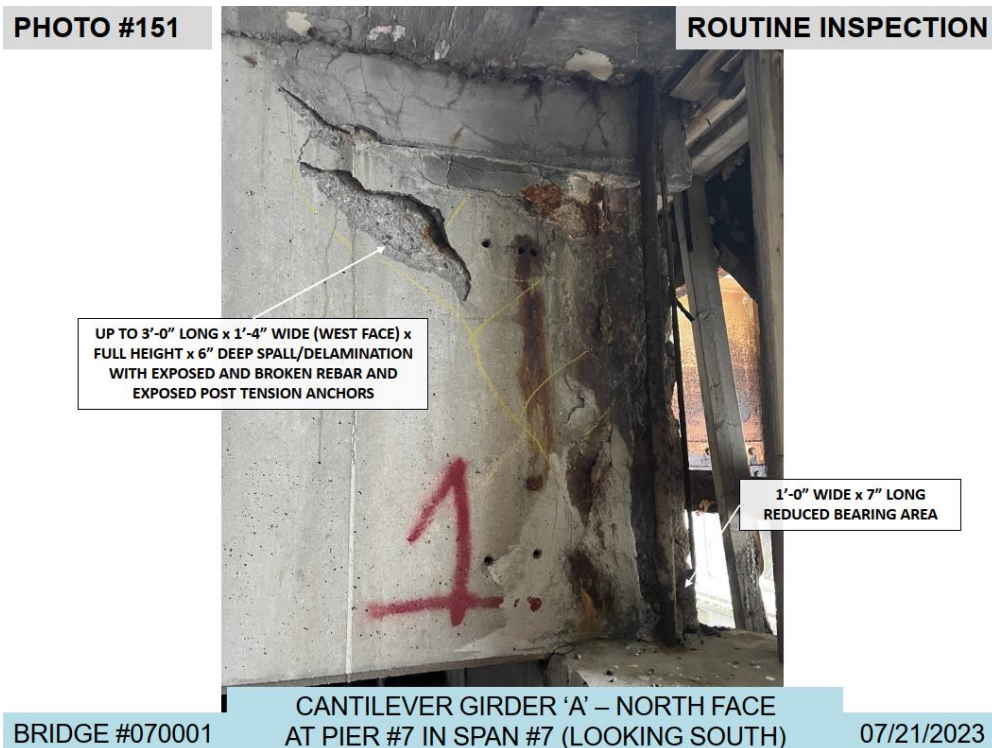
Figure 36. Inspection photo of exterior tie-down rod for cantilever beam A at Pier 7 taken July 2023 (AECOM).
