**Rhode Island State Police**  
**Collision Reconstruction Unit Report**

**Case Number: 20-298-CRU**

**Date: October 18<sup>th</sup>, 2020**

**Elmwood Avenue at Bissell Street**

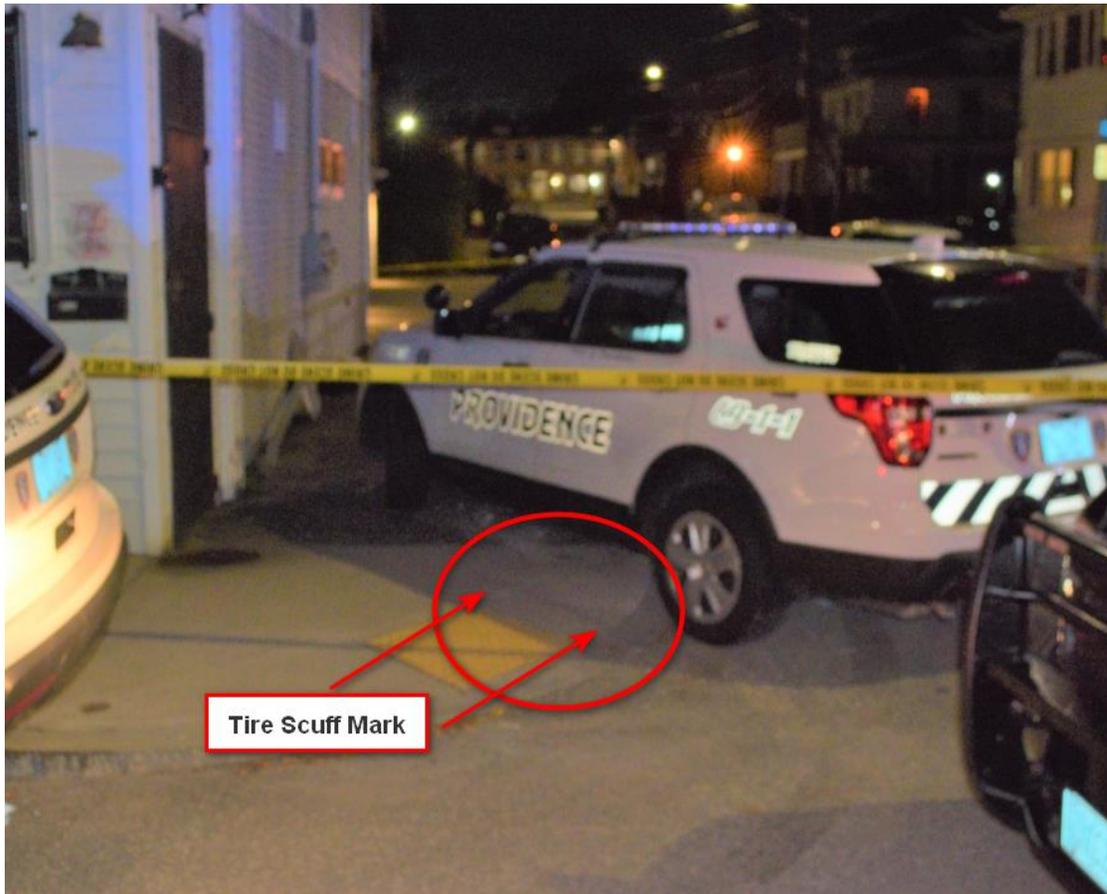
*Figure 4*

Figures 4 and 5 below depict the location of the Providence Police Cruiser as it came to rest on the sidewalk of Bissell Street. To the left of the Providence Police Cruiser and to the right of the tactile mat was a tire scuff along the sidewalk.

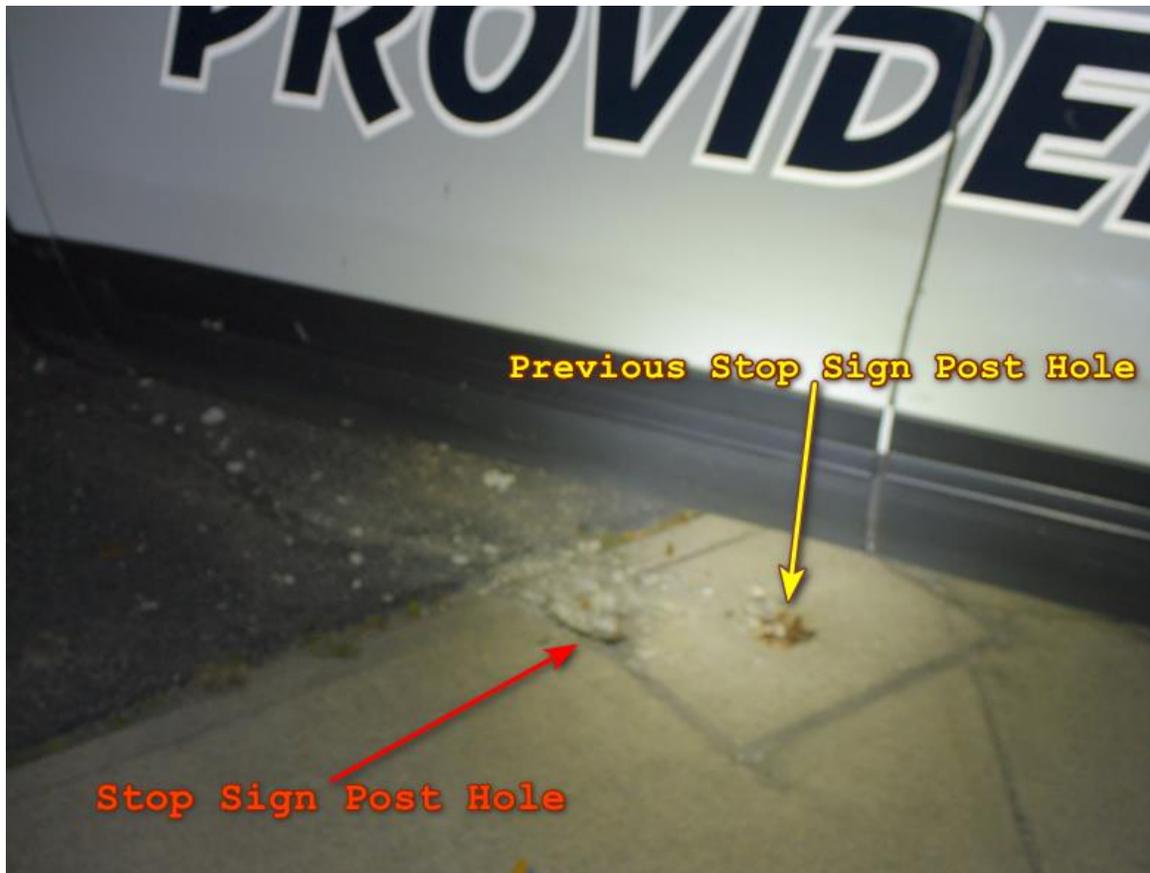
Figure 6

Underneath the Providence Police Cruiser was an area of broken cement in the sidewalk that marked the location of the stop sign post. This stop sign post hole was located to the southwest of a previous stop sign post that had also been broken from its mount. The directionality of the broken cement to the southwest was consistent with the Providence Police Cruiser striking the post while traveling on a southwesterly trajectory. (Figure 6)

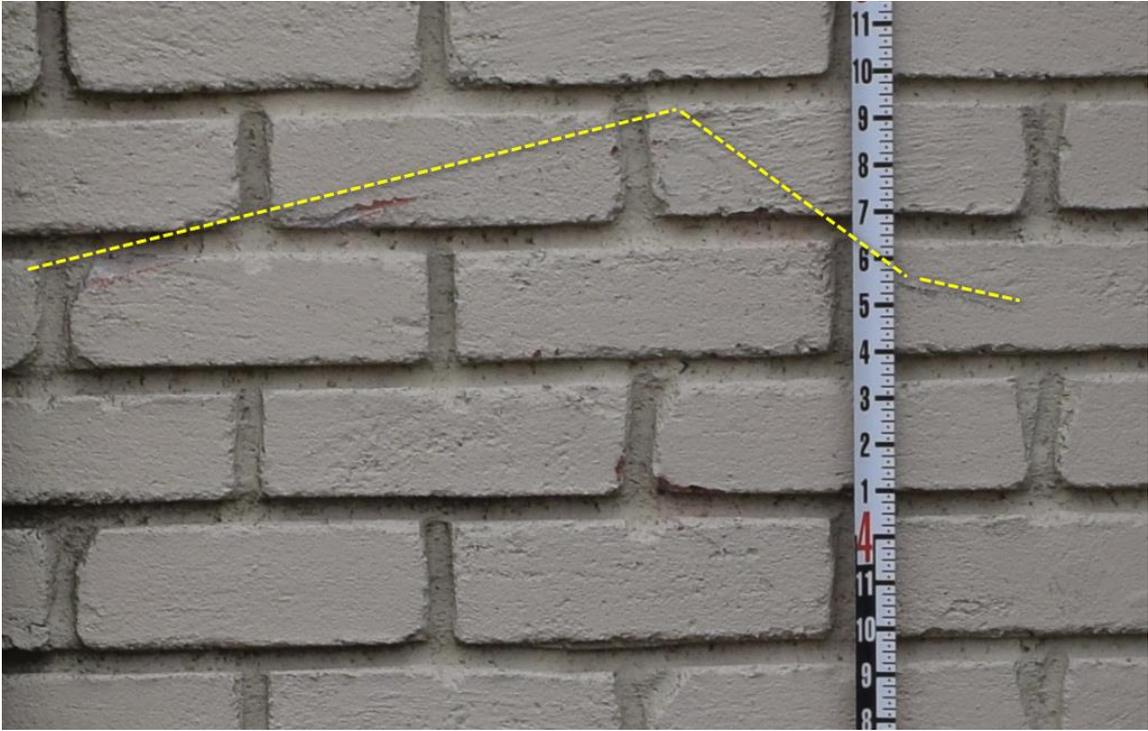
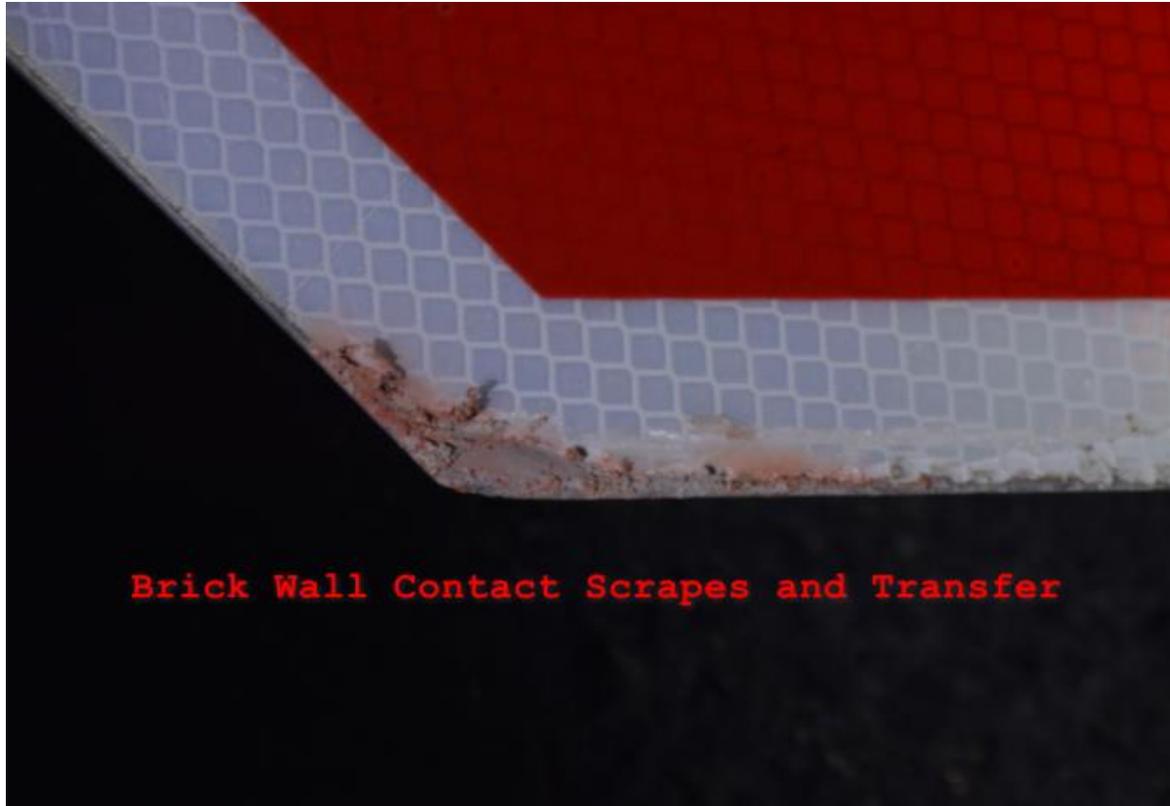
A closer examination of the first area of contact showed the outline of a portion of the octagonal side of the stop sign. This area started approximately four feet and five inches (4'5") above the ground and continued diagonally up to approximately four feet and eight inches (4'8") above the ground. From that point, the scrape was directed diagonally down to approximately four feet and five inches (4'5") before tapering off in a westerly direction. Within this scrape, a fragment of grey and white reflective material was located. This material was consistent with the reflective outer edge material of the

stop sign. An examination of the edges of the stop sign showed contact damage and transfer evidence consistent with striking this wall. (Figures 8 – 10)

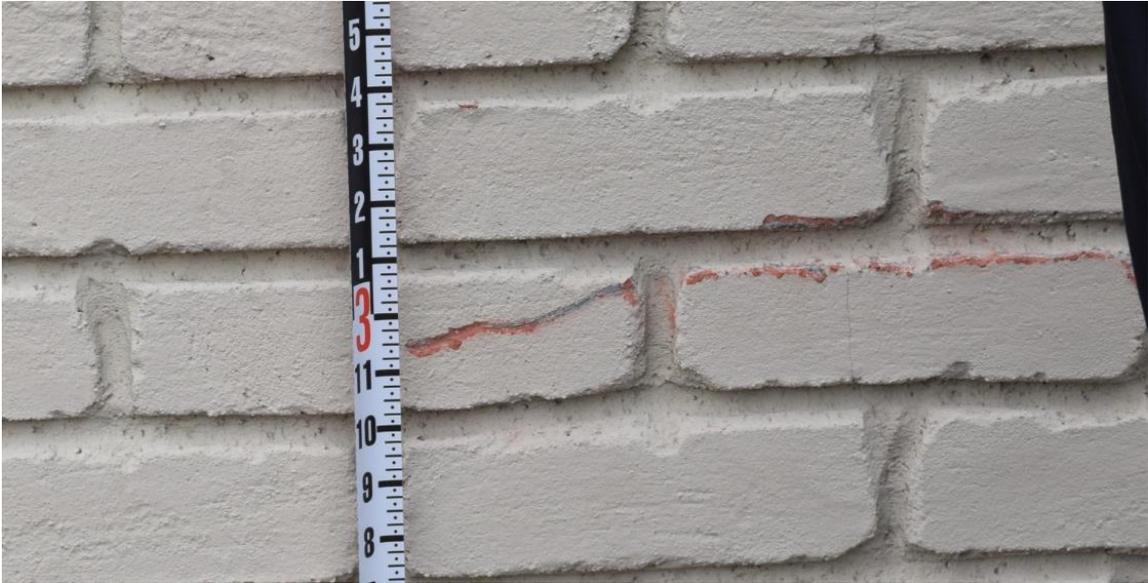
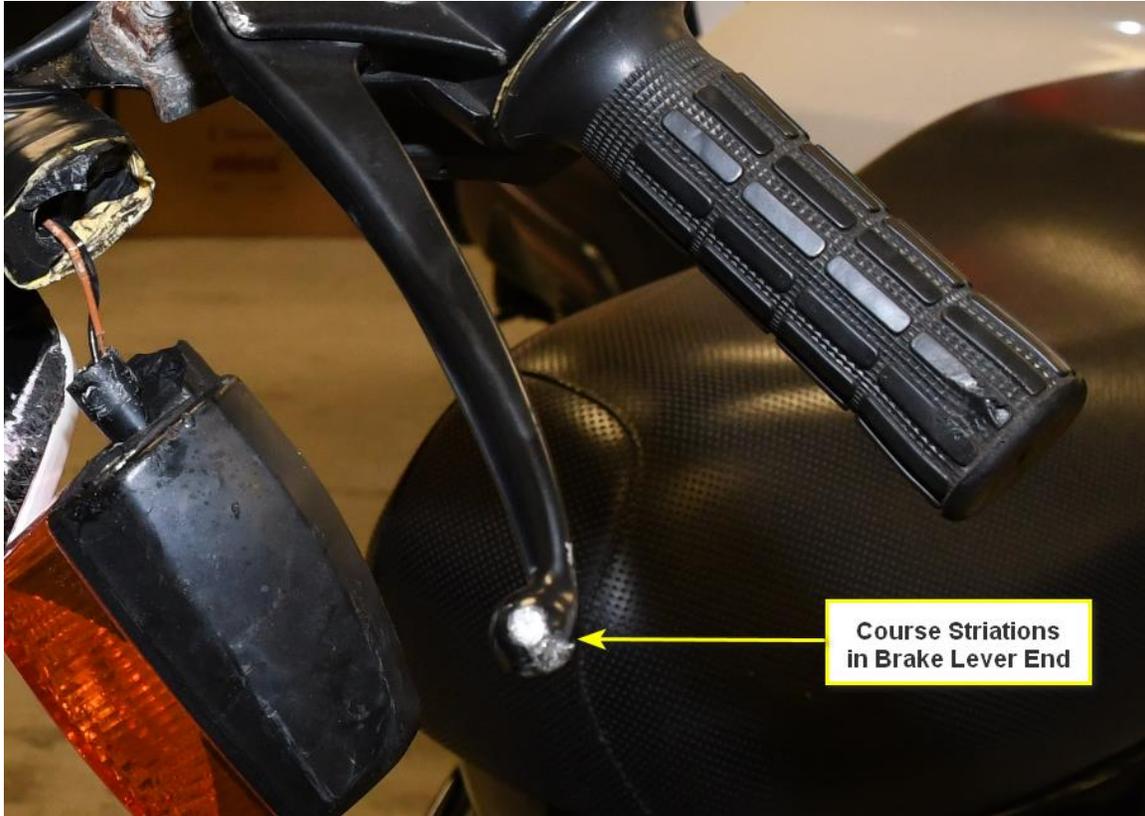
A closer examination of the second area of contact showed the distinct contact and damage pattern that was consistent with the knob end of the left brake lever of the scooter striking the wall. This contact area started approximately two feet and eleven-and one-half inches (2'11.5") above the ground, rising to approximately three feet and one inch (3'1") above the ground and continuing between the gap of two layers of bricks. An examination of the scooter showed that the left side of the handlebars were deflected rearward and downward. The knob end of the brake lever was scraped with course striations, consistent with contacting the brick wall. A measurement of the undamaged right side of the scooter showed that the right brake lever knob was approximately two feet and eleven- and three-quarter inches (2'11.75") above the ground. (Figures 11 – 13)

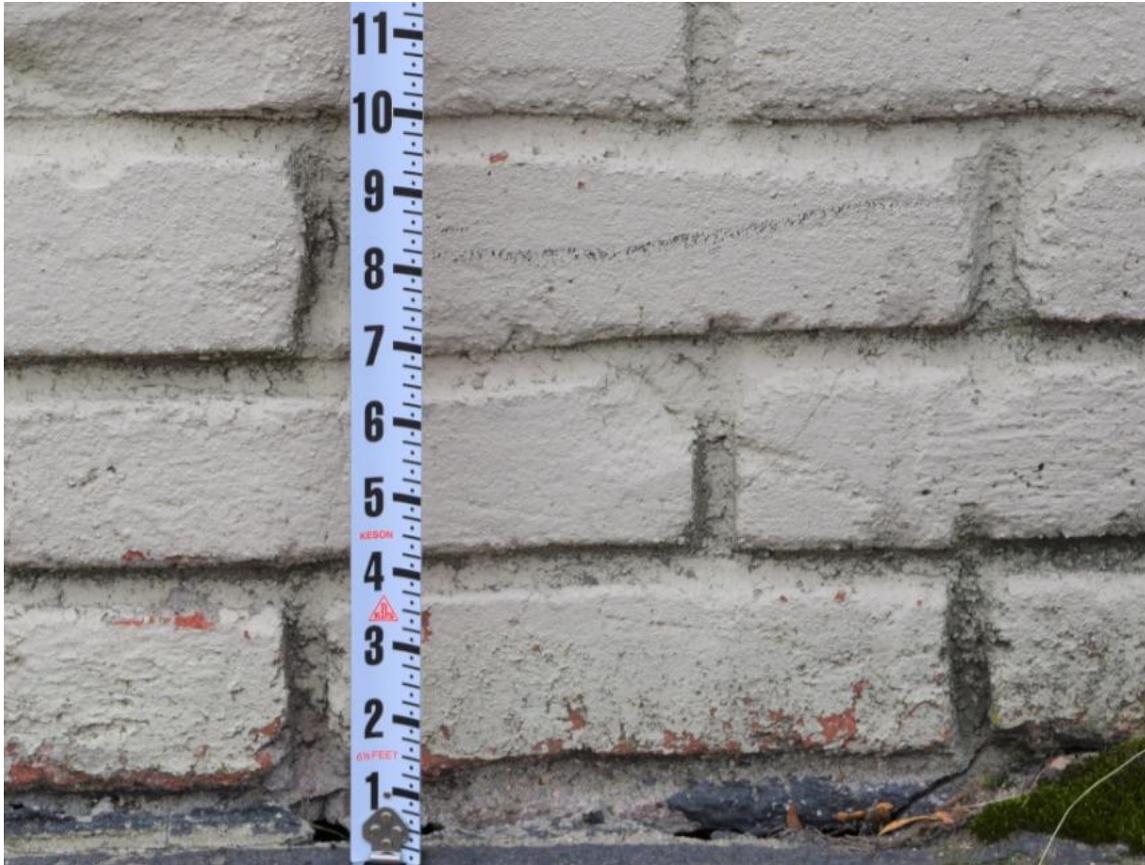
Figure 14

An examination of the third area of contact showed a black scuff mark on the white painted surface of the bricks that was consistent with the left foot peg of the scooter. This contact area started approximately eight inches (8") above the ground and continued diagonally up to approximately nine and one-half inches (9.5") above the ground. An examination of the scooter showed that the static height of the left foot peg was approximately nine inches (9") above the ground. This foot peg also contained an area of white paint transfer along its outside edge that was consistent with the color of the painted brick wall. (Figures 14 & 15)

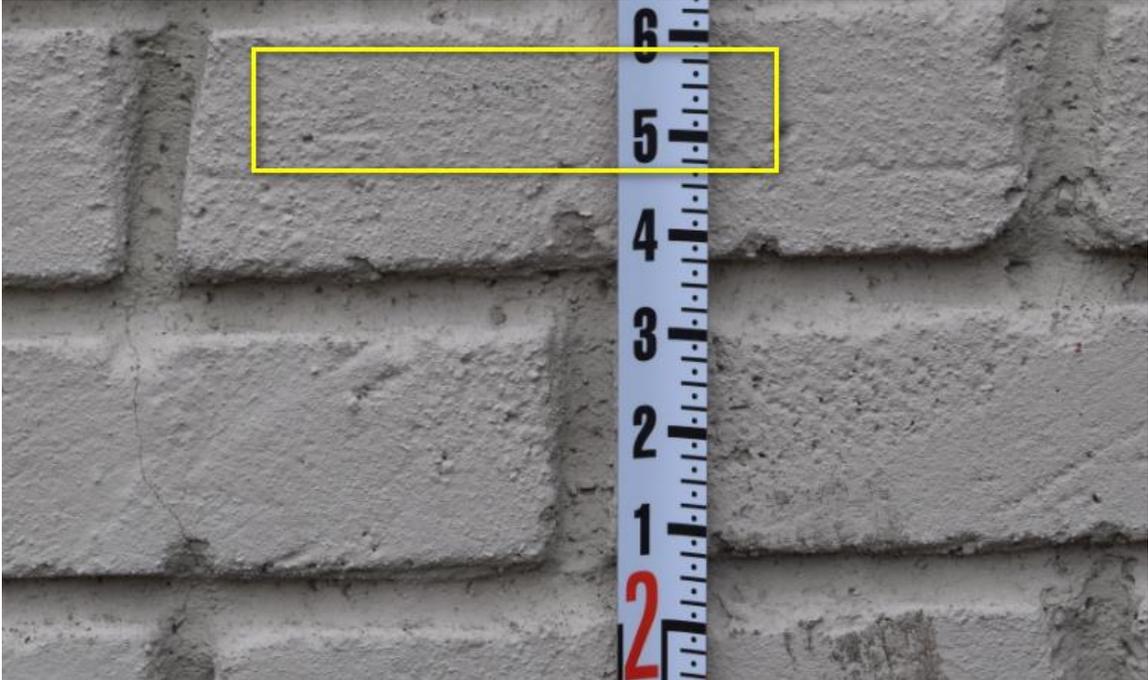
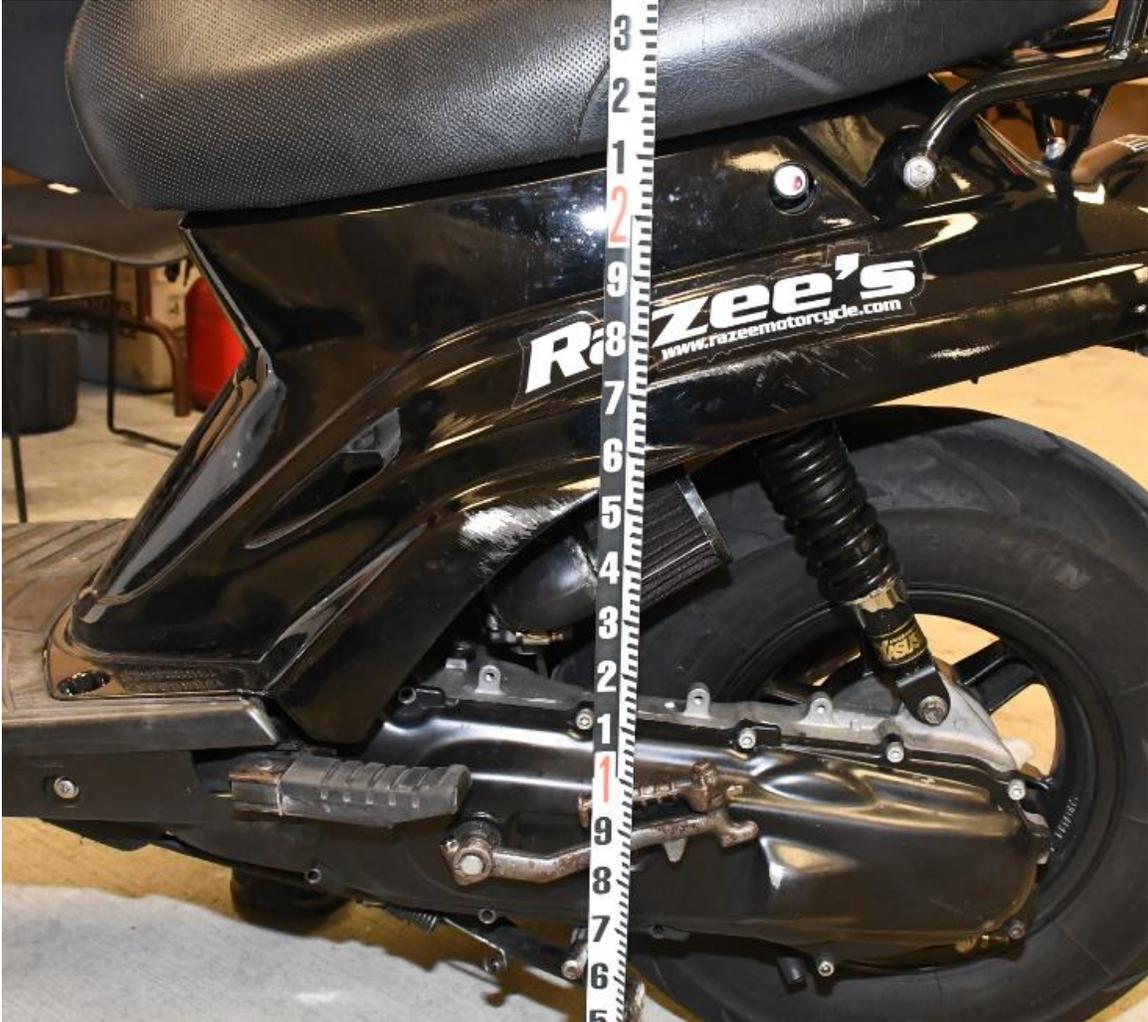
An examination of the fourth and fifth areas showed black scuff marks consistent with the plastic body panels of the scooter. The first mark was located approximately one foot and ten to eleven inches (1' 10"-11") above the ground. The second mark was located approximately two feet and five and one-half inches (2'5.5") above the ground and was shorter than the first scuff mark. (Figures 16 & 17) An examination of the left side panels of the scooter revealed numerous areas of scraping both in a horizontal and a vertical direction. Based on a review of the body camera footage, the scooter was also dragged on its left side after the collision before being stood upright and onto its kickstand.

The two areas of the scooter that were located that were consistent with these height profiles of the scrapes on the brick wall are depicted below in Figures 18 and 19. Whether the additional scrapes to the left panels of the scooter occurred during this crash event into the brick wall, or when the scooter fell over onto its left side onto the sidewalk, or whether they were from a previous incident(s), was undetermined by this investigation.

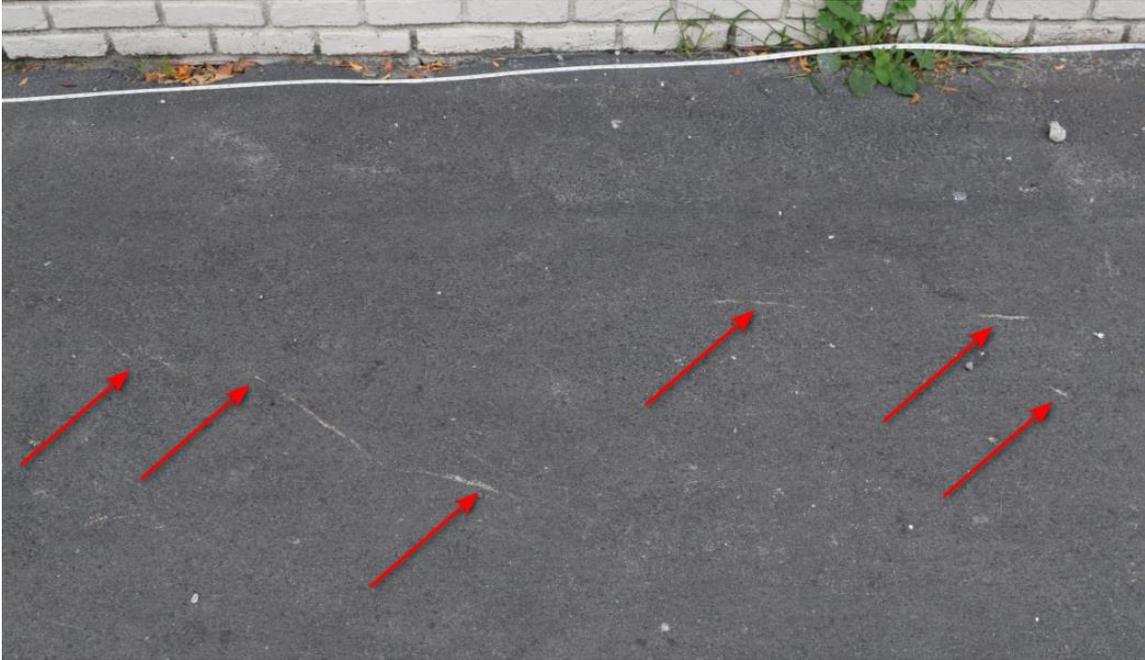
*Figure 20*

An examination of the sidewalk showed numerous gouges and scratches in the asphalt sidewalk that were consistent with the Yamaha scooter falling over onto its side while traveling in a westerly trajectory. (Figure 20)

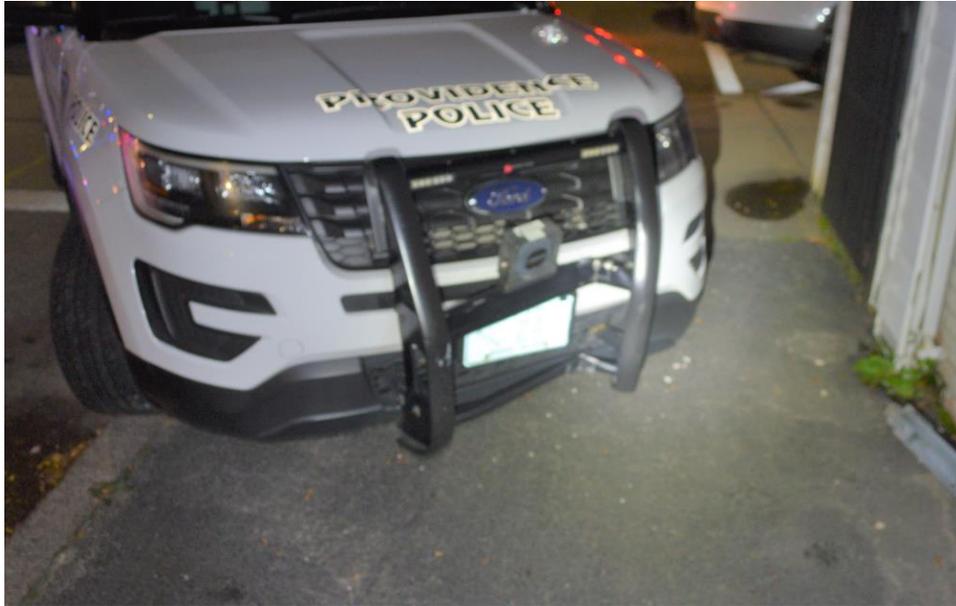
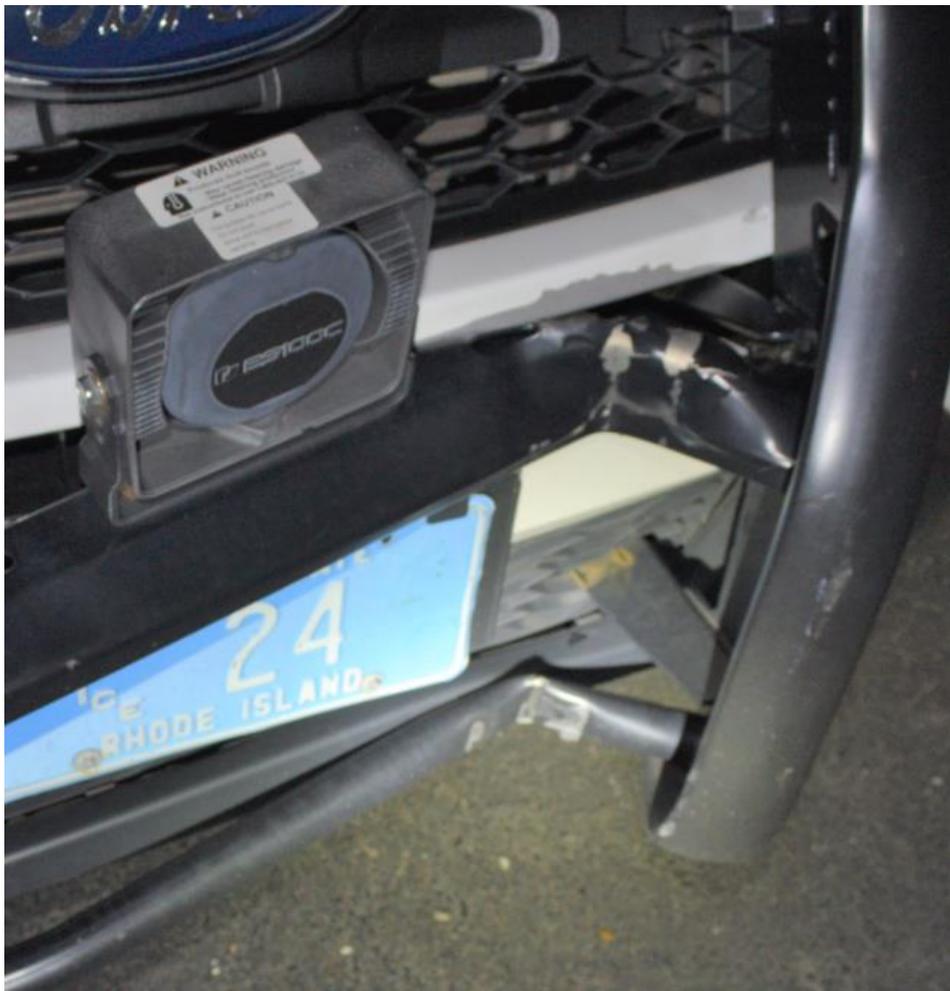
As the Providence Police Cruiser drove onto the sidewalk at the corner of Elmwood Avenue and Bissell Street, it struck a vertical stop sign and broke it from its mount in the sidewalk. The scene photographs show that the two inside cross rails of the front push bumper were deflected inward along the driver's side. This damage profile is consistent with the contour shape of the stop sign post. (Figures 21 & 22). Further analysis of this contact damage will be discussed in the **Vehicle Examination** section of this report. (Pages 41 – 42)

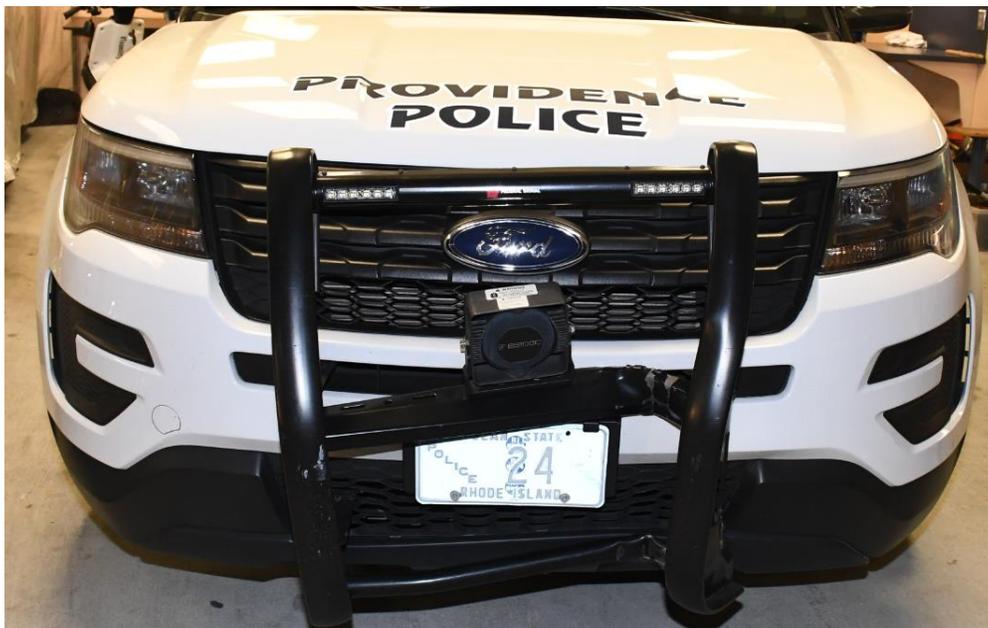
*Figure 25*

An examination of the front of the vehicle showed visible contact damage and deformation to the upper and lower cross rails of the push bumper. (Figure 25)

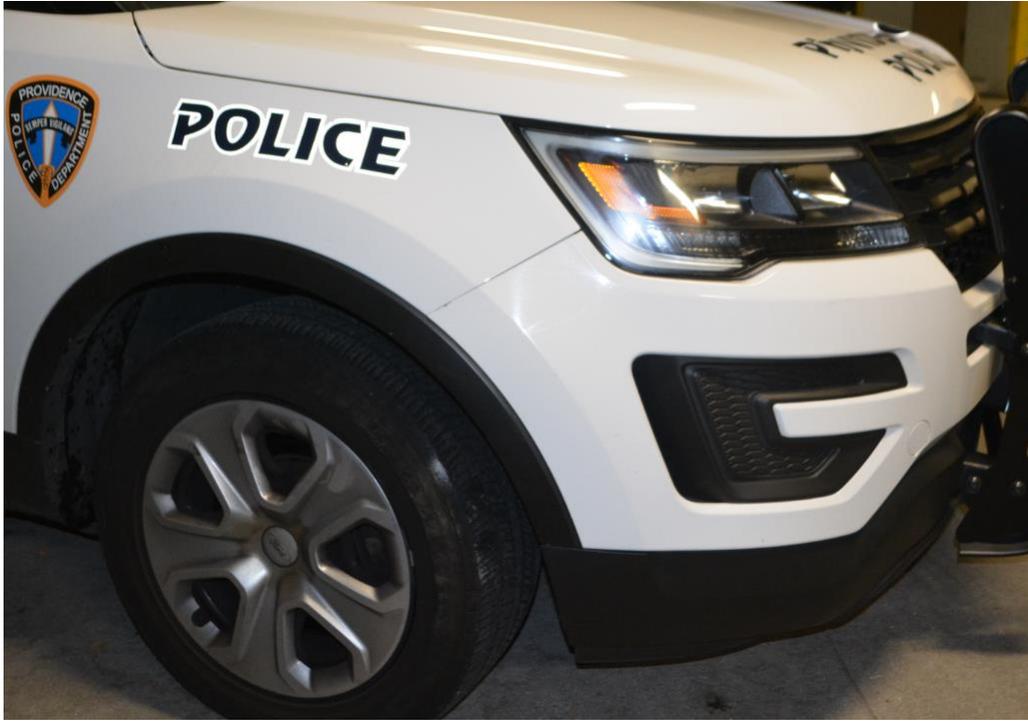
*Figure 26*

An examination of the passenger side and driver's side quarter panels and wheels showed no evidence of contact damage. (Figures 26 & 27)

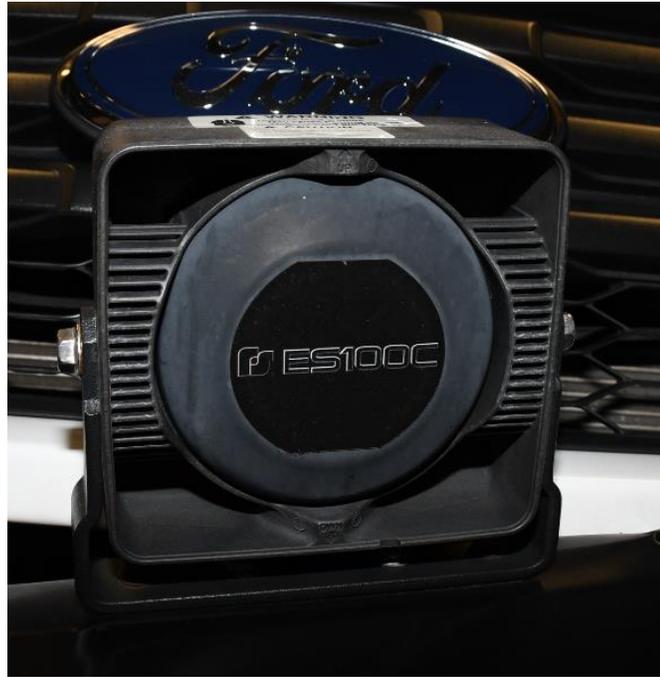
*Figure 30*

An examination of the external siren mounted to the upper cross rail of the push bumper showed no evidence of contact damage. (Figure 30)

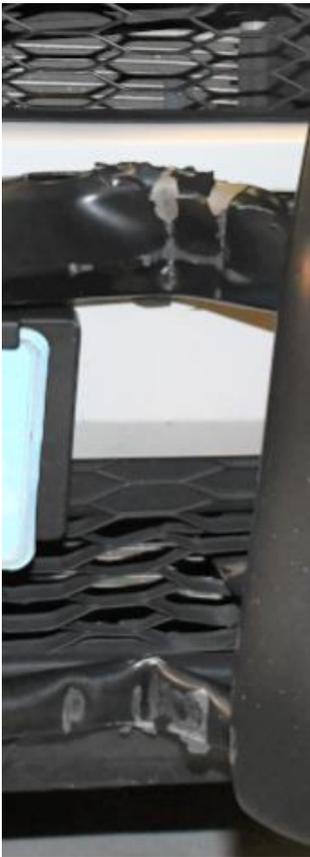
An examination of the upper and lower inner cross rails of the push bumper to the driver's side of the siren, showed the area of visible contact damage and deformation. The contoured profile of this area of damage was attributed to it striking the vertical stop sign post. (Figure 31)

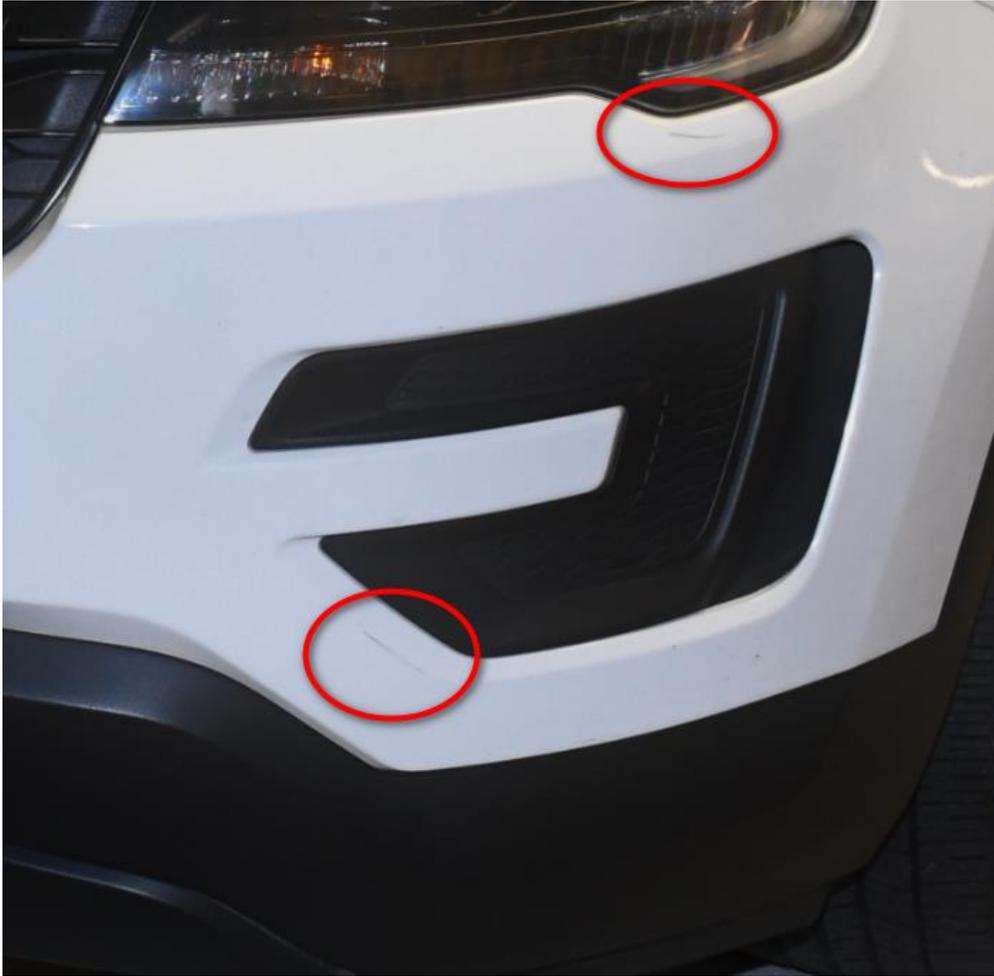
*Figure 35*

A closer examination of the front driver's side of the Ford showed two areas of contact transfer. The first area was above the contoured horizontal fascia of the bumper cover, just below the headlight assembly. The second area was lower, along the edge of a molded and recessed decorative black panel. (Figure 35)

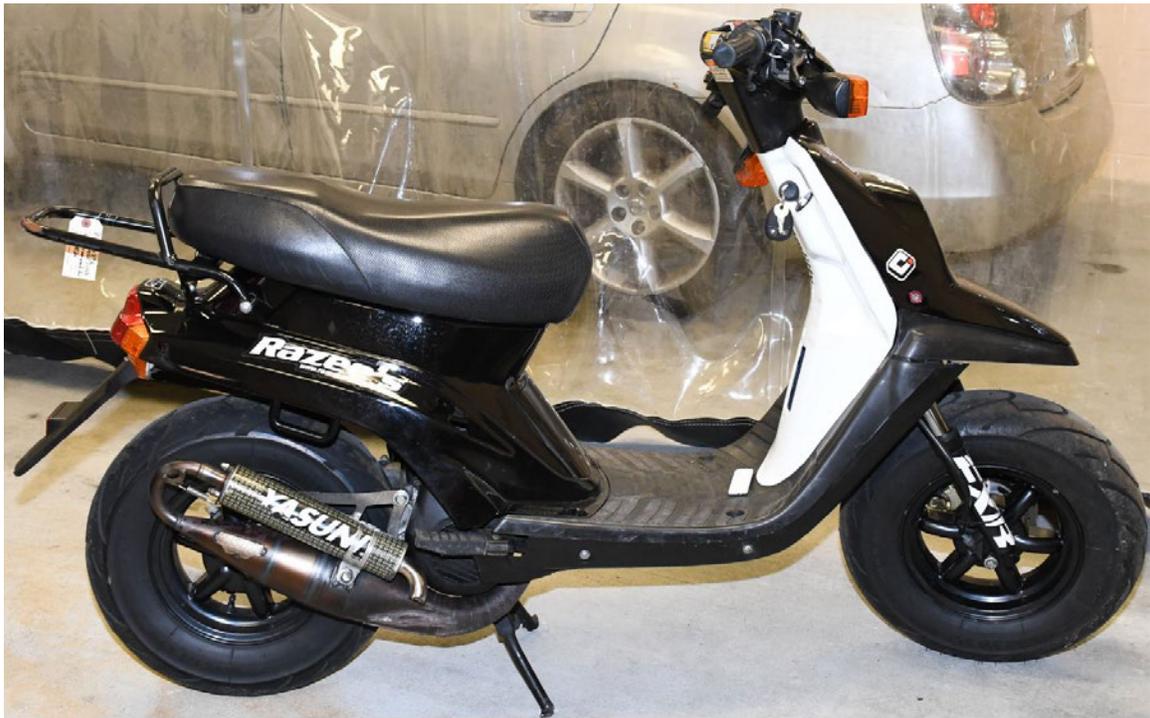
*Figure 36*

An examination of the right side of the scooter showed various areas of scratches, scuffs, and a deeper area of scraping along the muffler. However, none of these areas were attributed to this crash event. (Figure 36)

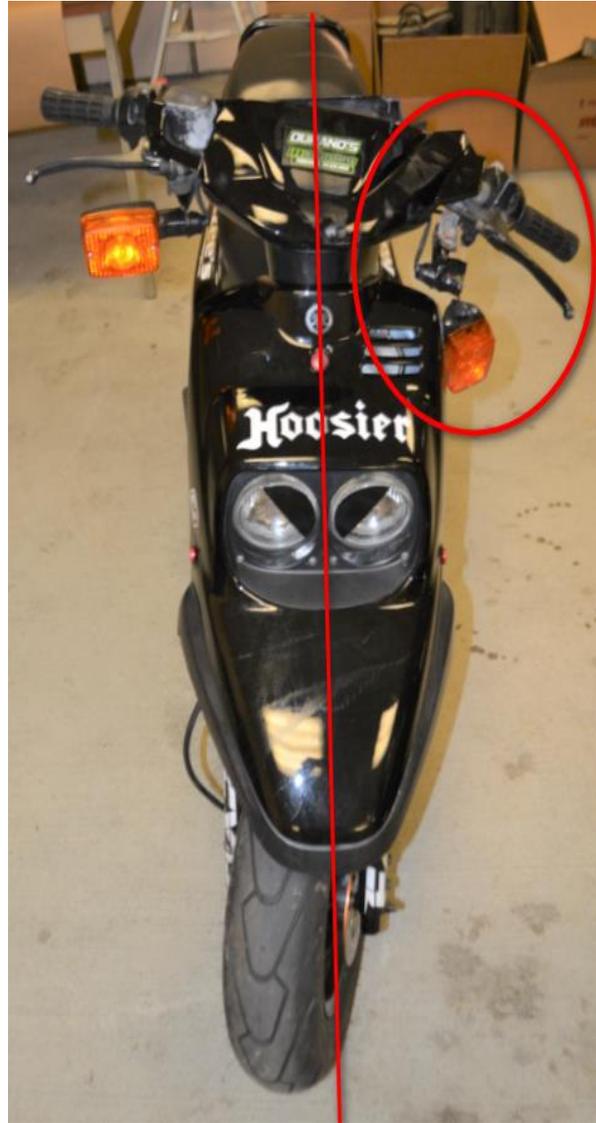
*Figure 37*

An examination of the front of the scooter showed that there were superficial scratches to the front tire fender mudguard. The right side (while sitting on the scooter) of the handlebars appeared undamaged. The right brake lever and the orange directional light assembly were intact. The left side of the handlebars (while sitting on the scooter) were deflected rearward and downward. The orange directional light assembly was broken and hanging by its wires. Its original mount appeared to have been previously broken and was being held in place with black electrical tape. The front tire of the scooter was no longer in alignment with the handlebars and was offset to the right. This damage was consistent with the left side of the scooter contacting the brick wall and deflecting the handlebars rearward and from its fall over onto its left side. (Figure 37)

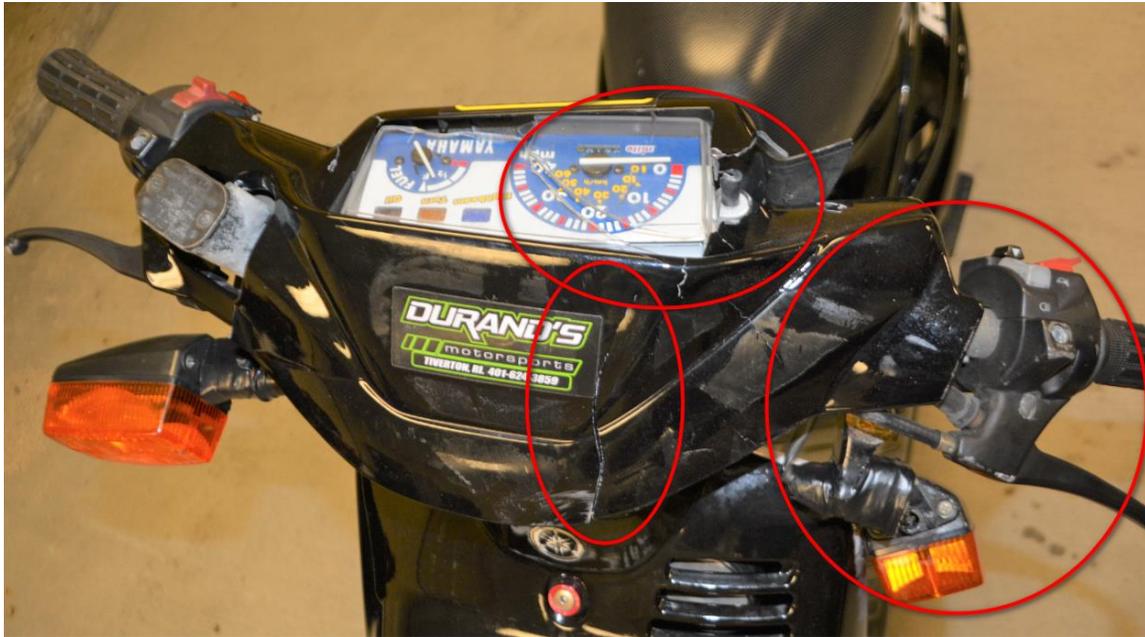
*Figure 38*

An examination of the front fairing and the instrument panel showed that the black plastic was fractured in several areas and the clear plastic cover of the instrument panel was cracked and displaced rearward. This damage was consistent with the left side of the scooter striking the brick wall and falling over onto its left side. (Figure 38)

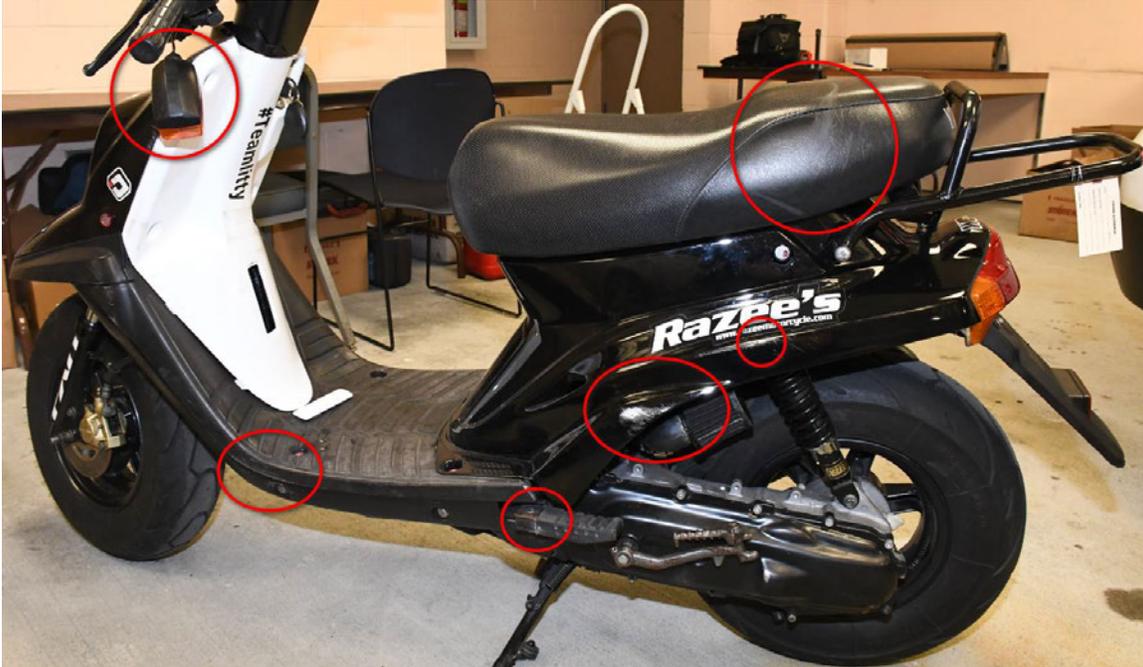
*Figure 39*

An examination of the left side of the scooter showed several areas of contact damage to the side panels and protruding components. At the front of the scooter, below the orange directional light assembly, were scratches and scuffs to the black plastic body panel. At the base of the footwell was an area of course scratches to the black plastic edge. The rear foot peg had scuffs containing a white material, consistent with its contact with the brick wall. The body panel above the chain case had an area of scratching and deeper scuffs through the black paint. The body panel above and outside the rear shock assembly also had an area of scratches and scuffs in the black plastic. The leather seat had two areas of transfer markings that were of an unknown origin. (Figure 39)
