**Rhode Island State Police**  
**Collision Reconstruction Unit Report**

**Case Number: 20-298-CRU**

**Date: October 18<sup>th</sup>, 2020**

**Elmwood Avenue at Bissell Street**

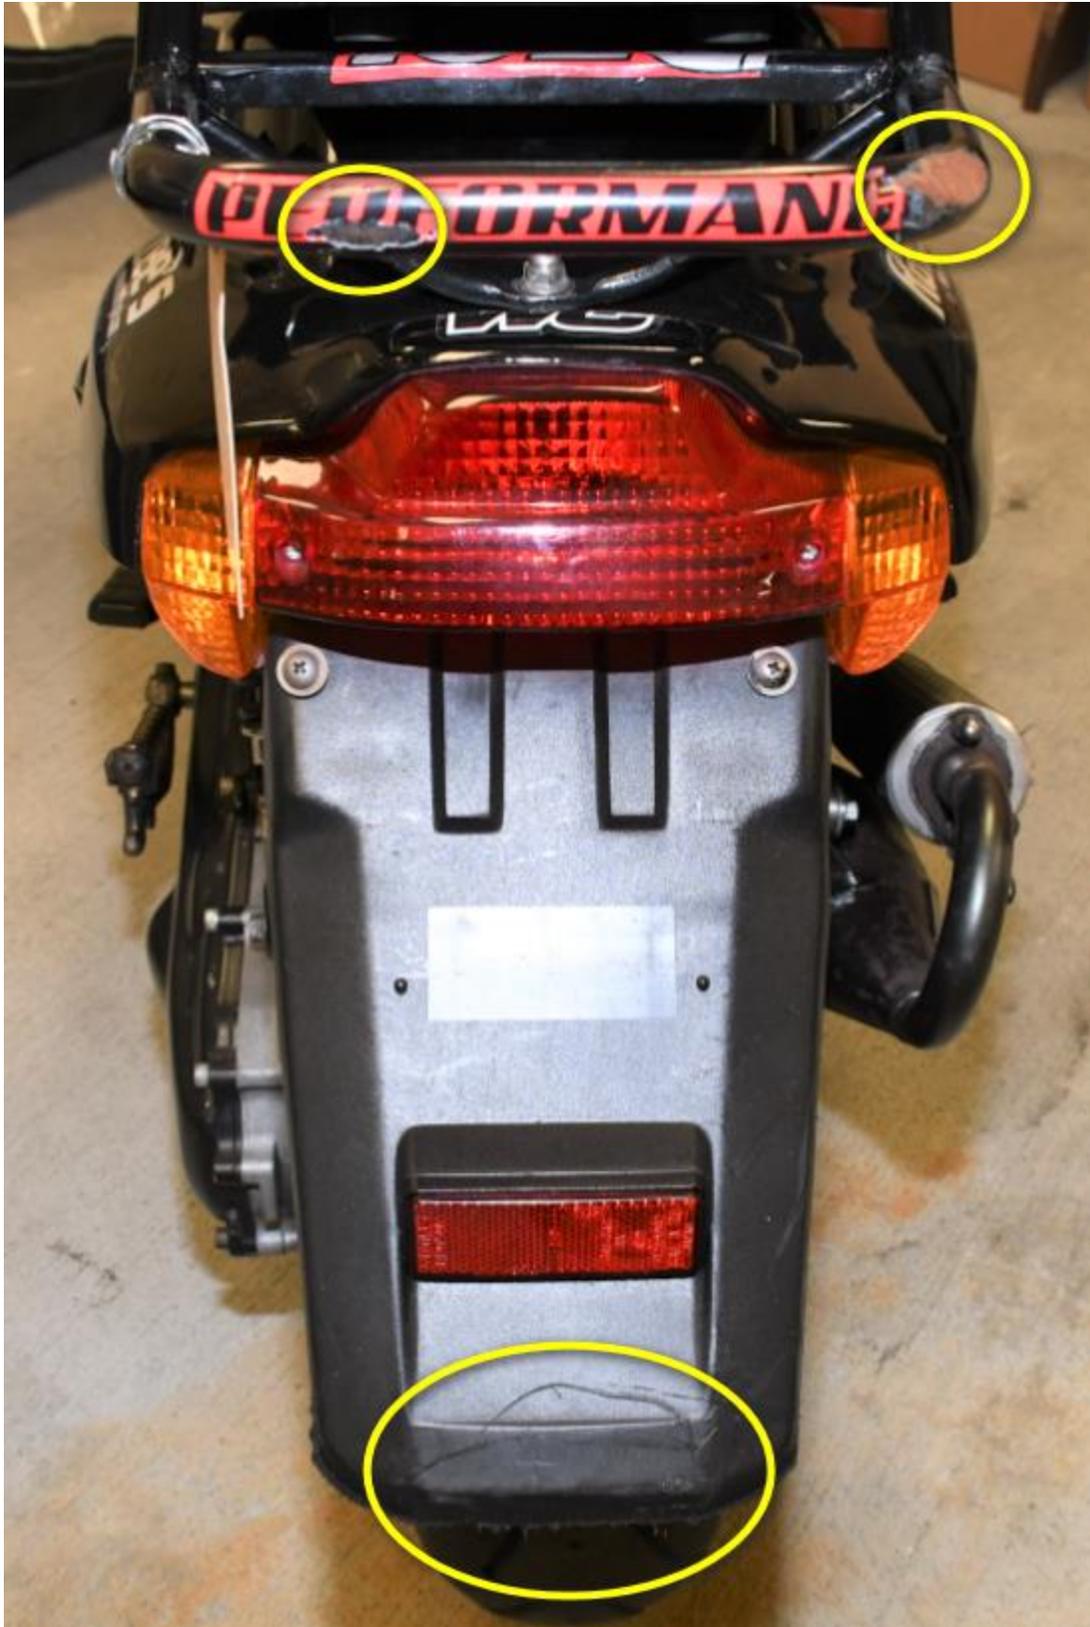
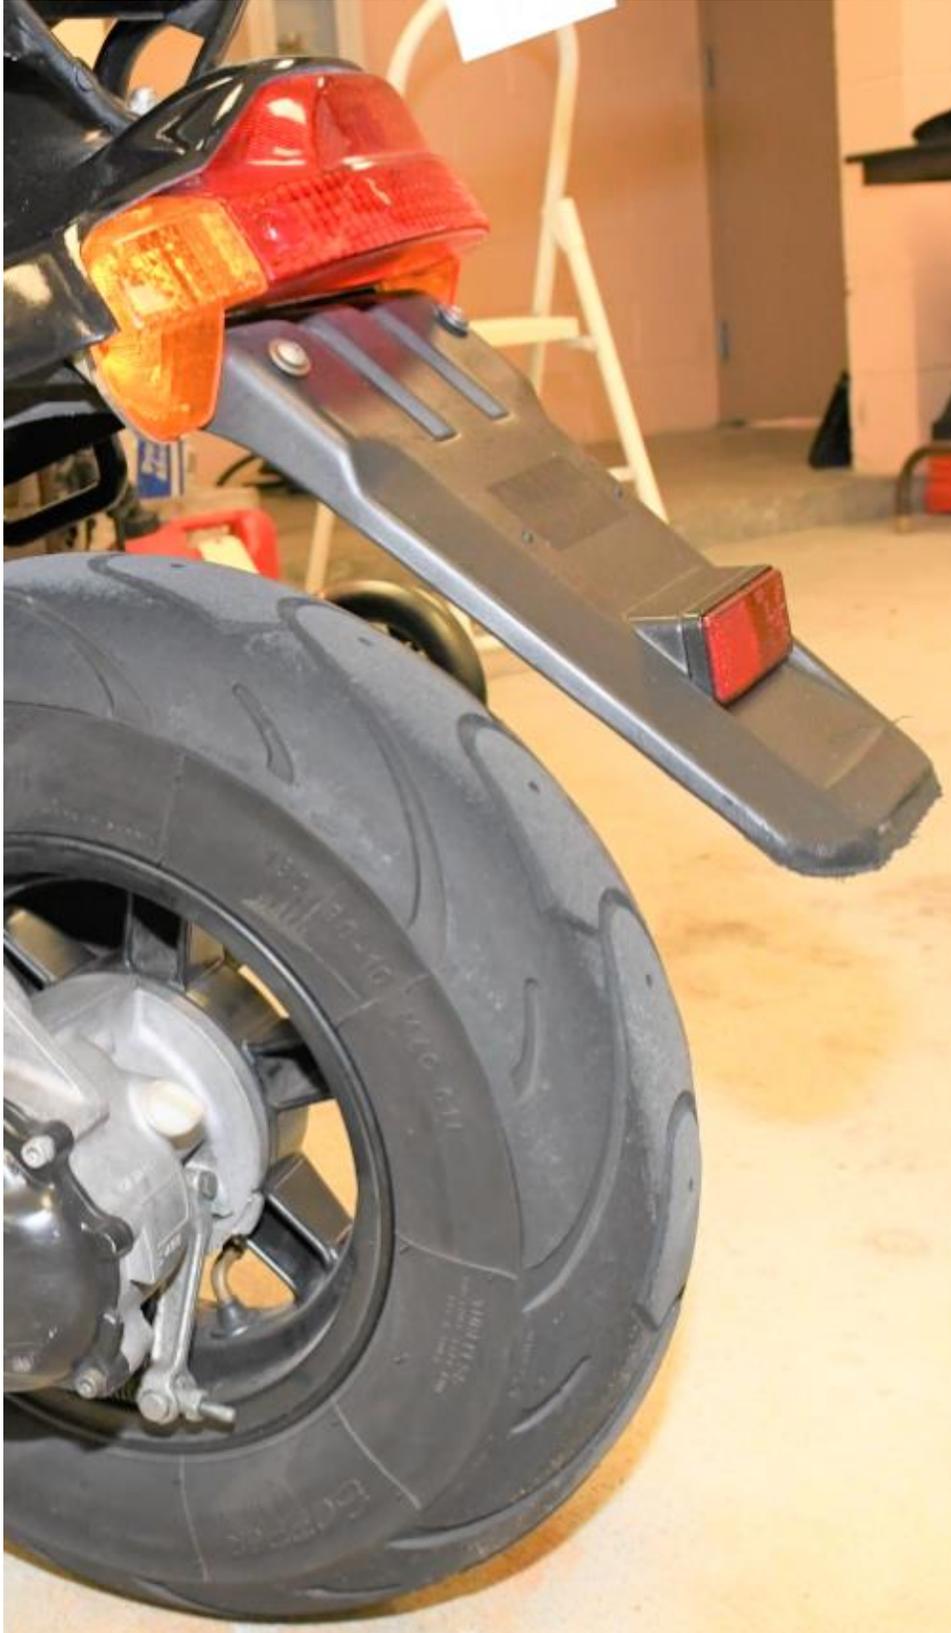
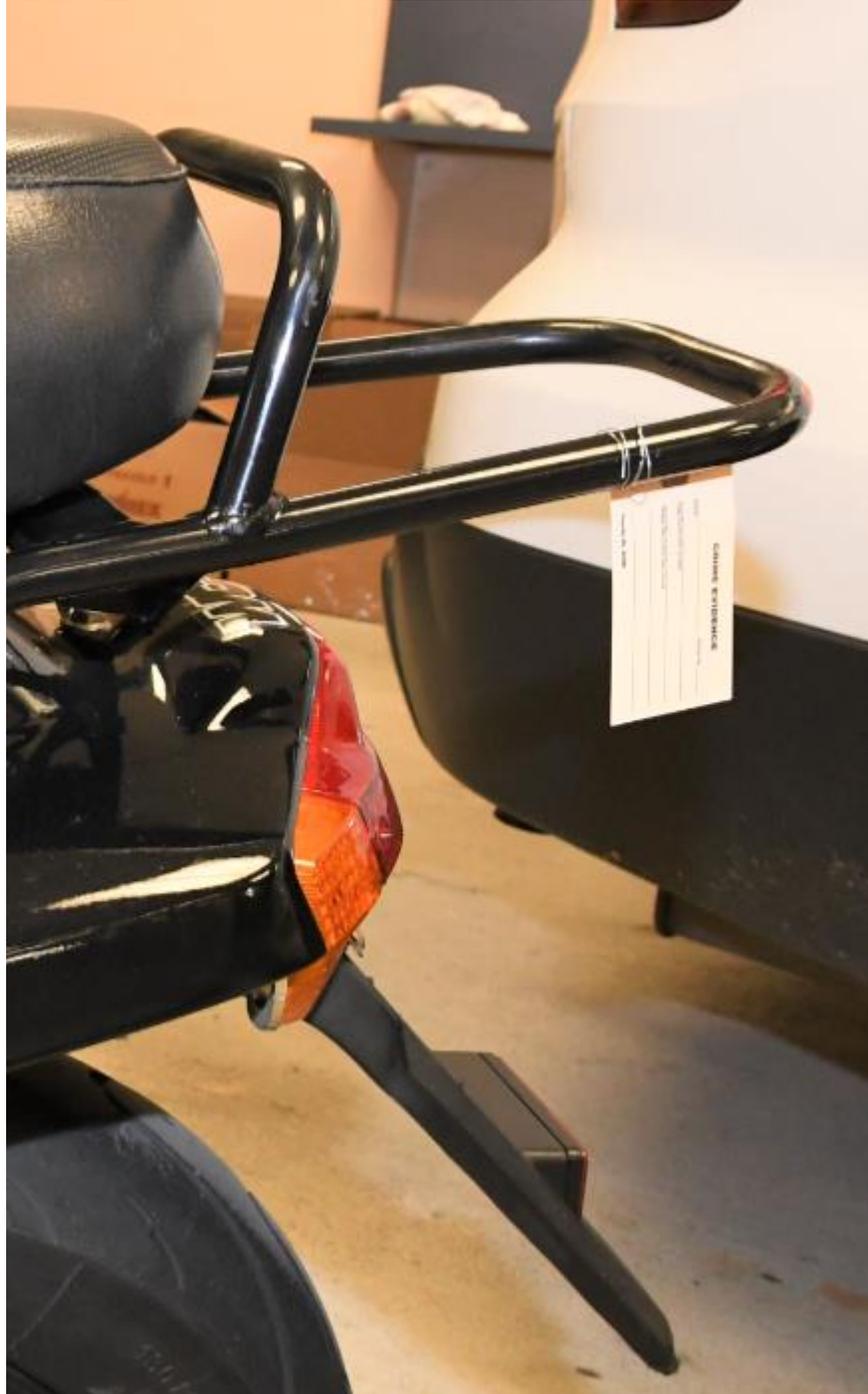
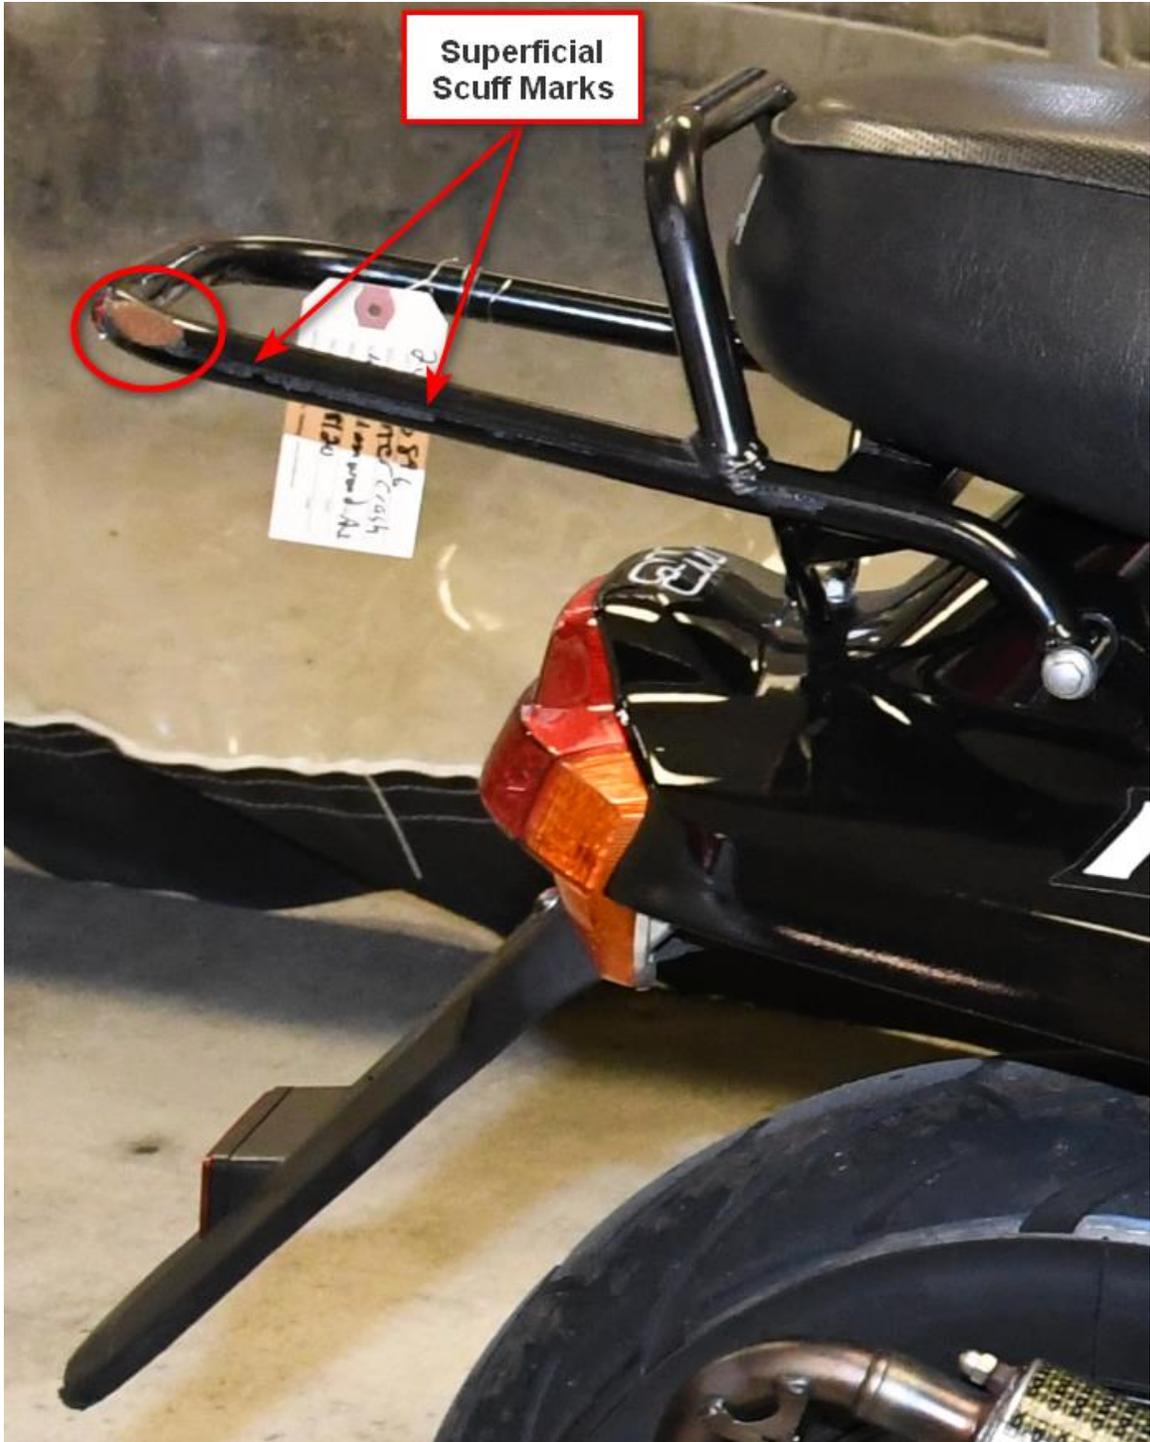
An examination of the rear of the scooter showed two areas of heavy scraping through the paint and into the steel of the metal cargo carrier bar. Both of these scraped areas were heavily oxidized and rusted, indicating that they had occurred prior to this incident. There was an additional area of contact scratches at the bottom of the rear mud flap in an irregular linear fashion. Along the right side of the steel cargo bar was an area of superficial scuff marks that did not penetrate the painted black surface. This examination showed no damage, displacement, cracks, or scuffs to the rear tail light assembly nor the rear plastic reflective lens on the mud flap. Both the cargo bar and the mudflap itself were in the proper alignment and showed no evidence of being struck and deflected forward. (Figures 40 – 43)

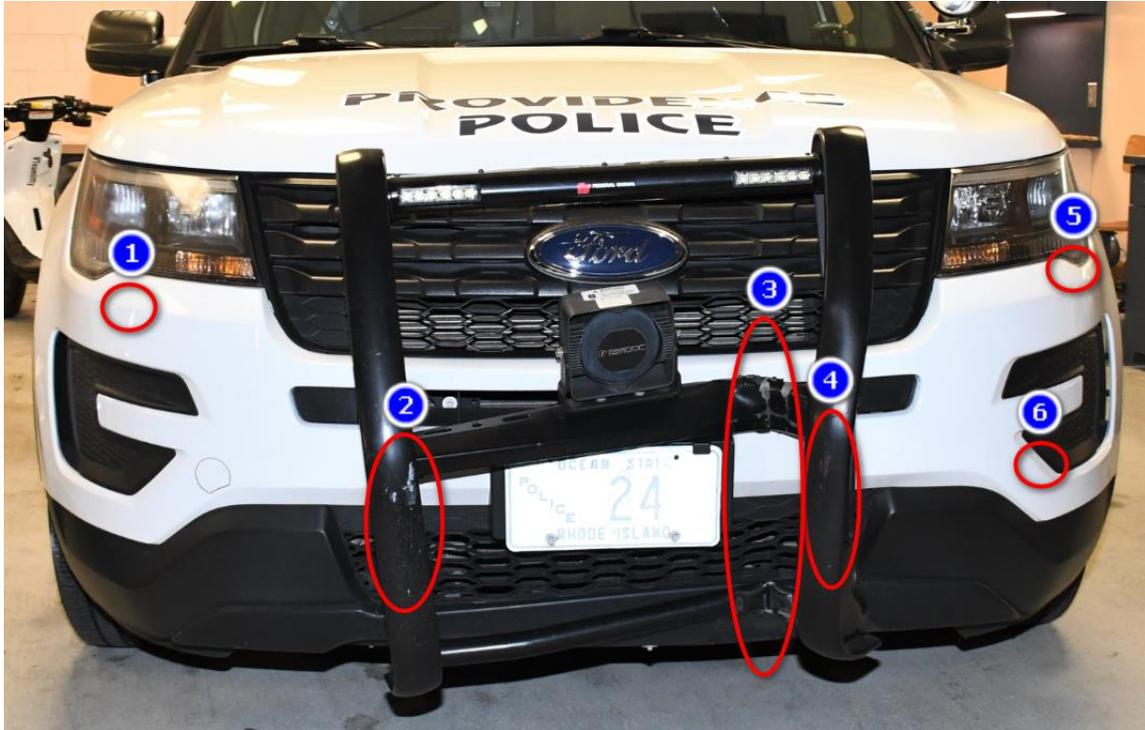
Figure 44

During the vehicle examination of the Providence Police Cruiser, we located six (6) distinct areas of contact damage or transfer. (Figure 44) Each one of those areas was measured and examined closely using macrophotography. Each one of those areas was later compared to the rear of the Yamaha scooter – both for contact transfer evidence and vehicle alignment configurations.

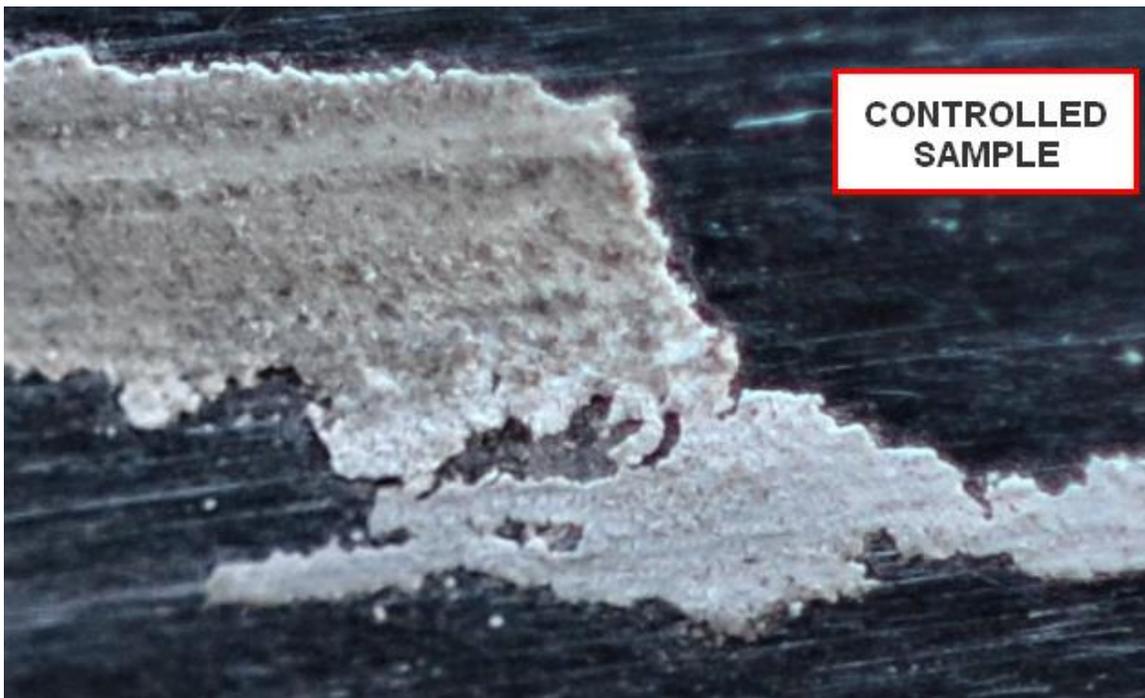
The area of the whitish scuffing and paint splatter on rubber housing around the vertical structure of the push bumper was examined. The area of the deepest scuffing was approximately one foot and nine inches (1'9") to one foot and eleven inches (1'11") above the ground – on the damaged and slightly out of alignment push bumper. There were also numerous areas of white paint splatter below. (Figures 46 & 47) Macrophotography of this area showed that there were scuffs and white latex or oil-based paint chips on the rubber itself. (Figure 48) These paint chips were consistent with a white latex paint or oil-based paint-controlled sample. (Figure 49)

When comparing this area of paint transfer to the rear of the Yamaha scooter, there was no white paint or protruding component that could have caused this contact damage transfer.

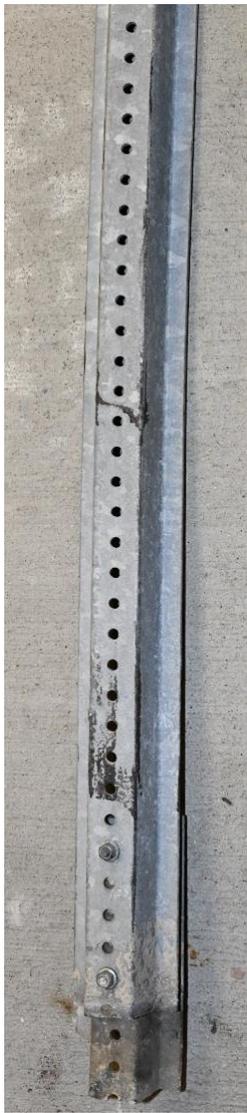
*Figure 50*

The area of the damage to the upper and lower cross rails of the push bumper were determined to be from striking the vertical stop sign post. The width and contour of the damage was consistent with this impact. The corresponding black paint and rubber contact transfer onto the signpost was also consistent with this impact. A further examination of the damage profile under magnification showed no evidence of any type of transfer evidence that was not consistent with the signpost contact. (Figures 50 – 53)

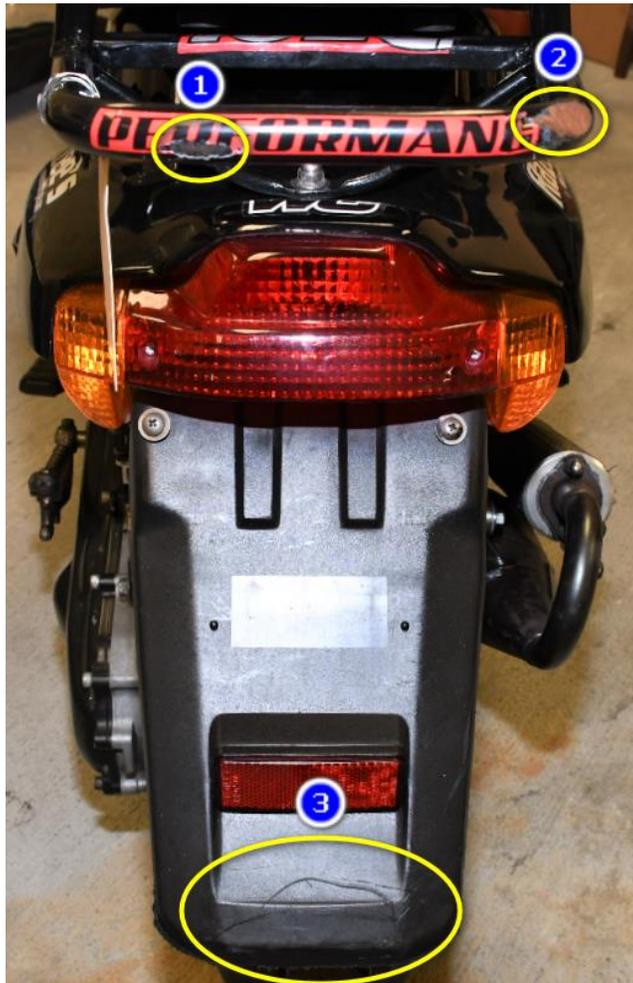
*Figure 62*

During the vehicle examination of the Yamaha scooter, we located three (3) distinct areas of contact damage along the rear of the vehicle. (Figure 62) Each one of these areas was measured and examined closely. Each one of these areas was also compared to the front of the Providence Police Cruiser – both for contact transfer evidence and vehicle alignment comparisons.

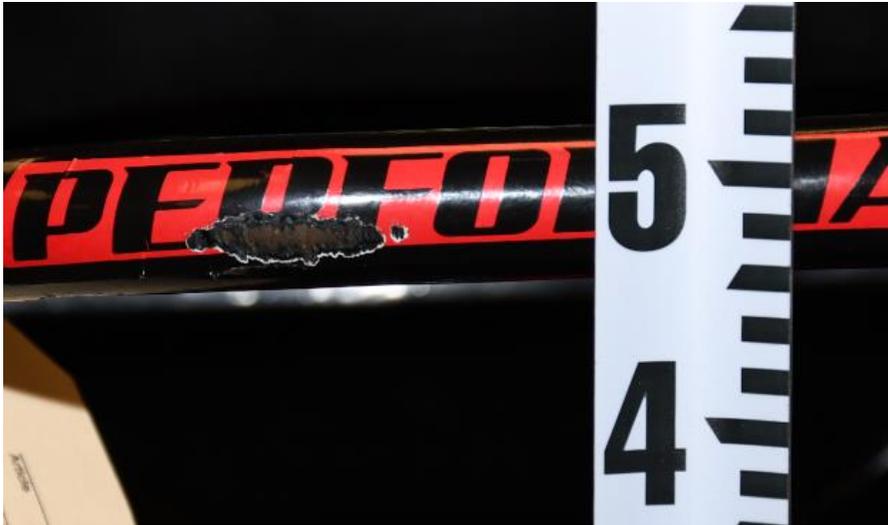
**Figure 63** (This ruler scale is in decimals – 2.5 feet is equivalent to 2'6")

This area of contact damage to the rear cargo carrier bar was to the left of the centerline of the scooter. This contact damage was an approximate one inch (1") horizontal scrape into the metal of the cargo bar, approximately two feet and six inches (2'6") above the ground. A closer examination showed that the channels of the scrapes were in a vertical direction. Within the scrapes were significant oxidation and rusting of the metal. This level of oxidation and rusting was not consistent with this damage occurring approximately forty-one (41) hours prior to these photographs being taken. (Figures 63 & 64)

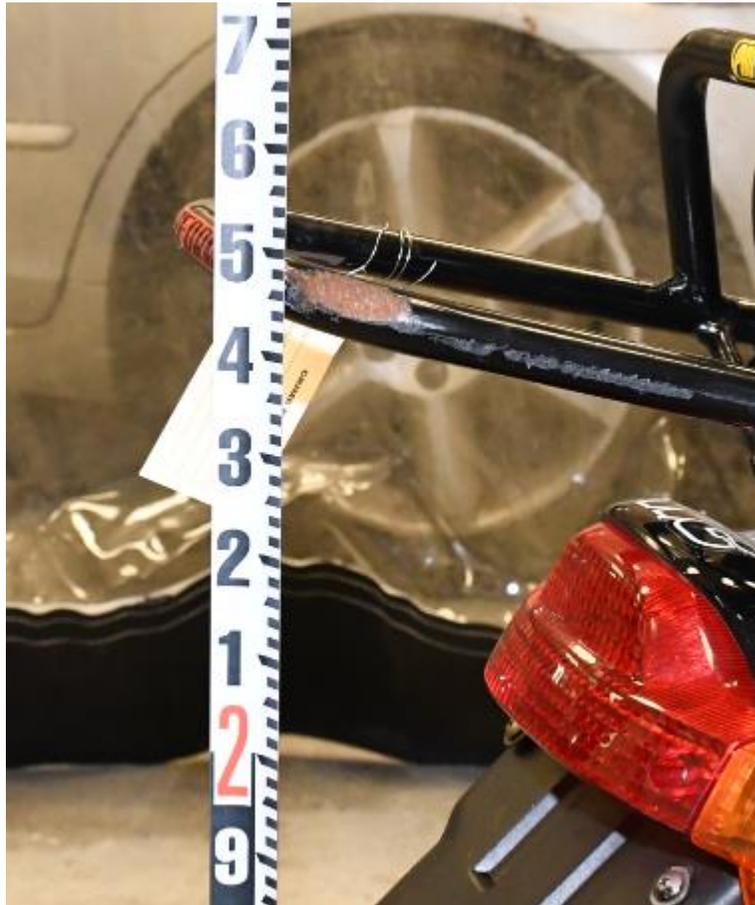
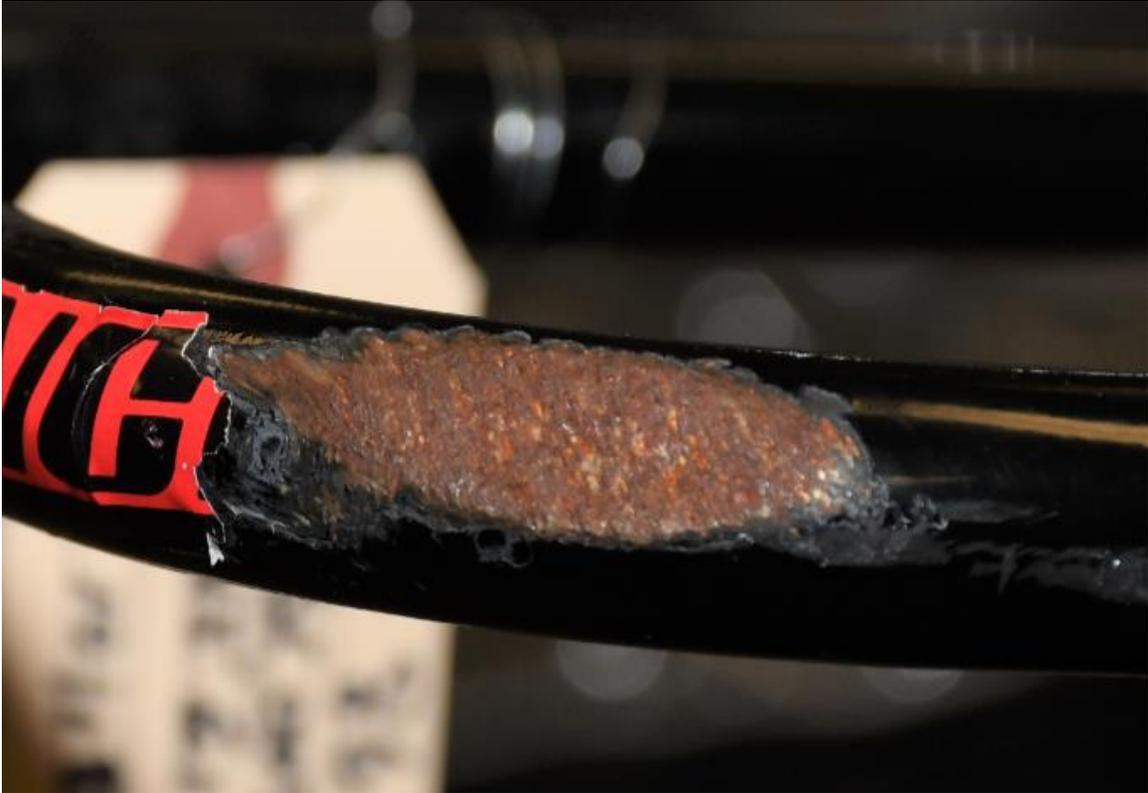
*Figure 66*

This area of contact damage was to the right side of the rear cargo carrier bar of the scooter. This contact damage was an approximate one and one-half inch (1.5") horizontal scrape into the metal of the cargo bar, approximately two feet and six inches (2'6") above the ground. A closer examination showed that the scrapes were in vertical direction and tapered off towards the rear of the scooter. Within the scrapes were significant oxidation and rusting of the metal, much heavier than the other scrape to the rear of the cargo bar as described previously. This level of oxidation and rusting was also not consistent with this damage occurring approximately forty-one (41) hours prior to these photographs being taken. (Figures 65 & 66)

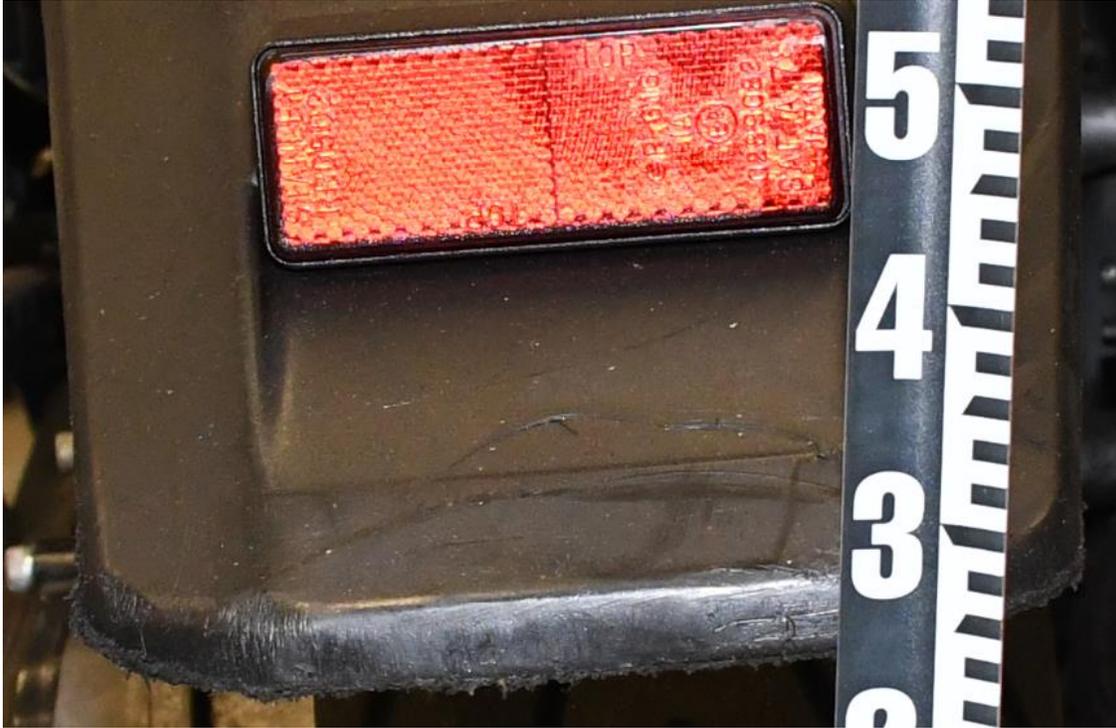
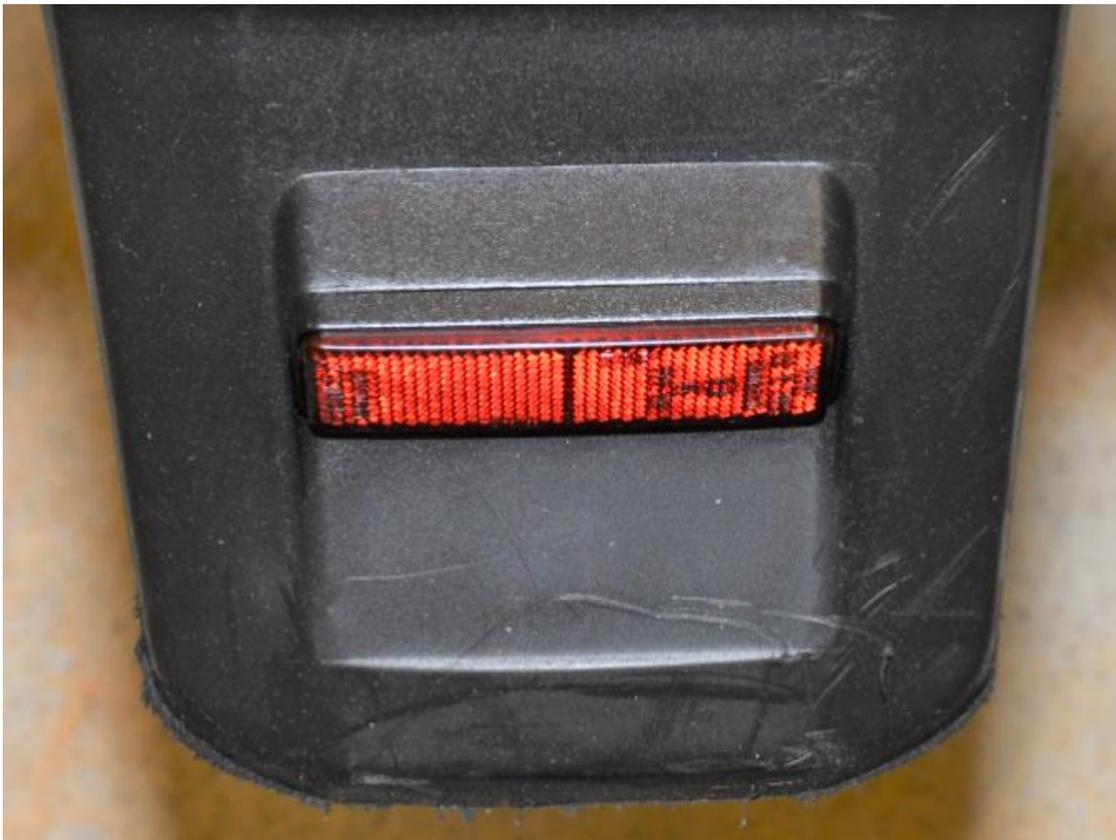
This area of contact damage was to the rear, underside, and edges of the rear black plastic mud flap of the scooter. The areas of damage were numerous course scrapes, gouges and scratches through the plastic in multiple directions. These scrapes were approximately one foot and three inches (1'3") to one foot five inches (1'5") above the ground. While the origin of all these scrapes and gouges was unknown, they are consistent with contact with course structures or aggregate such as asphalt or concrete, and not with any of the frontal components of the Providence Police Cruiser. (Figures 67 & 68)

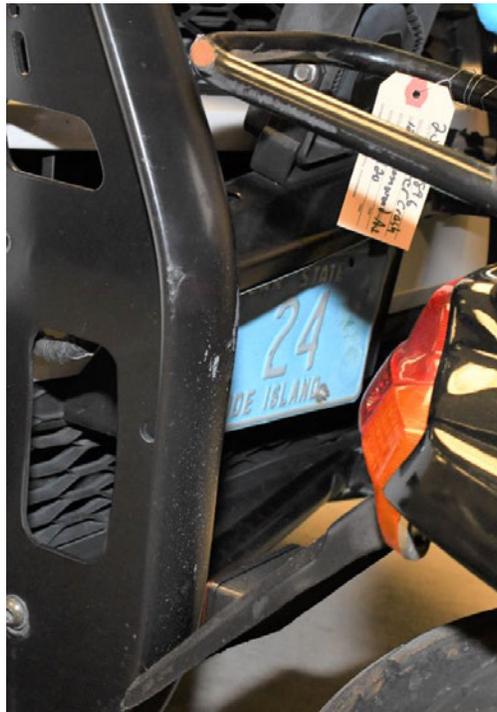
**Figure 69**

Area # 2, the vertical edge of the passenger side push bumper of the Providence Police Cruiser, contained areas of white paint transfer, not consistent with the rear of the scooter. An alignment of the scooter in this area showed that there was no corresponding contact damage or transfer on the push bumper from the rear cargo bar or mud flap of the scooter. (Figure 69)

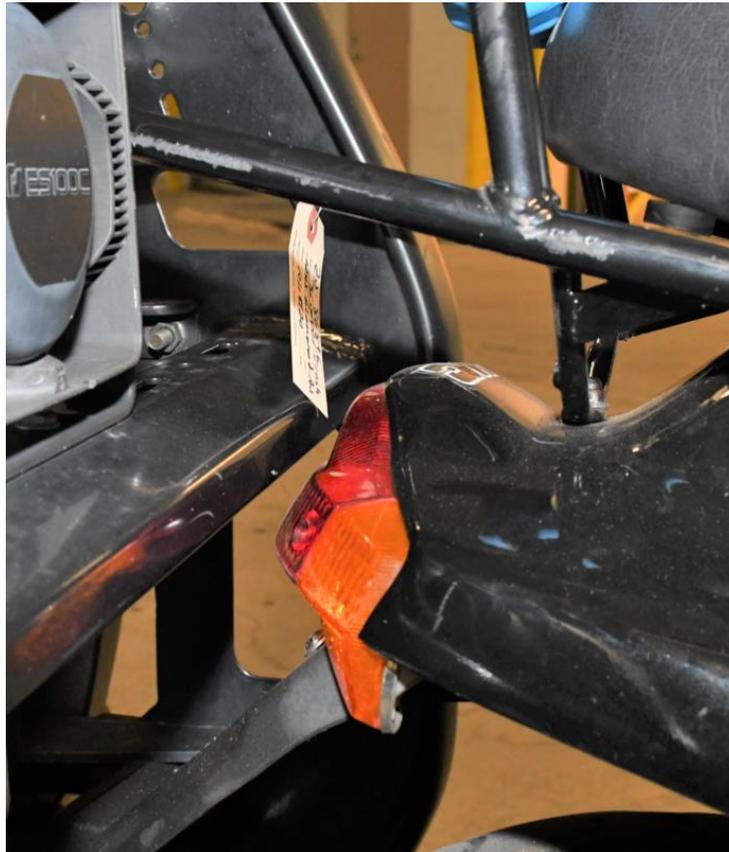
*Figure 70*

An examination of Area # 3 and the area between the two vertical rails of the push bumper was conducted. This examination showed that if the Providence Police Cruiser struck the rear of the Yamaha scooter anywhere in this area, there would have been visible contact damage somewhere along the interior vertical rails of the push bumper, the siren mounted in the center of the push bumper, the front grille of the Providence Police Cruiser, the cargo bar of the Yamaha scooter, the rear mud flap of the Yamaha scooter, or anywhere along the plastic lenses of the scooter's tail light assembly. The lack of any visible damage or contact transfer to either vehicle in these areas confirms that the Providence Police Cruiser did not strike the Yamaha scooter within the interior of the push bumper. (Figures 70 – 73)

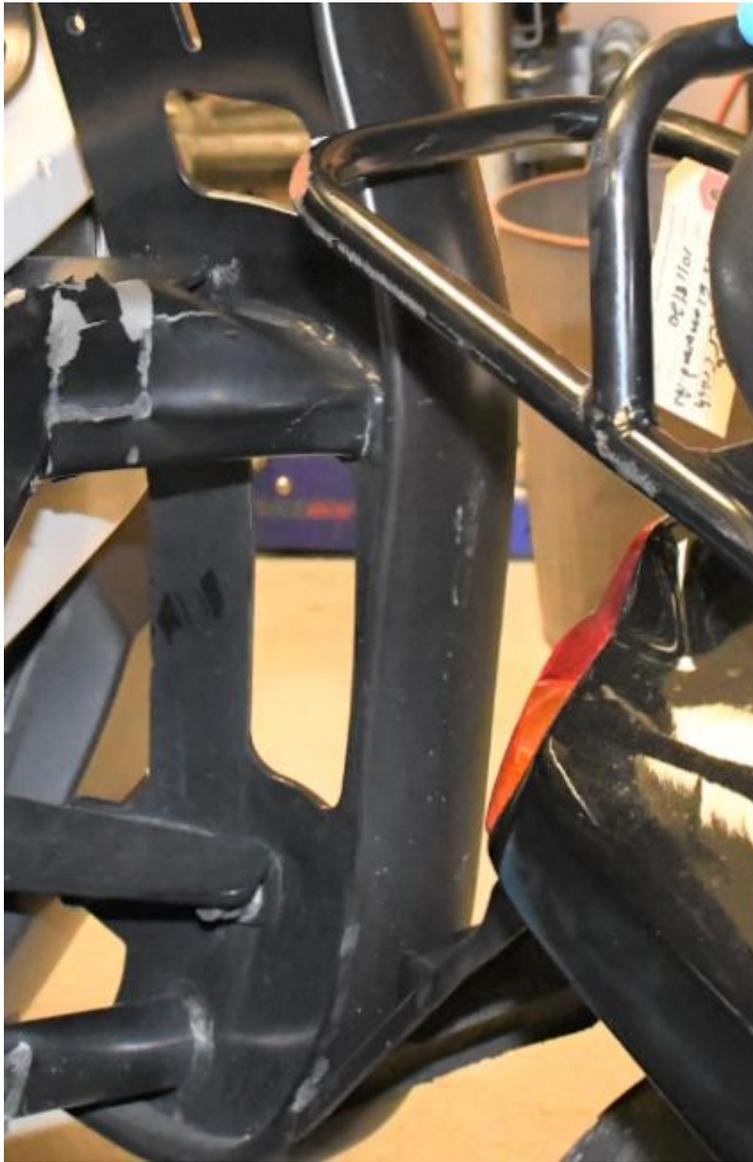
*Figure 74*

Area # 4, the vertical edge of the driver's side push bumper of the Providence Police Cruiser contained areas of white paint transfer, not consistent with the rear of the scooter, and a diagonal impression scuff. An alignment of the scooter in this area showed that the rear cargo bar was too high for both the scuffed area and the diagonal impression, and there was no corresponding contact damage or transfer on the push bumper from the rear mud flap of the scooter. The scuffs along the inside edge of the bottom of the rubber of the push bumper were attributed to its contact with the flared metal edge of the stop sign post, and not the soft and pliable plastic mud flap of the scooter. (Figure 74)

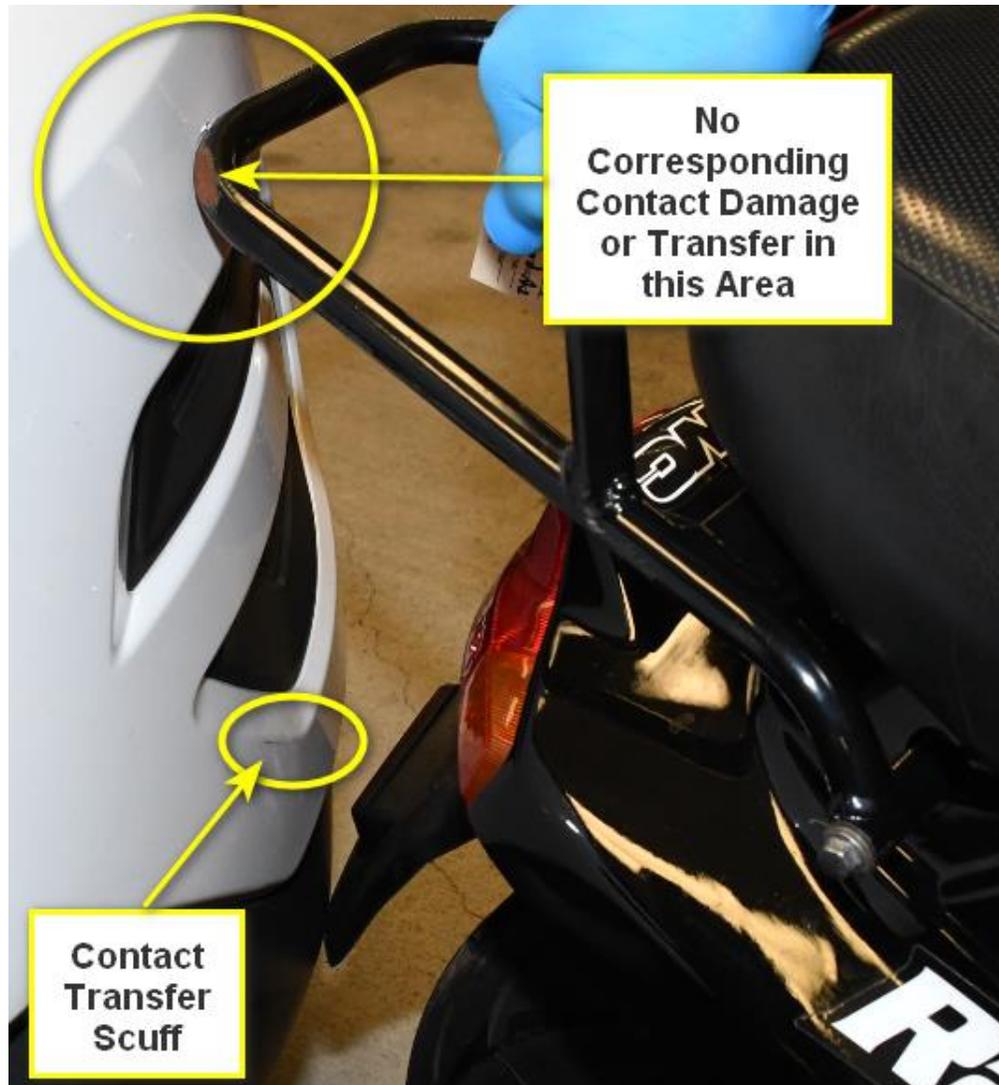
*Figure 77*

Area # 6, the black scuff along the molded edge of the recessed panel, did align with the height of a section of the rear mud flap of the scooter. However, the composition of the scuff itself was not consistent with the black plastic of the rear mud flap, as previously discussed on Page 47. There was also no corresponding contact damage or transfer to the front bumper of the Providence Police Cruiser from the rear cargo bar of the Yamaha scooter. During this alignment examination, the rear cargo bar made contact with the front bumper cover first, before the rear mud flap. Therefore, we were able to conclude that the contact transfer in Area # 6 was not from any contact with the mud flap of the Yamaha scooter. (Figure 77)

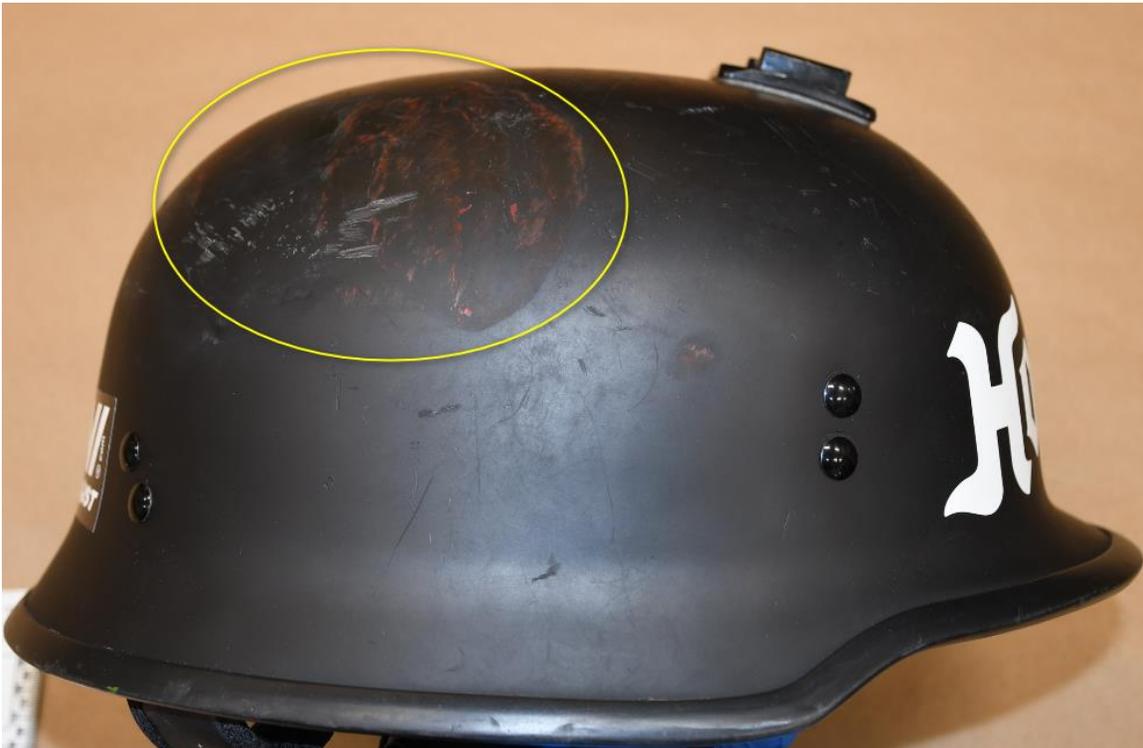
*Figure 78*

After reviewing the video surveillance footage as well as the stop sign and helmet of the Yamaha scooter operator, we were able to conclude that the stop sign struck Gonsalves along the back-right side of his helmet. Figure 78 below illustrates the area of the helmet that was struck.

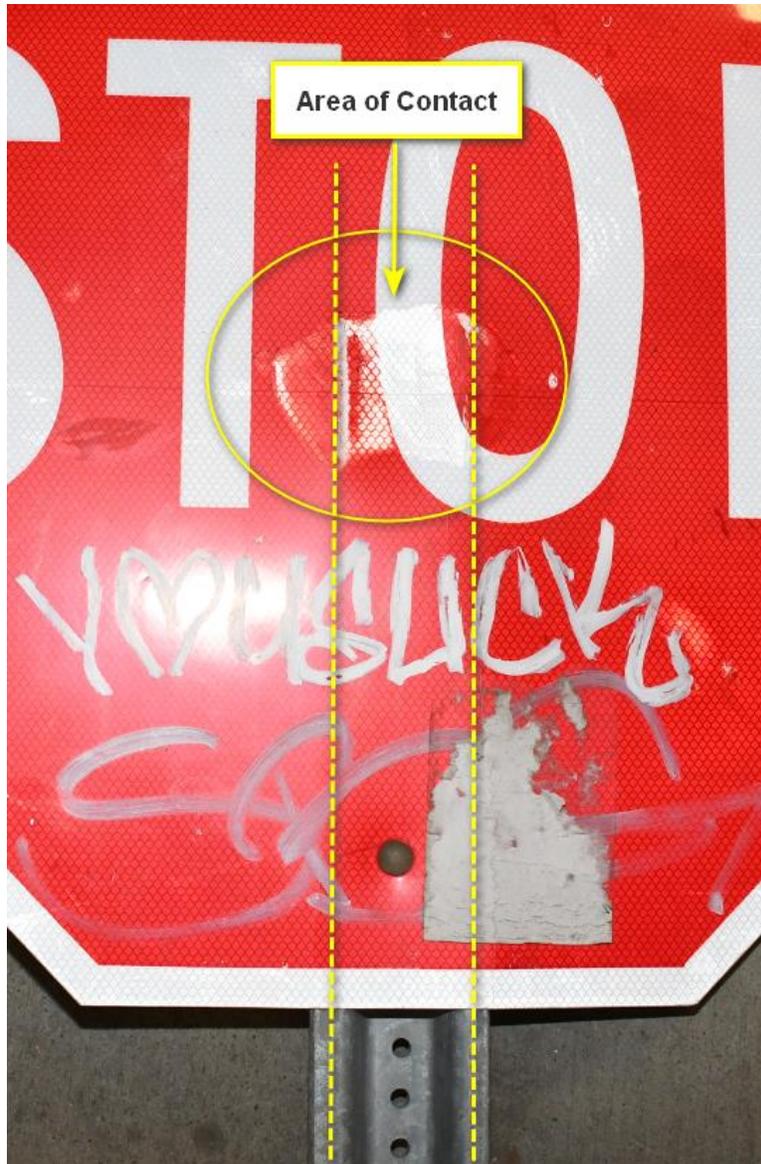
*Figure 79*

An examination of the stop sign itself showed an area of corresponding damage on the face of the stop sign. It should be noted that this area was in line with the metal signpost behind the face of the stop sign. This indicates that the helmet was not struck by the periphery of the sign, but rather by the metal post that runs through the center of the sign. (Figure 79)

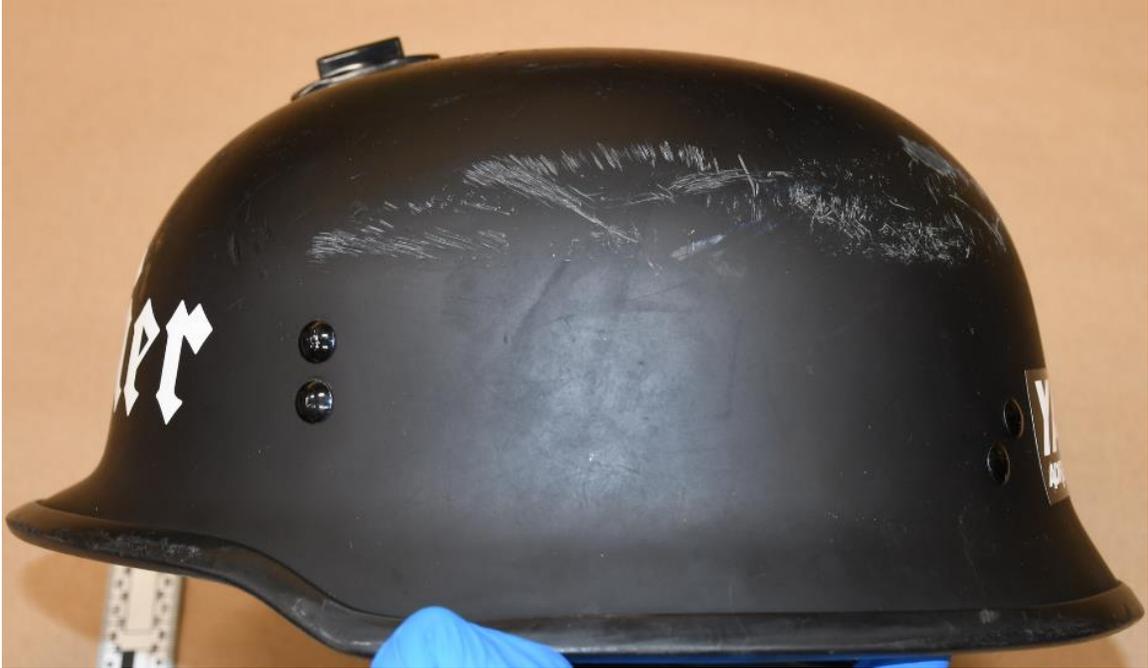
*Figure 80*

An examination of the rest of the exterior of the helmet showed superficial scrapes and scratches along the left side of the helmet. (Figure 80) These scrapes and scratches were consistent with contact with coarse or aggregate materials, such as asphalt or concrete.

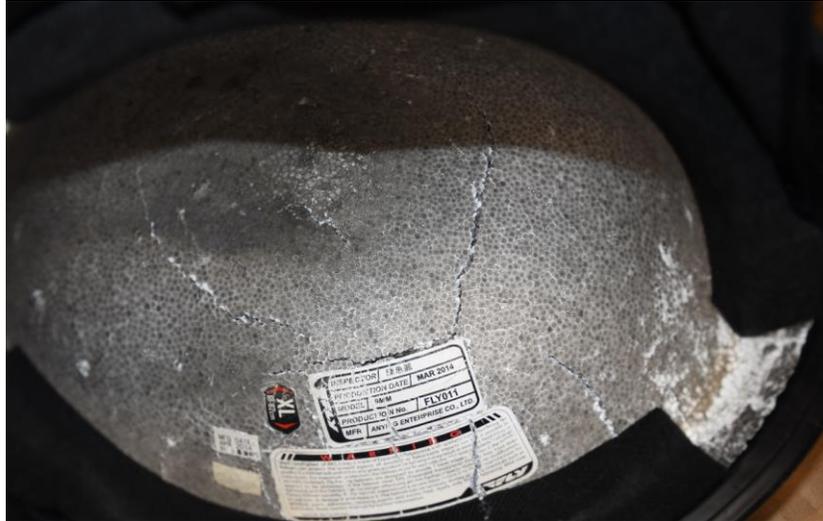
**Figure 81**

An examination of the interior of the helmet showed that the interior Styrofoam type liner was cracked in several areas. These cracks in the Styrofoam type liner were prevalent along the interior right side of the helmet. (Figure 81)
