**Rhode Island State Police**  
**Collision Reconstruction Unit Report**

**Case Number: 20-298-CRU**

**Date: October 18<sup>th</sup>, 2020**

**Elmwood Avenue at Bissell Street**

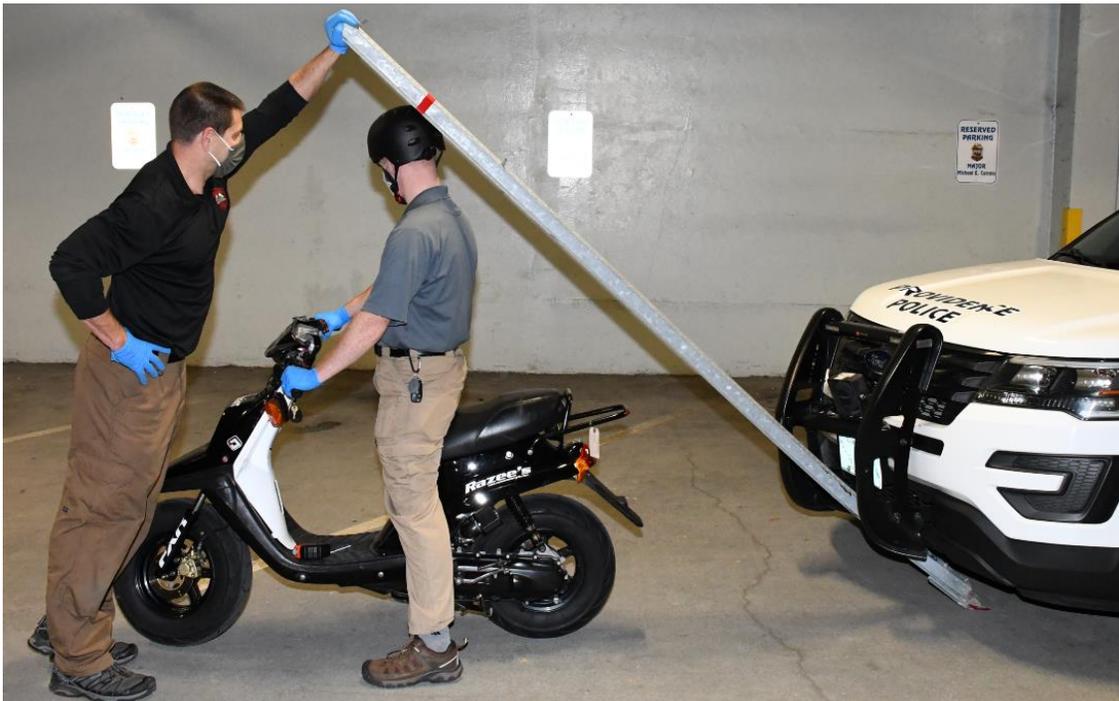
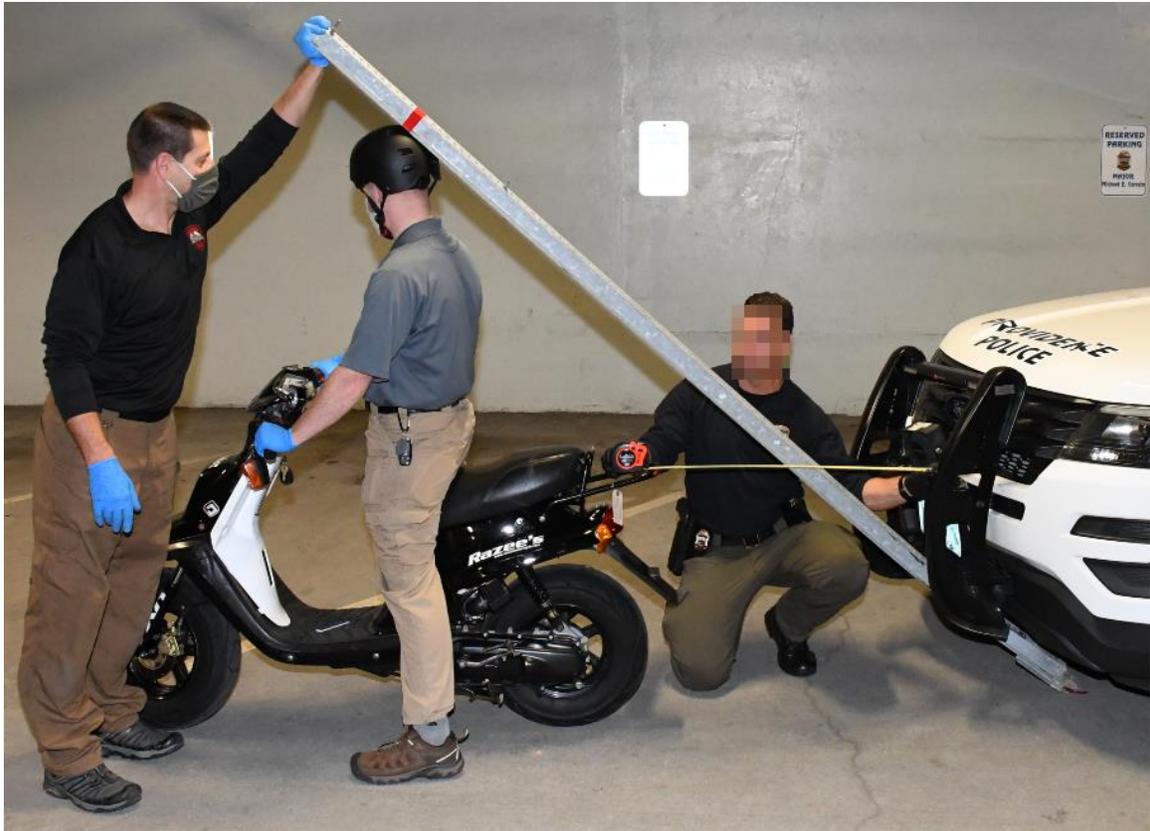
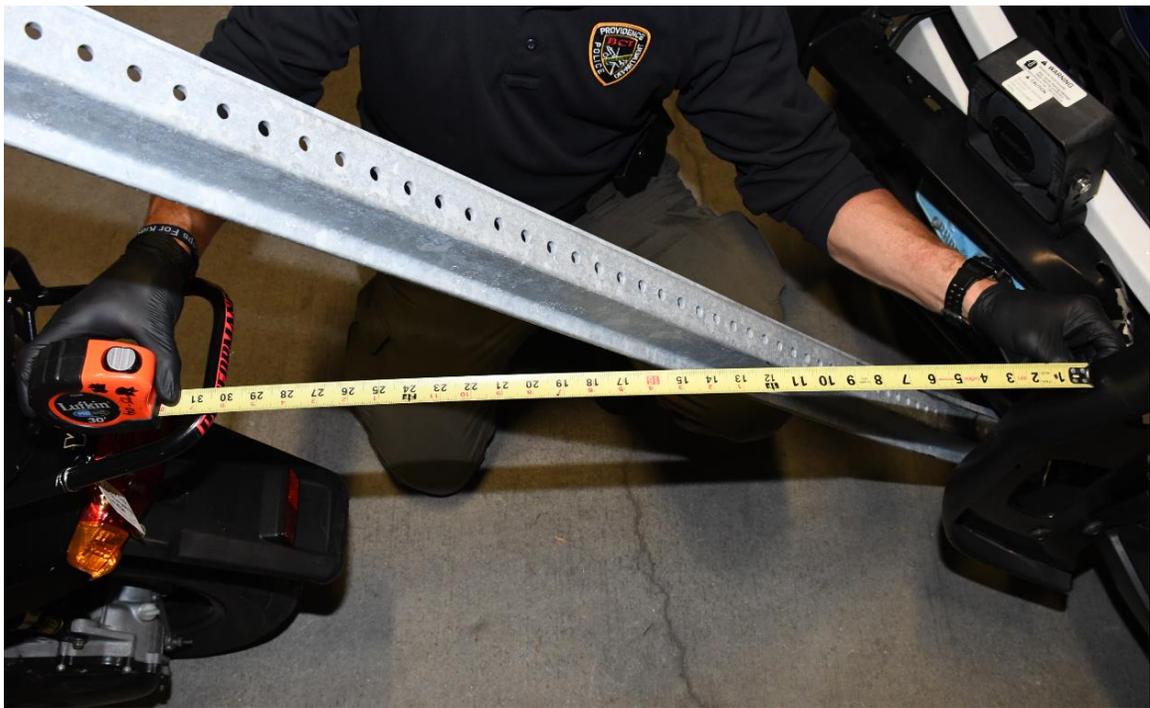
An additional examination was conducted with the scooter operator standing, with both feet on the ground, and not sitting on the seat of the Yamaha. The examination of this alignment showed that the closest the Cruiser could be to the rear of the Yamaha scooter with the operator standing was approximately thirty (30") inches. (Figures 85 – 87)

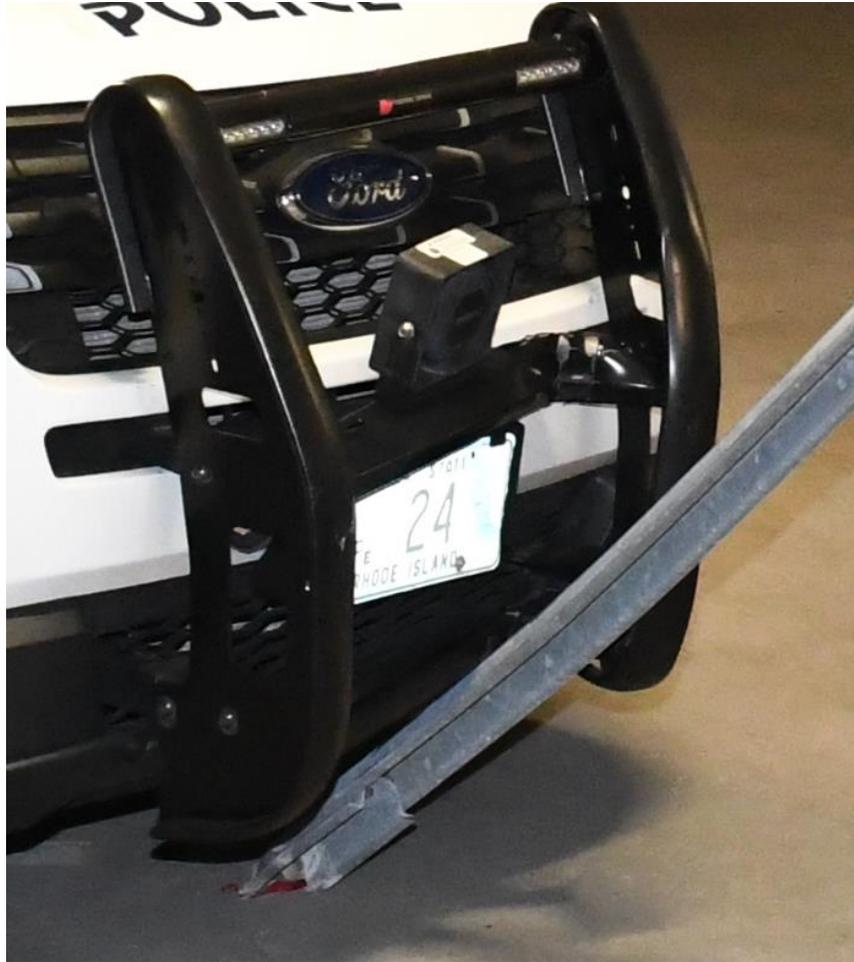
*Figure 88*

It was determined that due to the configuration of the inner rails of the push bumper and the clearance above the ground, that the Cruiser could never get close enough to the rear of the Yamaha scooter and still have the stop sign post make contact with its operator in the alignment that it did. The higher up the post the Cruiser drove, the lower the end of the post became. (Figure 88)
