RHODE ISLAND STATE POLICE

On October 19th, 2020, the Rhode Island State Police was tasked with assisting your office with the investigation of a crash event involving a Providence Police Cruiser and a Yamaha Zuma Scooter on Elmwood Avenue at Bissell Street. On November 6th, 2020, I completed the Collision Reconstruction Unit Report and a copy was delivered to your office on November 9th, 2020.

- 1) Can you explain/add detail to what is meant by emergency steering and emergency braking?**

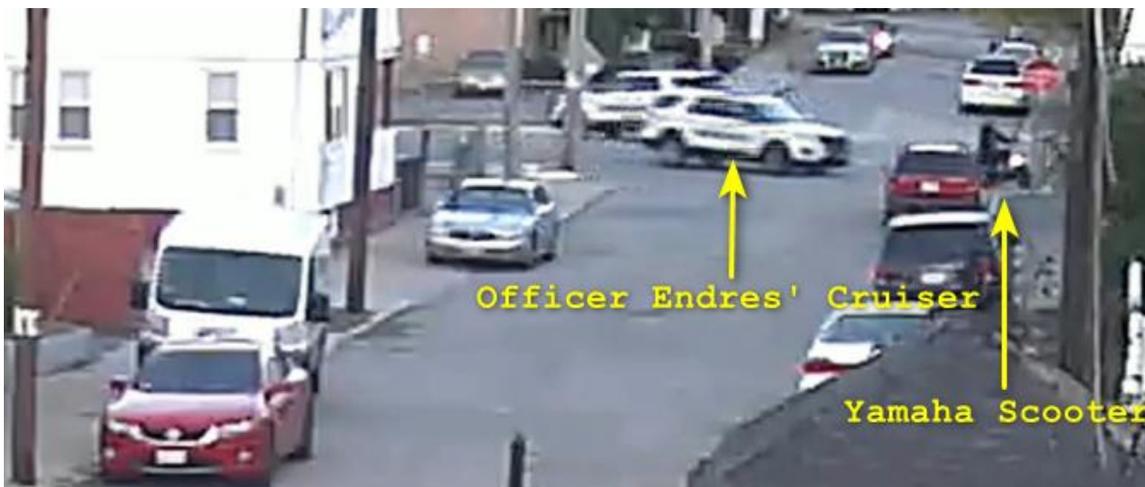
Video Time 5:50:09.433

The figure below was taken from a surveillance video and indicates the location of Officer Endres' vehicle approximately 0.73 seconds before its collision with the stop sign post. It is during this time that the steering wheel angle increases to the right. At the half second mark (0.5) the Cruiser's Anti-Lock Braking System will be recorded as being enabled and the airbag control module recorded steering back to the left. During the next half second interval, the steering increases rapidly to the right again with continued ABS braking before striking the stop sign post.

Based upon Officer Endres' position in the roadway and the heading of the Cruiser at this point, I believe that Officer Endres began steering the Cruiser to the right to follow the scooter onto Bissell Street. Once Officer Endres realized his trajectory towards the building and the stop sign post, he applied rapid steering and maximum braking in an effort to avoid striking an obstacle – in this instance the stop sign post, the building on the corner, and/or the Yamaha scooter. These steering and braking actions are consistent with obstacle avoidance techniques using emergency braking and steering maneuvers.

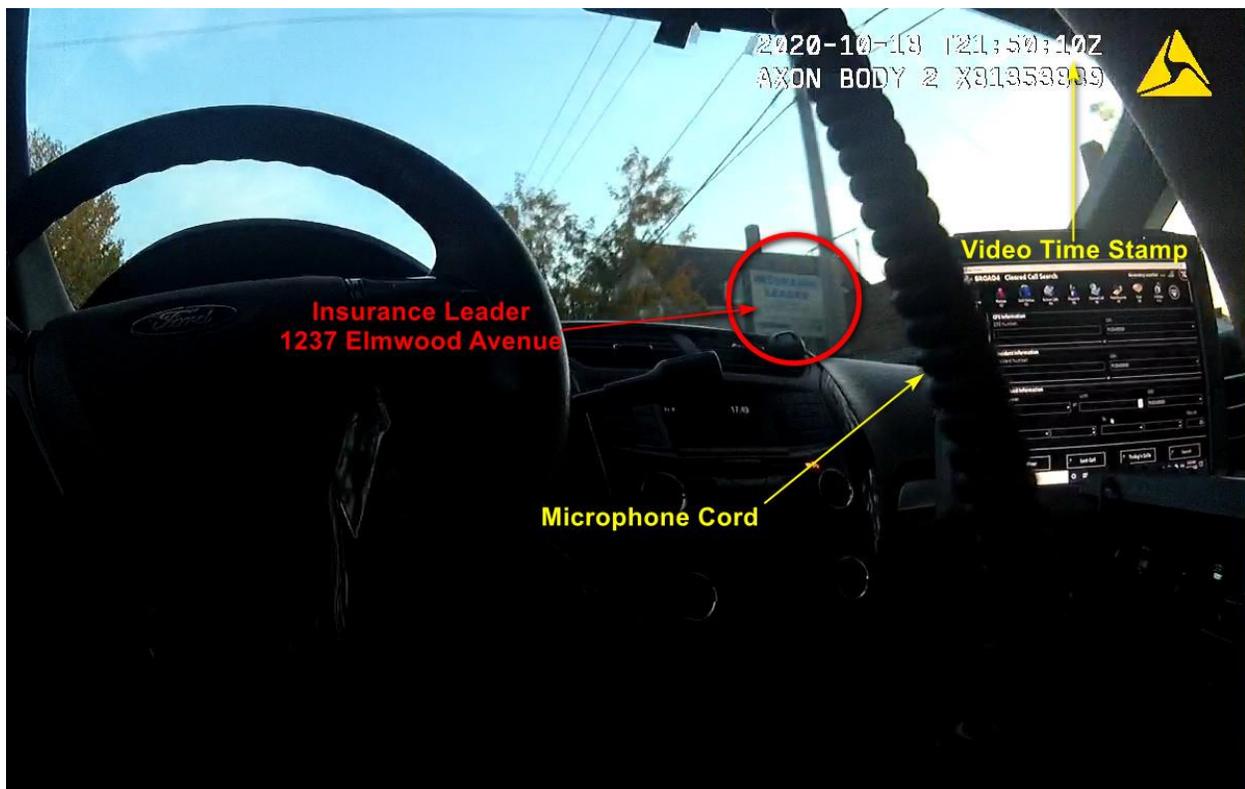
During the investigation into this crash event, it was determined that Officer Endres used his radio in Cruiser # 24 to say, "Box this guy in," a few seconds prior to the crash. After reviewing Officer Endres' AXON body camera footage, he can be seen utilizing his microphone in his Cruiser at the 21:50:10 to the 21:50:12 second mark of the video. At this time, the exterior sign of the Insurance Leader business, located at 1237 Elmwood Avenue is visible to the south of the Cruiser.

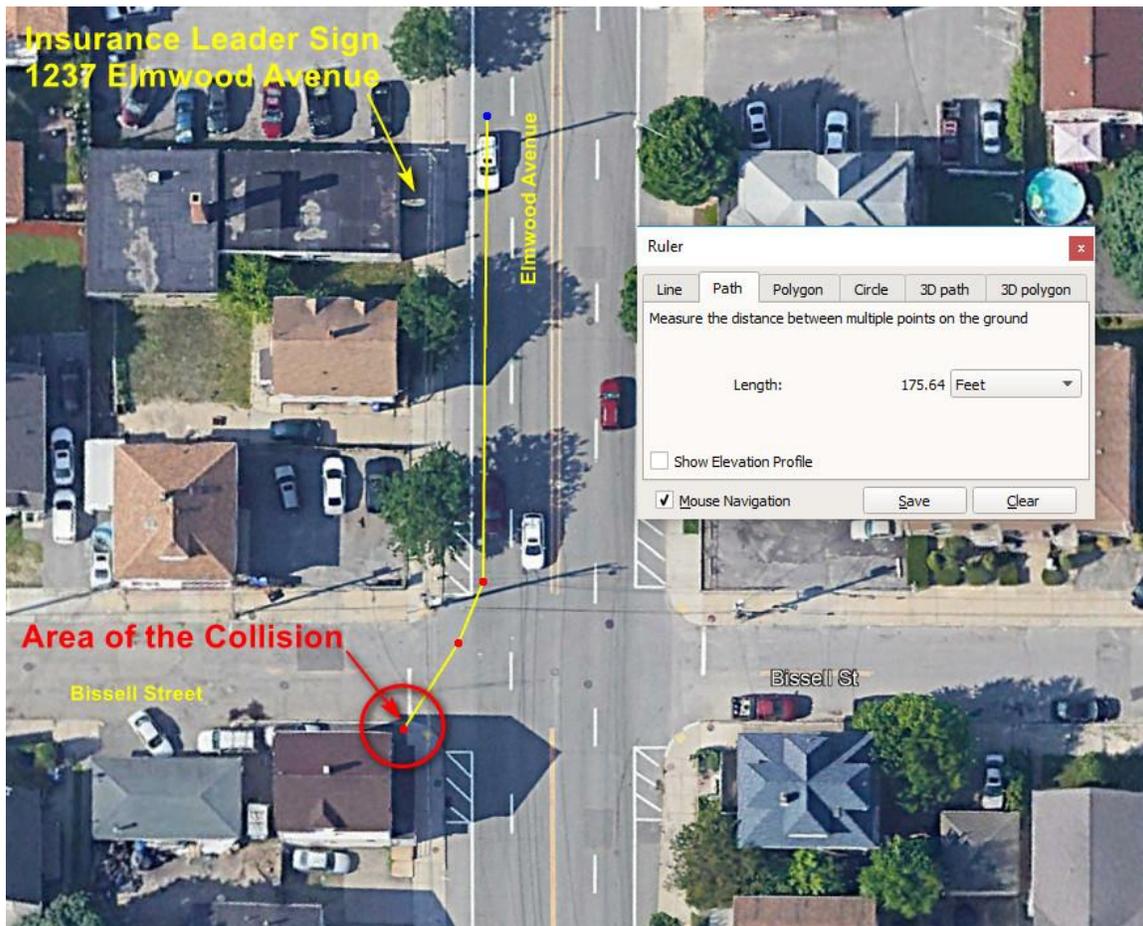
From this point, Officer Endres is over 175 feet north of his collision with the stop sign post. Officer Endres' AXON body camera footage also captures the approximate time of his collision with the stop sign post at the 21:50:16 second mark. Based on this analysis, the time from the Officer Endres' radio transmission of "Box this guy in," to his collision with the stop sign post was determined to be approximately 4 to 5 seconds.

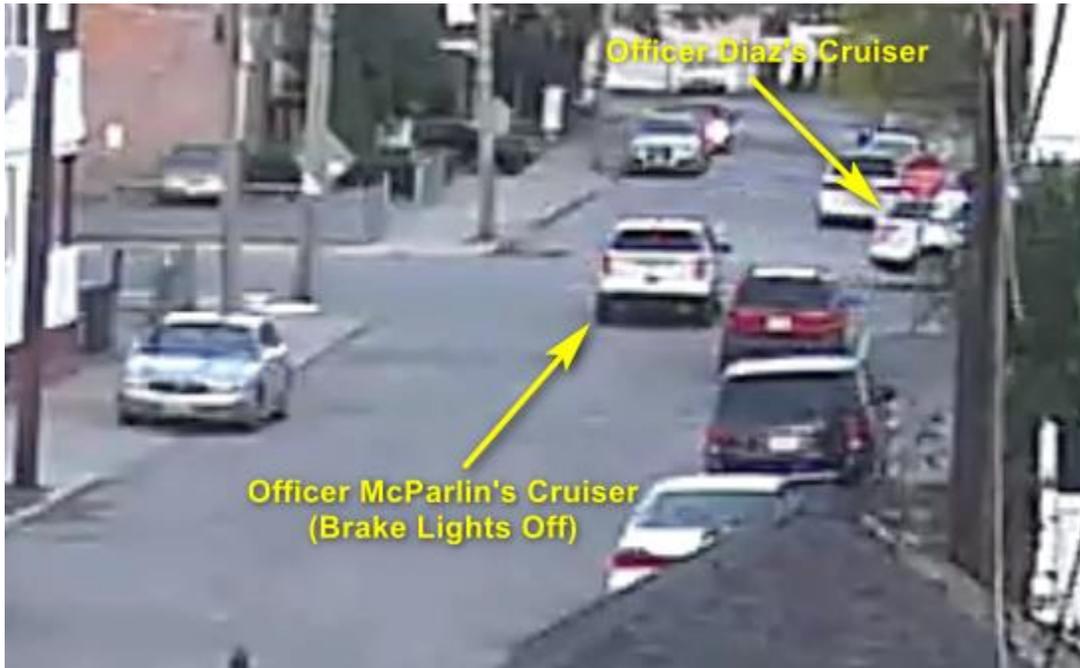
Time Stamp 5:50:04 (Not synched to Office Endres' AXON Body Camera Time)

A review of Officer McParlin's actions were also examined as part of this investigation. Using the surveillance video from the Advanced Telesystems Group Inc. business, it was determined that Officer McParlin began to pull out of Bissell Street eastbound onto Elmwood Avenue and started into the intersection at the video time stamp of 5:50:04. Officer McParlin's Cruiser can be seen moving into the intersection and then stopping while Officer Diaz's Cruiser continued south past Bissell Street. Once Officer Diaz's Cruiser passed, Officer McParlin began to pull out of Bissell Street and turned north onto Elmwood Avenue. Based on this timing and Officer McParlin fully crossing the southbound lane of Elmwood Avenue, it was determined that Officer McParlin started into the intersection before Officer Endres' radio transmission, and made no attempt to "box in" the approaching Yamaha Scooter. The figure below depicts Officer McParlin's Cruiser continuing into the intersection once Officer Diaz's Cruiser safely passed. Officer Endres' Cruiser would then strike the stop sign approximately six (6) seconds later at the video time stamp of 5:50:10.
