**STATE OF RHODE ISLAND
OFFICE OF THE ATTORNEY GENERAL**

**INVESTIGATIVE REPORT
January 7, 2021**

Incident Type: Motor Vehicle Collision
Incident Location: Elmwood Avenue and Bissell Street in Providence
Incident Date: October 18, 2020
Police Department: Providence Police Department
Officers Involved: Kyle Endres and Brad McParlin
Injured Party: Jhamal Gonsalves

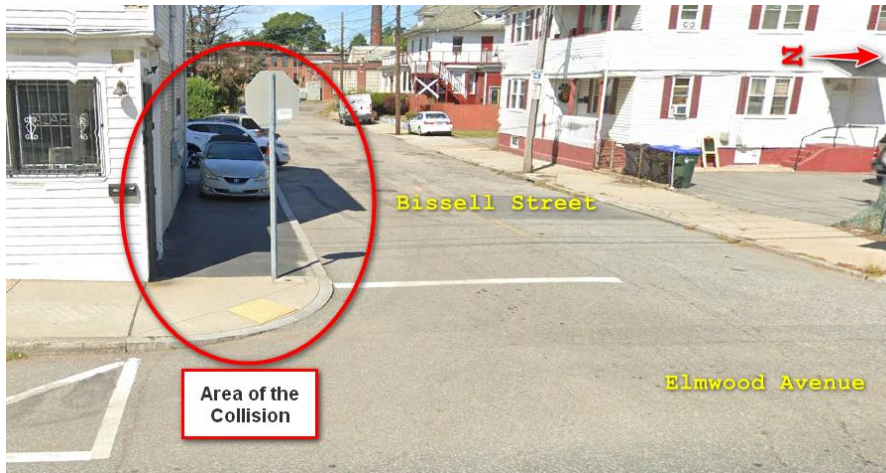
Google Earth Pro Image from 2019

On October 18, 2020 at approximately 5:50 p.m., Mr. Gonsalves was travelling south on Elmwood Avenue while operating a black and white Yamaha scooter. He turned west onto the southwest sidewalk of Bissell Street, using the sidewalk ramp. Mr. Gonsalves negotiated the turn, driving between the stop sign and the wall while on the sidewalk.⁹

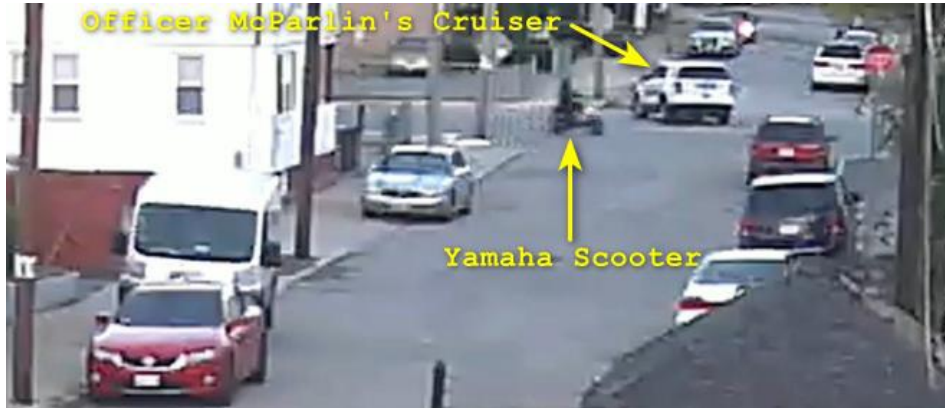
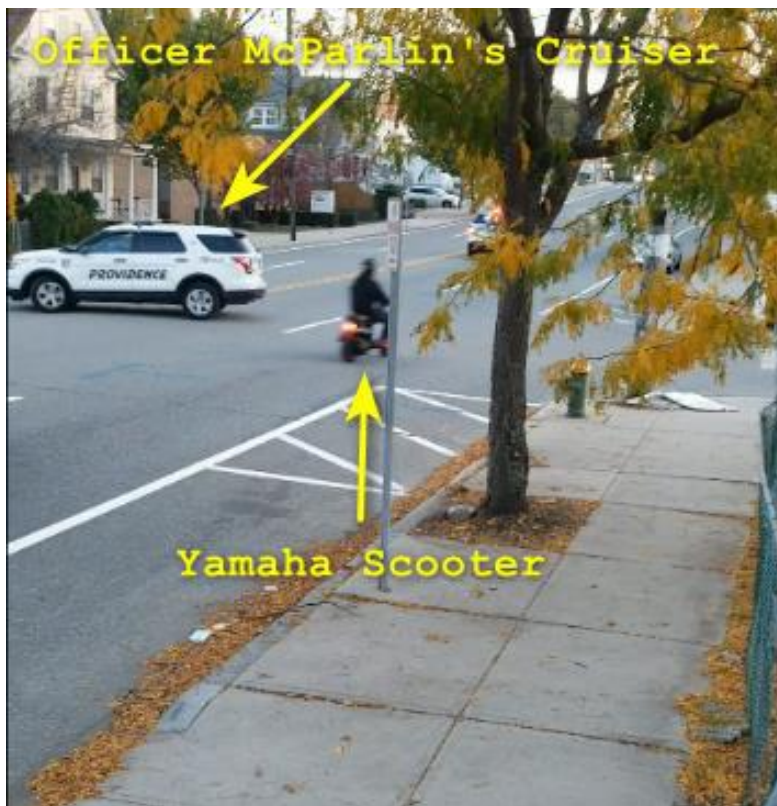
Bissell Street Video

5:50:08.266 Mr. Gonsalves' scooter is seen driving southbound in the right lane of Elmwood Avenue and entering the intersection of Elmwood Avenue and Bissell Street. The front wheel of the scooter can be seen turning to the right. Officer McParlin's vehicle is observed crossing from the left southbound lane of Elmwood Avenue, across the yellow center lines into the northbound lanes. Officer Endres' cruiser is not yet visible:

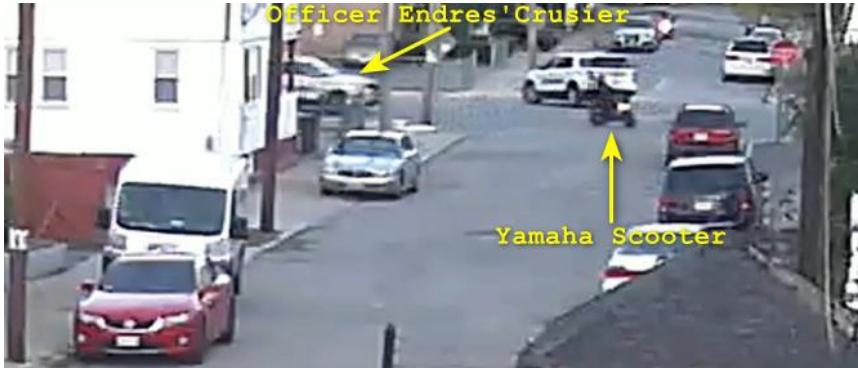
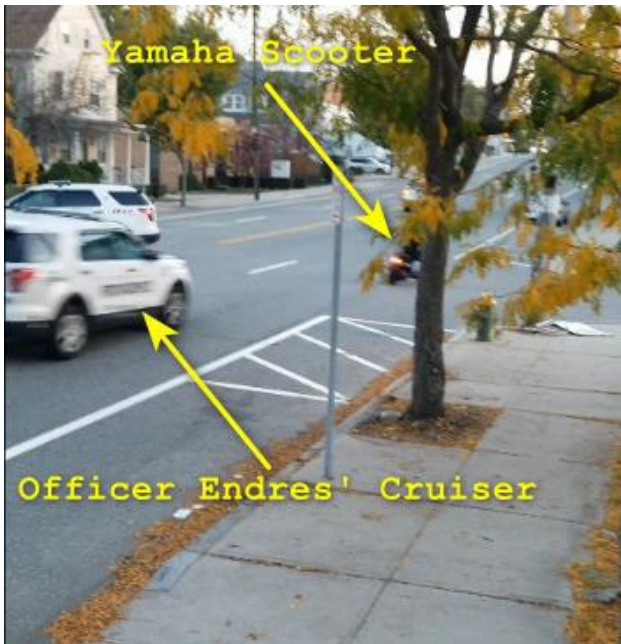
Bissell Street video

5:50:08.666 Mr. Gonsalves' scooter is in the intersection of Elmwood Avenue and Bissell Street. The front wheel of the scooter can be seen turning to the right, and the rider appears leaning to the right. The scooter's brake light is illuminated. Officer McParlin's cruiser appears to have mostly cleared the southbound lanes of Elmwood Avenue. Officer Endres' cruiser has not yet reached the intersection of Elmwood Avenue and Bissell Street:

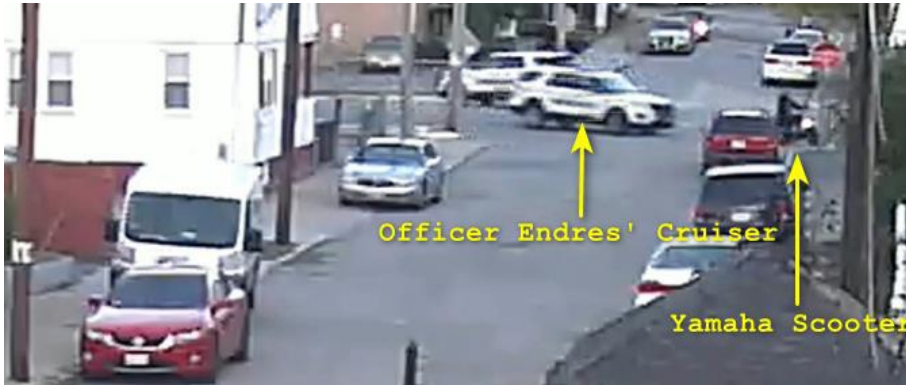
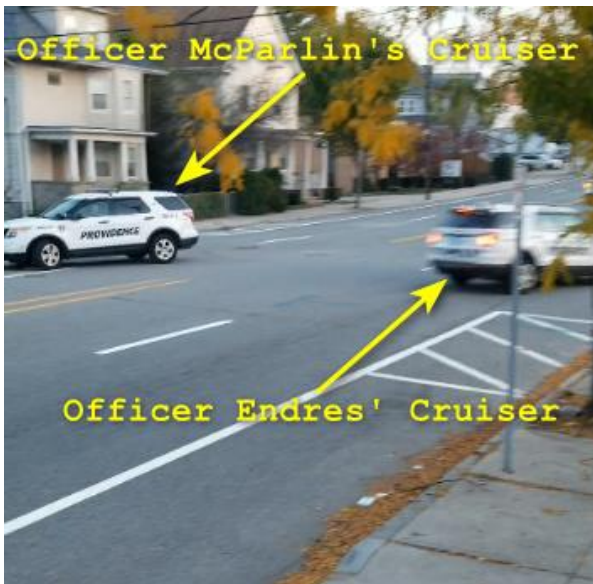
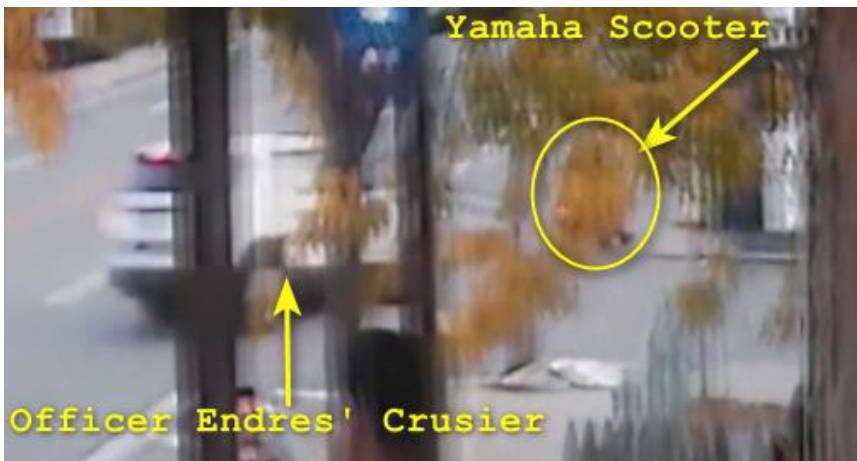
Bissell Street Video

5:50:09.433 Less than a second later, Mr. Gonsalves' scooter begins to drive onto the sidewalk along the southwest corner of Elmwood Avenue and Bissell Street. Officer Endres' cruiser is about half-way across the entrance to Bissell Street and can be seen turning to the right while activating the brakes of the vehicle:

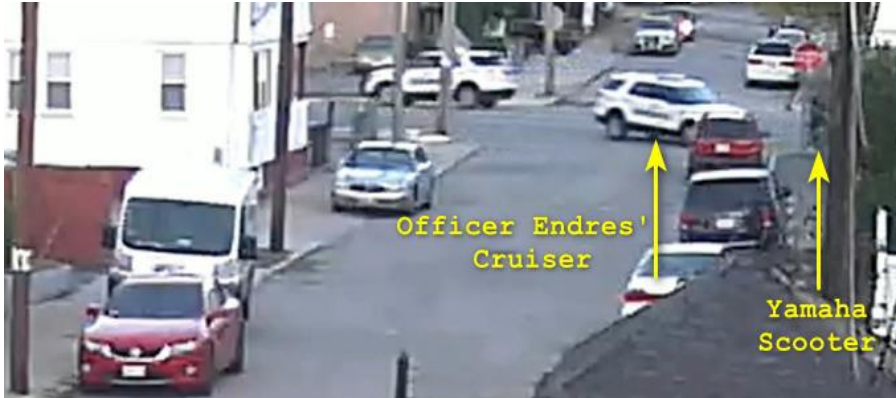
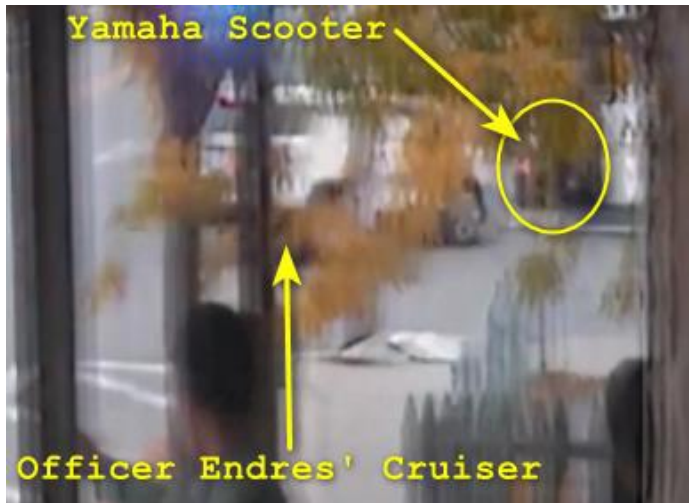
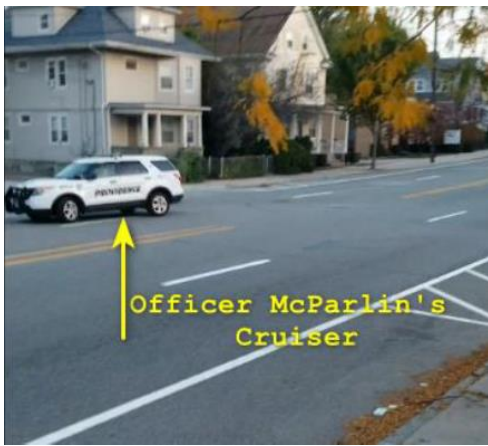
Bissell Street Video

5:50:09.800 Less than half a second later, Mr. Gonsalves has driven onto the sidewalk and is passing the stop sign post as he travels west on the sidewalk, between the stop sign and the wall of the adjacent business. Officer Endres is still crossing Bissell Street with the front of his cruiser in front of a red vehicle parked on the south side of Bissell Street. The Elmwood Video depicts the cruiser's and scooter's brake lights on. Civilian Witness #4's video is now focused solely on Officer McParlin's cruiser in the northbound lanes:

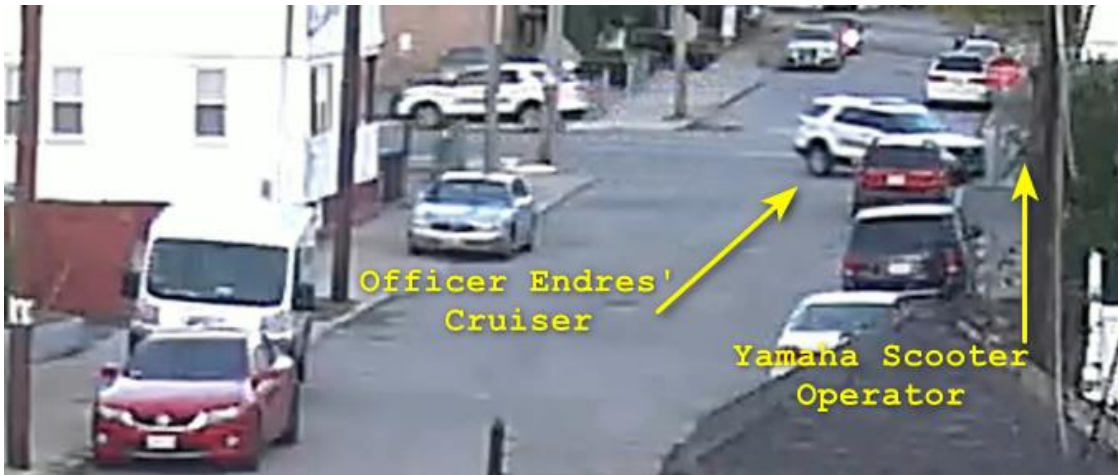
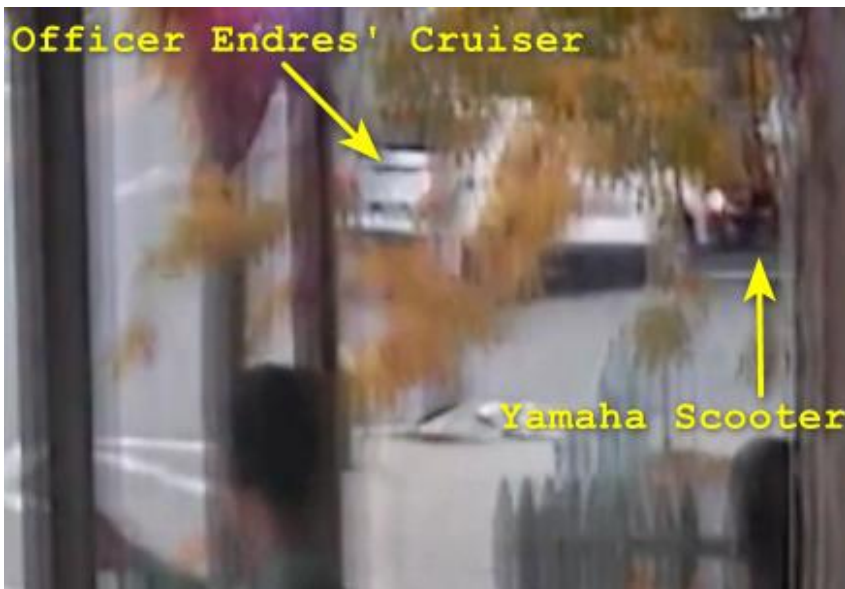
Bissell Street video

5:50:10.033 Less than half a second later, Officer Endres' cruiser is beginning to mount the curb. He has not yet hit the stop sign. (Civilian Witness #4's Video which is still focused only on Officer McParlin's cruiser did not capture this moment):

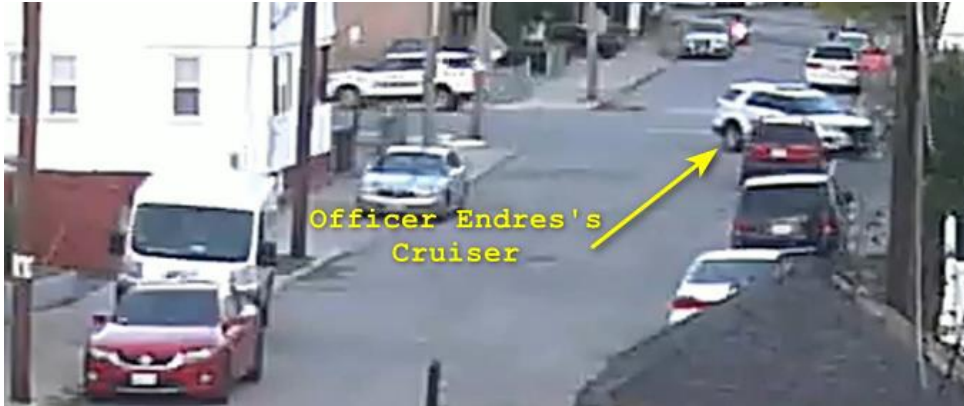
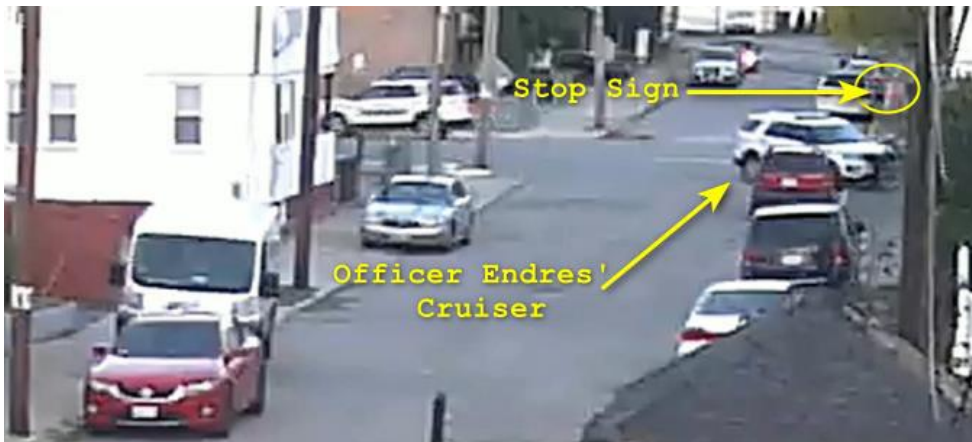
Bissell Street Video at 5:50:10.166

5:50:10.166 - 5:50:10.200 At this moment, the Bissell Street Video captured the stop sign first being struck by Officer Endres' cruiser and beginning to move downward. The Civilian Witness #4 Video did not capture this because it had panned to Officer McParlin's cruiser. The view from the Elmwood Video is largely obstructed by foliage. The State Police Reconstruction Unit Report determined that Officer Endres' cruiser struck the stop sign post but had not made contact with the scooter – which is out of the video frame:

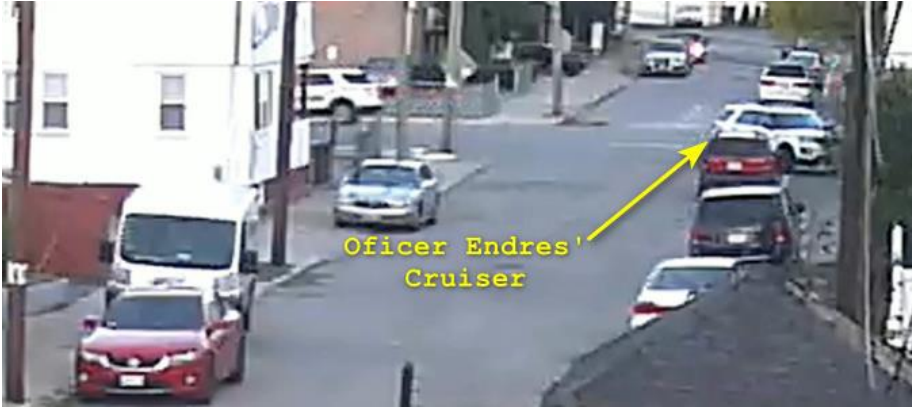
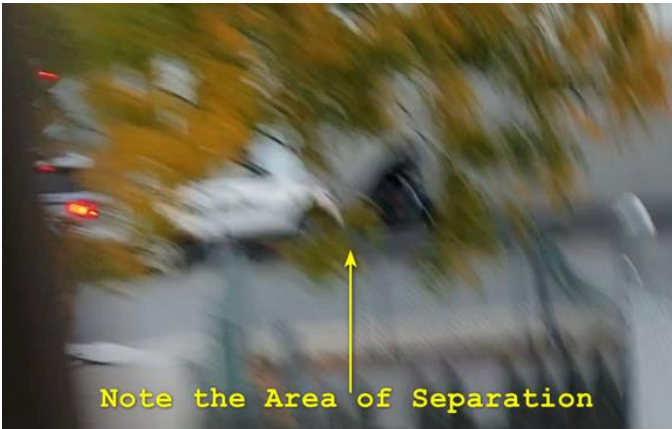
Bissell Street Camera

5:50:10.633 At this point, just short of a half second later, the stop sign has been driven over and Officer Endres' cruiser's front passenger tire has just mounted the curbing. The rear brake lights of Officer Endres' cruiser can also be seen in the Civilian Witness #4 Video, which had just panned back to the site of the crash. That video captured the separation between Officer Endres' cruiser and Mr. Gonsalves' scooter:

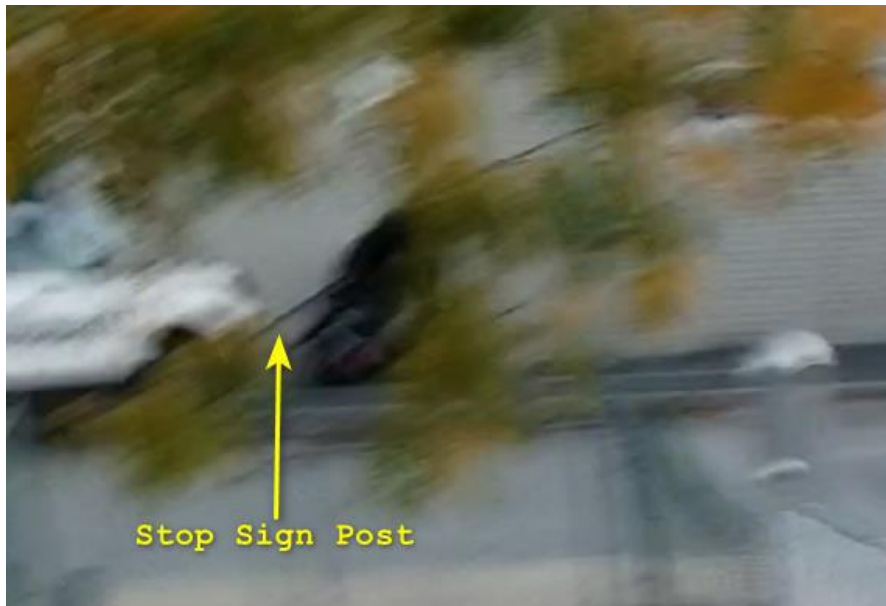
Civilian Witness #4 Video - Magnified

5:50:10.733 A tenth of a second later, the Civilian Witness #4 Video captures the stop sign post in contact with the operator of the scooter. The still shows that Mr. Gonsalves was still upright, though tilting sideways, when the post made contact with him:

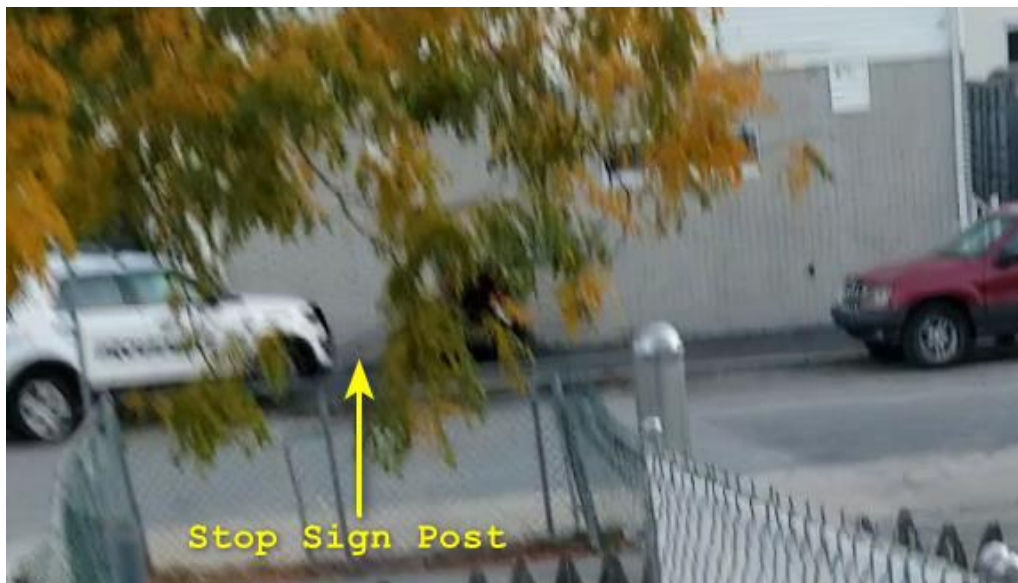
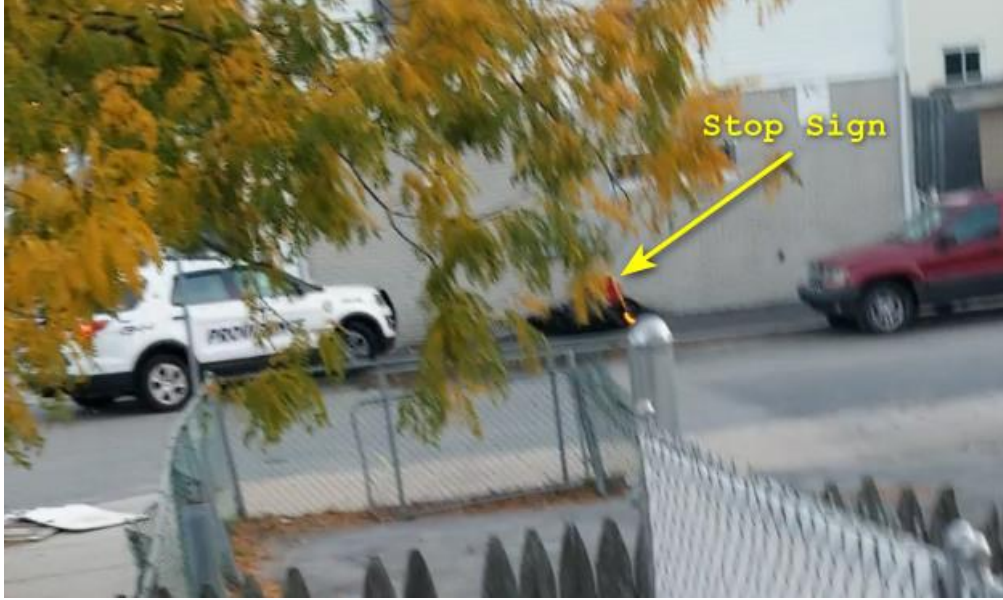
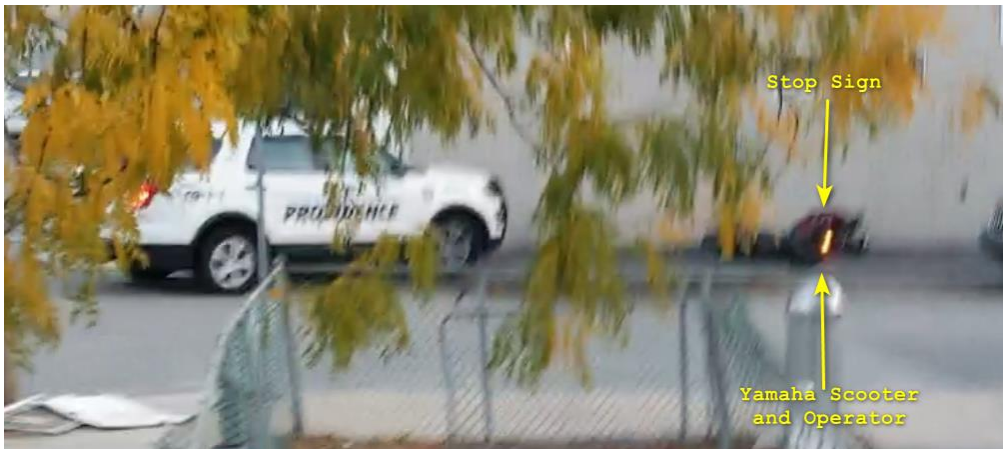
Civilian Witness #4 Video 5:50:10.933- Magnified

5:50:10.933-5:50:11.766 In approximately the next .8 second, Officer Endres' cruiser comes to a complete stop and the scooter and Mr. Gonsalves falls over onto the sidewalk and slide away from the cruiser before stopping. In the Civilian Witness #4 Video, the stop sign face is clearly visible alongside the fallen scooter and Mr. Gonsalves. The following images show the progression to the final resting location of the cruiser and Mr. Gonsalves:

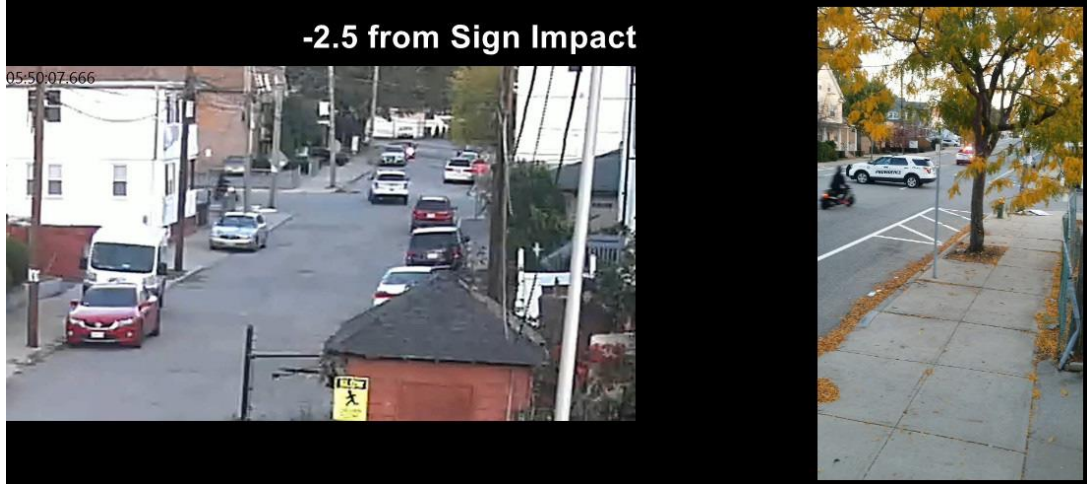
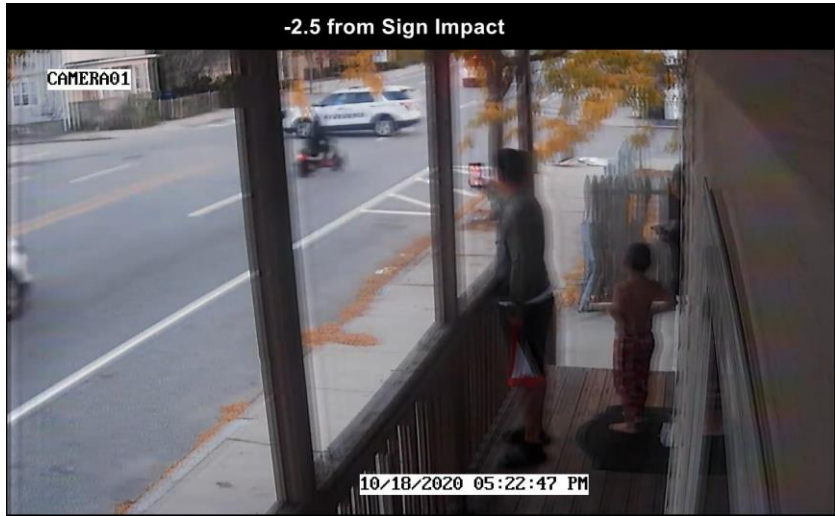
Time 05:50:07.666

The following diagrams and still images from the State Police Collision Reconstruction Report at 98-105, demonstrate this progression of events:

In sum, the video evidence and State Police collision reconstruction analysis demonstrate that Officer McParlin drove out of Mr. Gonsalves' way as Mr. Gonsalves headed into the Elmwood Avenue/Bissell Street intersection. In doing so, Officer McParlin cleared a path of travel down the right side of Elmwood Avenue. In State Police Lieutenant Jeffrey L'heureux's expert opinion, Officer McParlin's actions, moving out of the way of Mr. Gonsalves as he was driving down Elmwood Avenue, are not consistent with an officer attempting to "box in" someone.
