I-195 Washington Bridge (700)

Forensic Evaluation and Procedural Audit Related to PT Tie-Down Failures

I-195 SB Washington Bridge over Seekonk River
Providence, RI

DRAFT REPORT

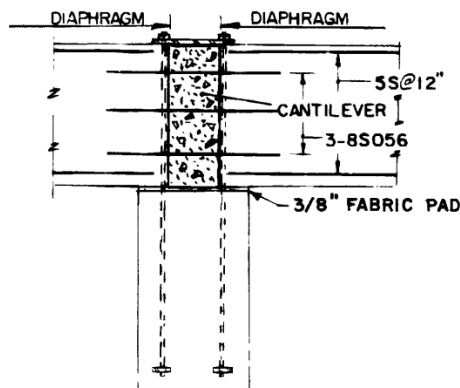
Figure 6. Section depicting PT anchor plates and tie-down rods at end span cantilever supports (Sheet 143, Detail Sheet 8 of original plans, 1967).

At the subject span ends, there are six concrete girder lines (A-F), each with twin tie-down rods connected to an anchor plate at the top that straddles the cantilever beam (Figure 6). The tie-down rods are generally embedded in the diaphragms at ends of the cantilever beams and extend down into the corbels, making them thus not visible for inspection. However, at the four outward corners at girder lines A and F of Piers 6 and 7, the outboard tie-down rods lie to the exterior of the cantilever beam ends, where there are no diaphragms, and are exposed from the top of the beam seat to the bottom of the concrete deck. Original design drawings required the prestressing rods to be $1 \frac{3}{8}$ " diameter high strength pre-stressing rod with threaded ends (Figures 7 and 8).

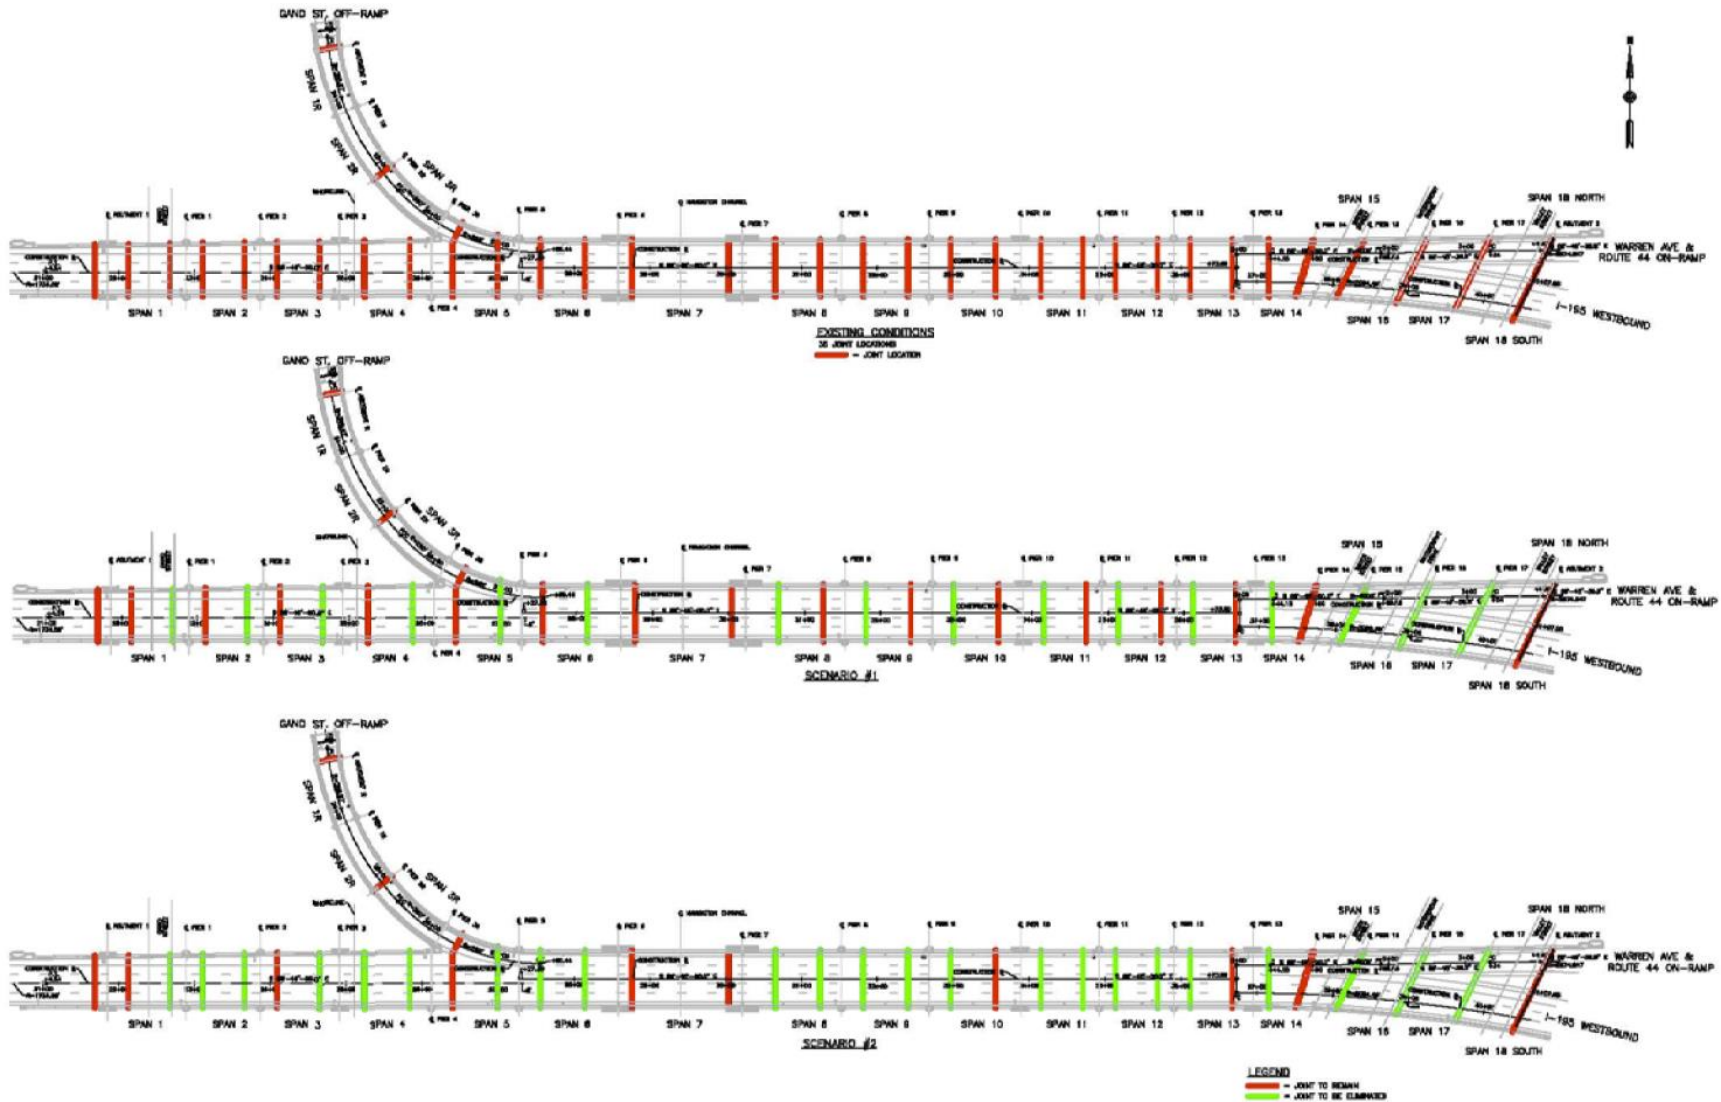
AECOM's report stated, "Two joint elimination scenarios were evaluated and a scenario that eliminates 65% or 23 of the existing 35 deck joints is recommended as the preferred alternative. An approximate 6' wide portion of deck will be removed and reconstructed at the 23 locations where joints will be eliminated. The remaining 12 joints will consist of strip seal joints (8 locations), asphaltic plug joints (2 locations) and pourable joint seals (2 locations). The impact that joint elimination has on the pier columns was investigated and all pier columns were found to be adequate." Figure 16 shows the original joint configuration and 2 joint replacement scenarios. Figure 17 presents the resulting link slab location plan for the selected scenario 2, as shown in rehabilitation plans.

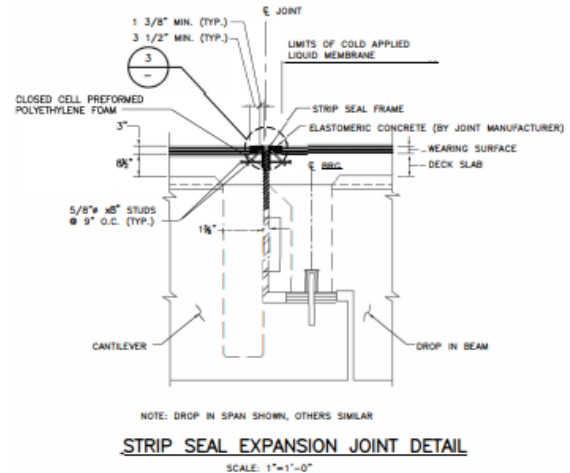
Figure 19. Strip Seal Joint Detail, Sheet 48, RIDOT Contract 2016-CB-059, 2016.

To accommodate the restraint added by the partial depth closure pours, the joints at the ends of the newly adjoined units were to be reworked to accommodate greater anticipated movement. Figure 19 shows the proposed detail for a strip seal at a drop-in-cantilever corbel support, for example.

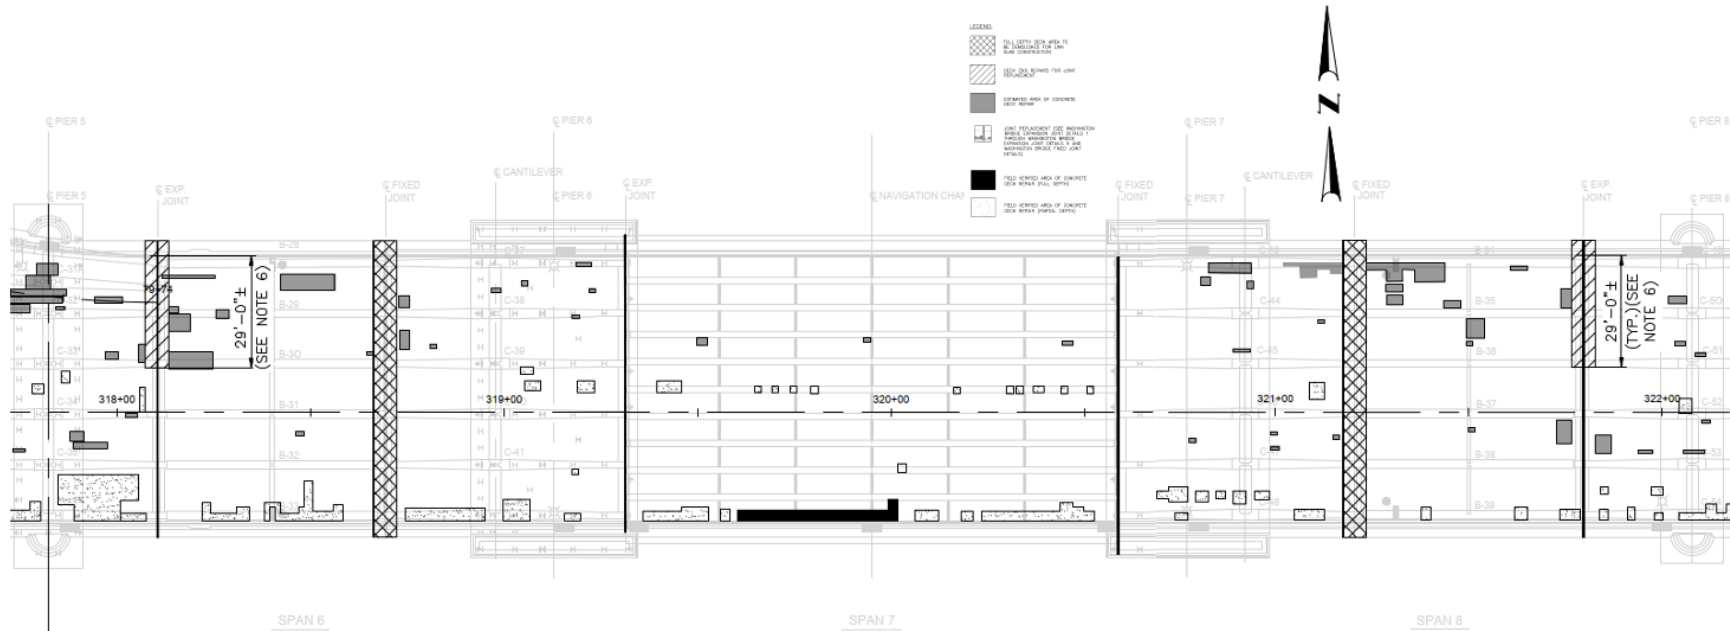
Figure 21. Spans 6 through 8 repair plan for Contract 2021-DB-020 (Compiled from excerpts of Sheets 57 and 58 of IFC Submission, I-195 Washington North Phase 2 Rehabilitation, Volume 4).

With regard to Piers 6 and 7 in Span 7, the joints at the concrete cantilever to steel superstructure transition at the pier walls were retained. The deck joints above the first cantilever corbel-to-drop-in beam support from the Pier 6 and Pier 7 pier walls in Span 7 were to be replaced with a link slab (Figure 21). The effective length of continuous deck increased from about 63'3" to 120'6", or approximately double. Figure 22 shows the intended details for the joint demolition and link slab installation at the drop-in spans. Figure 23 shows a concrete repair detail in the vicinity of the Pier 6 and Pier 7 cantilever tie-down connections.

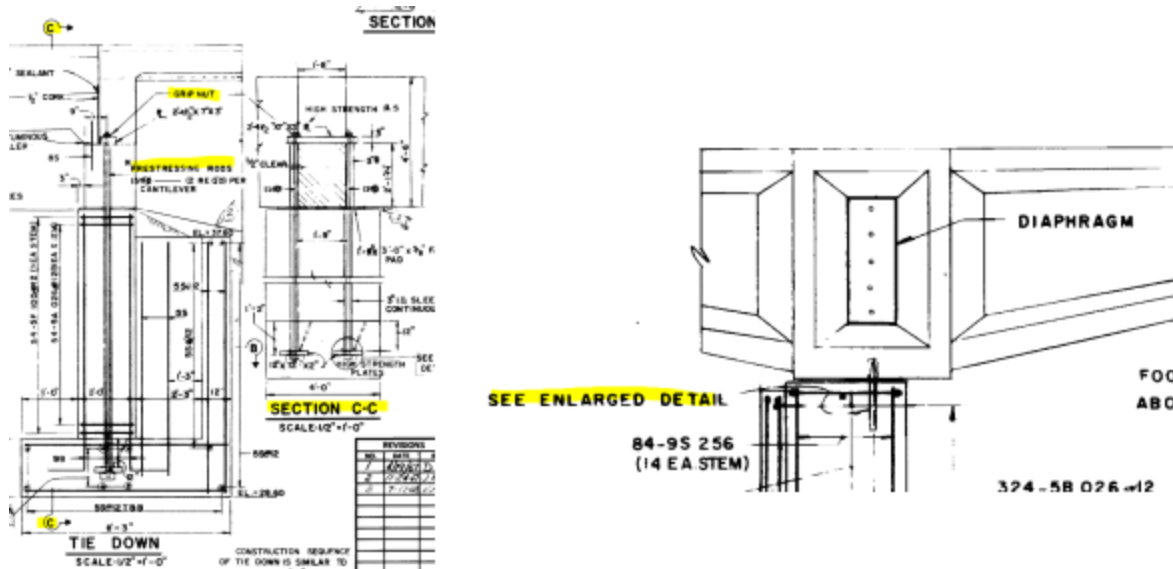
Figure 24. Excerpt regarding Abutment 1 cantilever restraint from IFC Calculations²⁰

Figure 24 was included as part of this passage and shows the Abutment 1 tie-down detail and the cantilever beam support and pintle detail (highlights by VHB). No similar discussion is presented in the IFC calculations for cantilever tie-down locations at Piers 6 and 7.

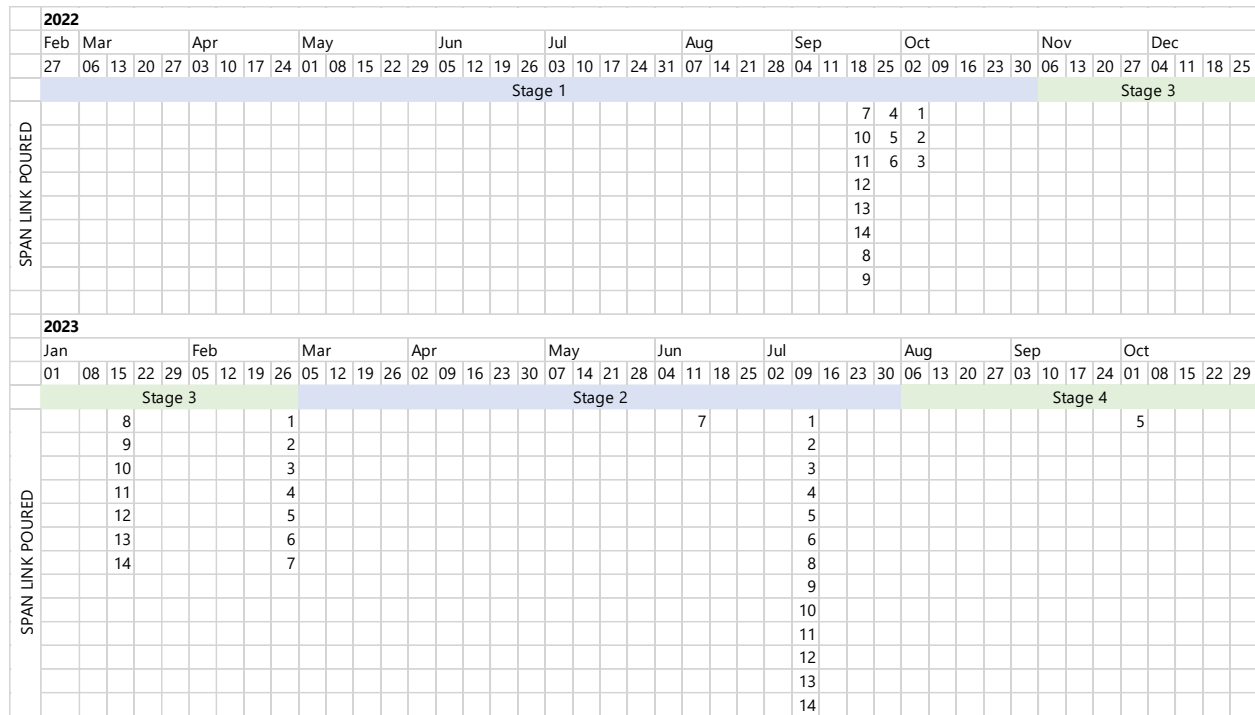
Figure 37. Link slab placement timeline

The two fractured rods were discovered during December 2023. The sequence of link slab closures is illustrated in the timeline of Figure 37. Specifically, closures for Span 6 (adjacent to Pier 6) occurred in September 2022, February 2023, and July 2023. Likewise, Span 7 closures (adjacent to Pier 7), occurred in September 2022, February 2023, and June 2023. The exact time of the fractures cannot be determined, but they were not observed during the July 2023 routine inspection. WJE's forensic evaluation noted that the thickness of corrosion product on the fractured surfaces suggests the fractures had not occurred very close to the time of discovery. However, it is likely fracture occurred within the timeframe that the link slabs were placed.
