**Rhode Island State Police**  
**Collision Reconstruction Unit Report**

**Case Number: 20-298-CRU**

**Date: October 18<sup>th</sup>, 2020**

**Elmwood Avenue at Bissell Street**

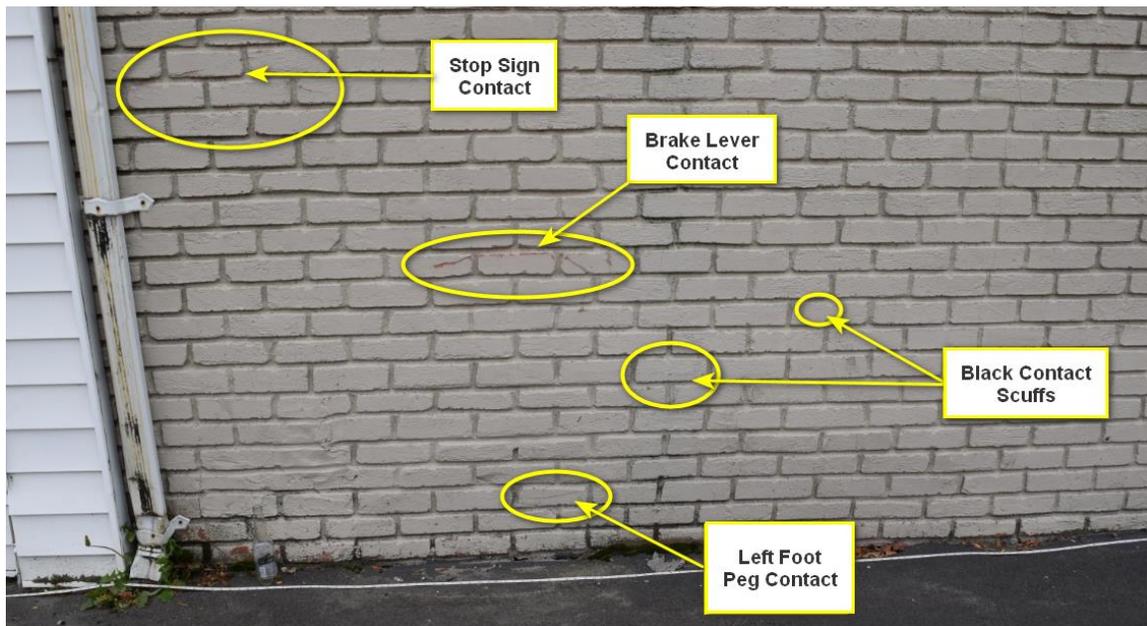
*Figure 7*

This area was attributed to the knob end of the left brake lever of the Yamaha scooter contacting the wall. The third area located was a black scrape along the third row of bricks up from the ground. This area was attributed to the rear foot peg along the left side of the scooter. The fourth and fifth areas located were black scuff marks along the bricks. These areas were attributed to the left side panels of the scooter contacting the wall. (Figure 7)

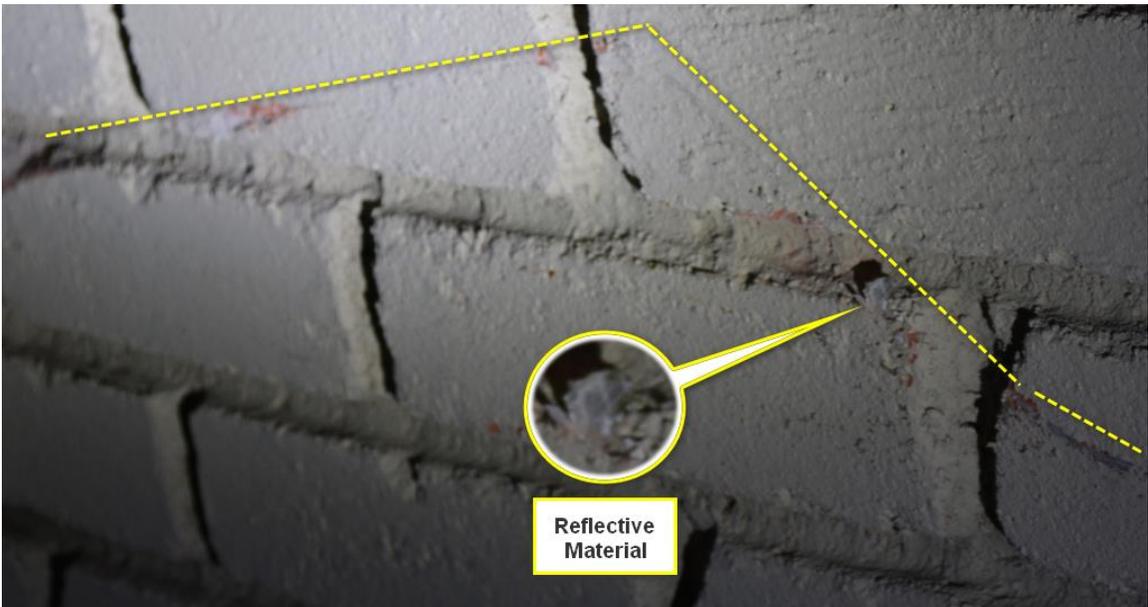
*Figure 9*

A closer examination of the first area of contact showed the outline of a portion of the octagonal side of the stop sign. This area started approximately four feet and five inches (4'5") above the ground and continued diagonally up to approximately four feet and eight inches (4'8") above the ground. From that point, the scrape was directed diagonally down to approximately four feet and five inches (4'5") before tapering off in a westerly direction. Within this scrape, a fragment of grey and white reflective material was located. This material was consistent with the reflective outer edge material of the

stop sign. An examination of the edges of the stop sign showed contact damage and transfer evidence consistent with striking this wall. (Figures 8 – 10)

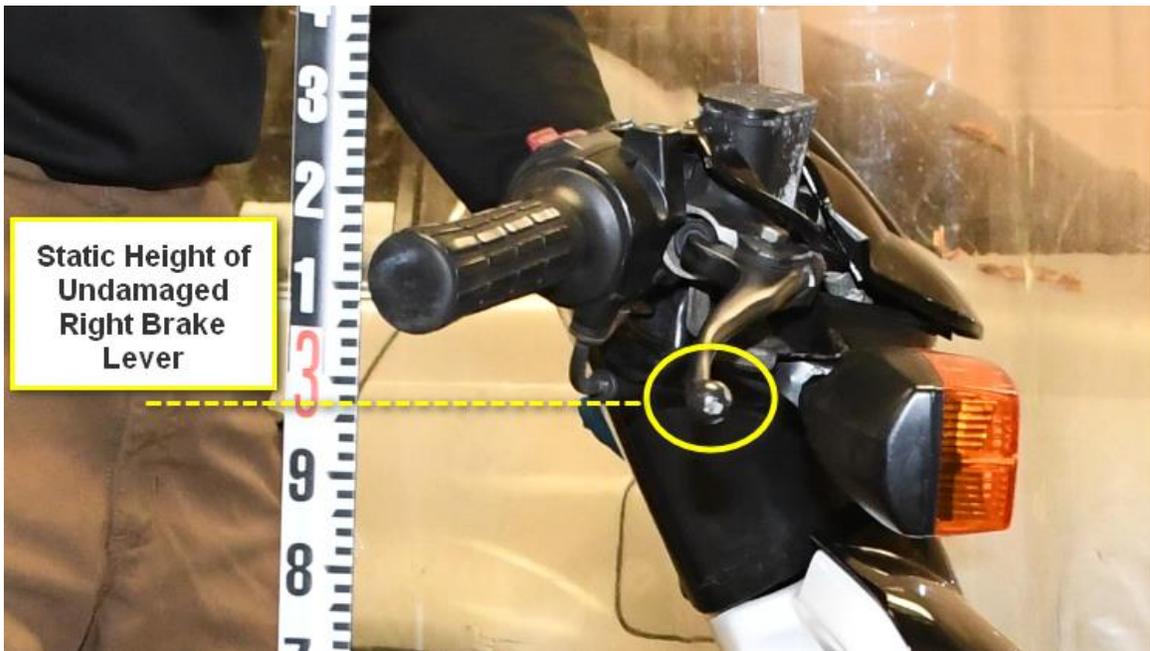
Figure 12

A closer examination of the second area of contact showed the distinct contact and damage pattern that was consistent with the knob end of the left brake lever of the scooter striking the wall. This contact area started approximately two feet and eleven-and one-half inches (2'11.5") above the ground, rising to approximately three feet and one inch (3'1") above the ground and continuing between the gap of two layers of bricks. An examination of the scooter showed that the left side of the handlebars were deflected rearward and downward. The knob end of the brake lever was scraped with course striations, consistent with contacting the brick wall. A measurement of the undamaged right side of the scooter showed that the right brake lever knob was approximately two feet and eleven- and three-quarter inches (2'11.75") above the ground. (Figures 11 – 13)

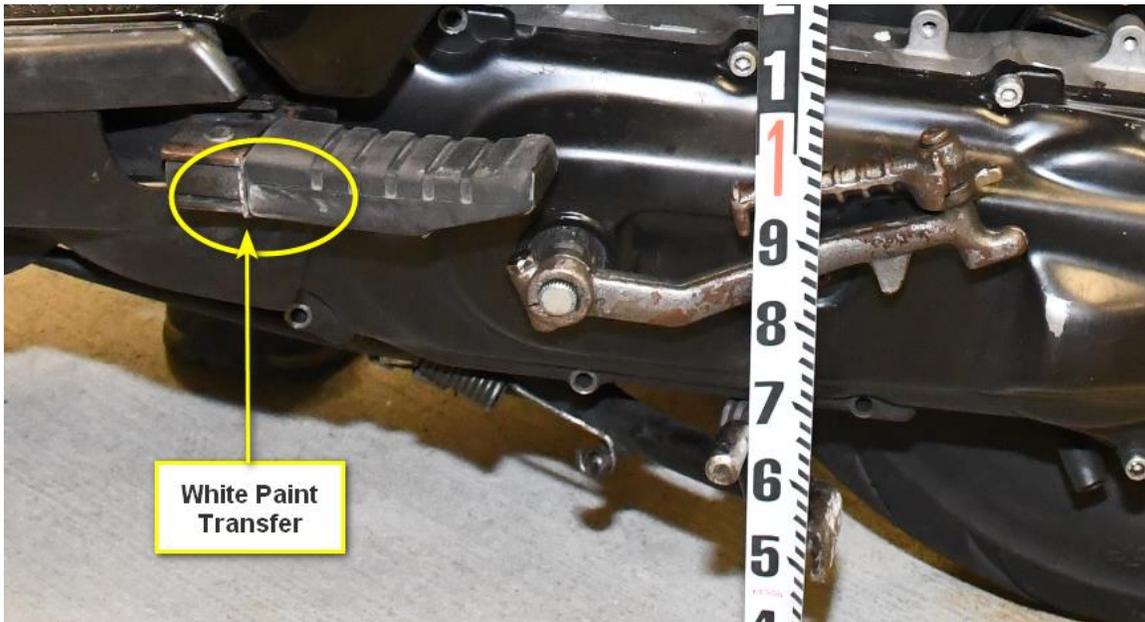
Figure 15

An examination of the third area of contact showed a black scuff mark on the white painted surface of the bricks that was consistent with the left foot peg of the scooter. This contact area started approximately eight inches (8") above the ground and continued diagonally up to approximately nine and one-half inches (9.5") above the ground. An examination of the scooter showed that the static height of the left foot peg was approximately nine inches (9") above the ground. This foot peg also contained an area of white paint transfer along its outside edge that was consistent with the color of the painted brick wall. (Figures 14 & 15)

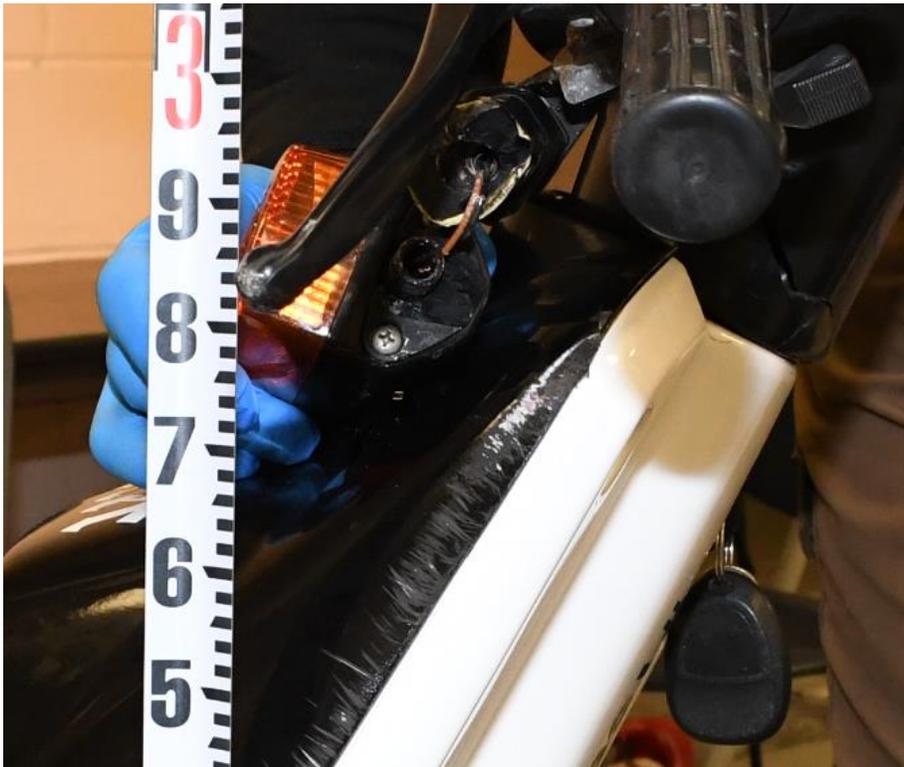
*Figure 18*

The two areas of the scooter that were located that were consistent with these height profiles of the scrapes on the brick wall are depicted below in Figures 18 and 19. Whether the additional scrapes to the left panels of the scooter occurred during this crash event into the brick wall, or when the scooter fell over onto its left side onto the sidewalk, or whether they were from a previous incident(s), was undetermined by this investigation.

(This ruler scale is in decimals – 2.8 feet is equivalent to 2'10")

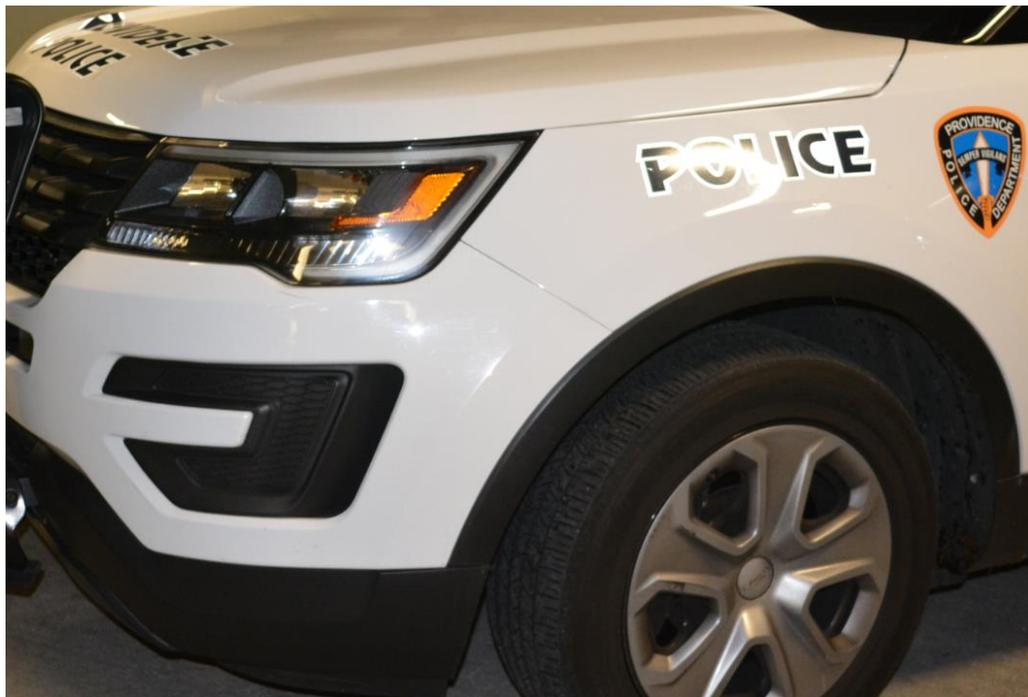
*Figure 27*

An examination of the passenger side and driver's side quarter panels and wheels showed no evidence of contact damage. (Figures 26 & 27)

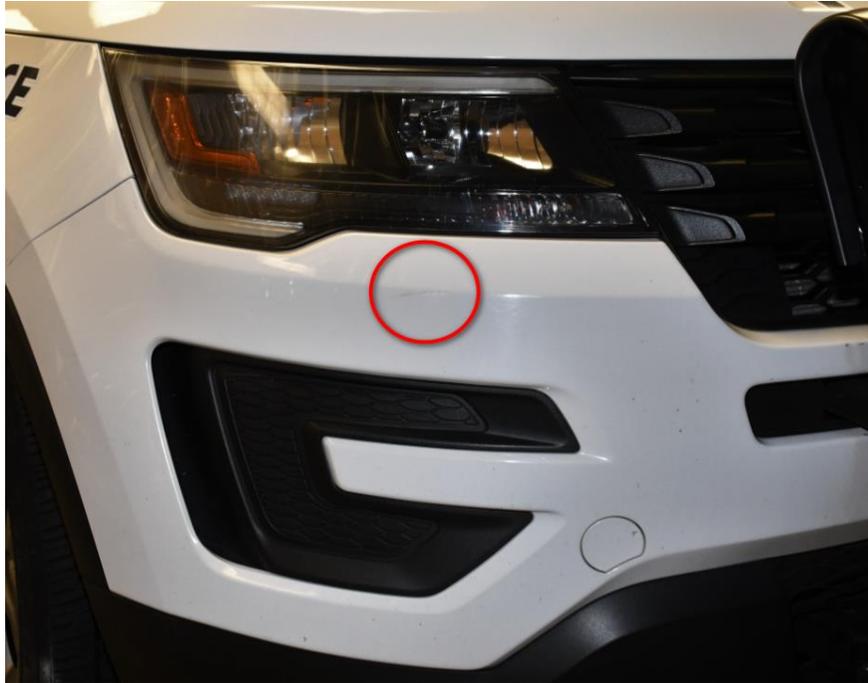
*Figure 28*

A closer examination of the front passenger side of the Ford showed one area of black scuffing contact transfer just below the headlight assembly. (Figure 28)

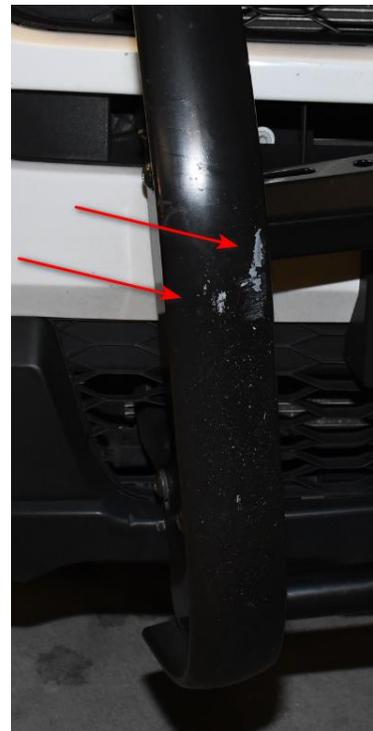
*Figure 29*

A closer examination of the rubber housing around the vertical structure of the push bumper on the passenger side of the vehicle showed an area of a whitish scuffing and paint transfer. There were also numerous areas of superficial scratches and scuffs and additional white paint splatter. (Figure 29)

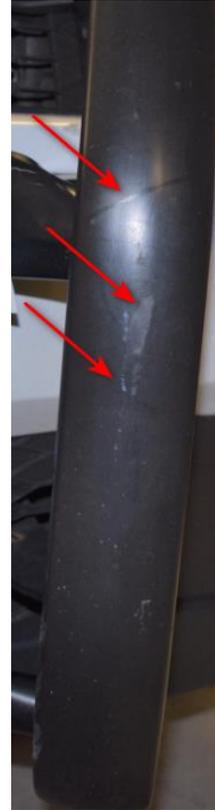
**Figure 32**

A closer examination of the rubber housing around the vertical structure of the push bumper on the driver's side of the vehicle showed an area of scuffing with a whitish area of paint transfer. There was a diagonal impression scuff above this area and numerous superficial scratches and scuffs and additional white paint splatter below. (Figure 32)

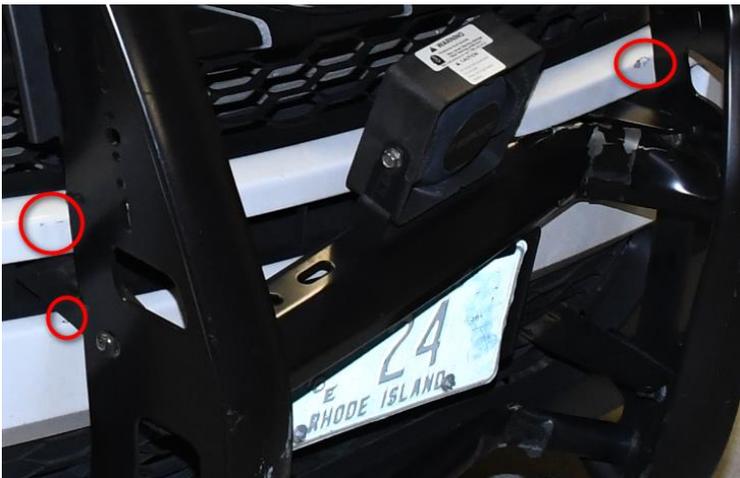
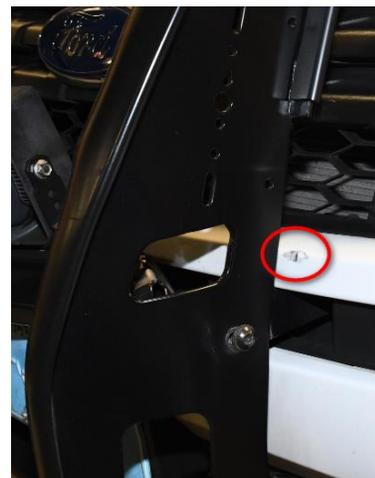
Behind the push bumper assembly were three areas of visible contact transfer onto the front bumper cover of the Providence Police Cruiser. These three areas of transfer were consistent with the push bumper being deflected rearward during its collision with the stop sign post and making contact with the plastic bumper cover. (Figures 33 & 34)

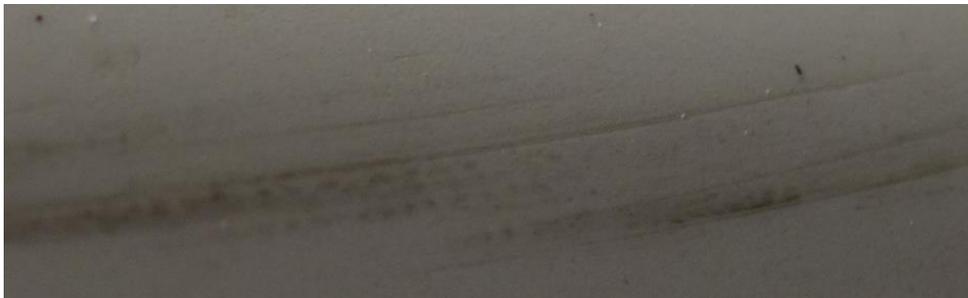
Figure 45

This area below the passenger side headlight assembly was determined to be a two and a quarter-inch (2.25”) black horizontal scuff mark, approximately two feet and five inches (2’5”) above the ground. (Figure 45) This mark did line up with the rear cargo bar of the Yamaha scooter, however, during this investigation, video surveillance footage of the crash event was obtained from the west end of Bissell Street. This video surveillance footage clearly shows that at no time did this area of the Providence Police Cruiser come in contact with the rear of the scooter. As a result, Area # 1 will be excluded from any further analysis. This video surveillance footage will be discussed at length later in the report. (Pages 59 – 79)

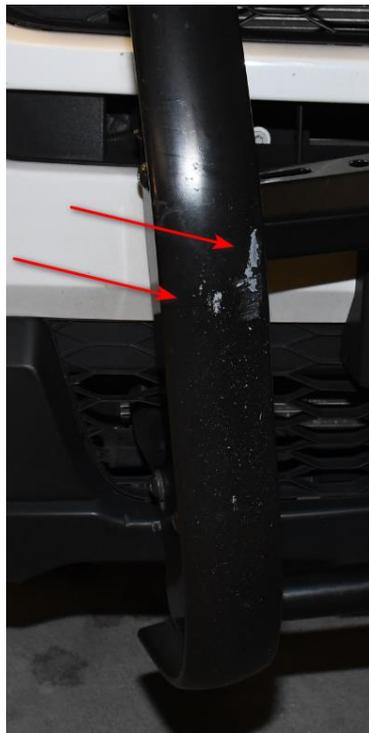
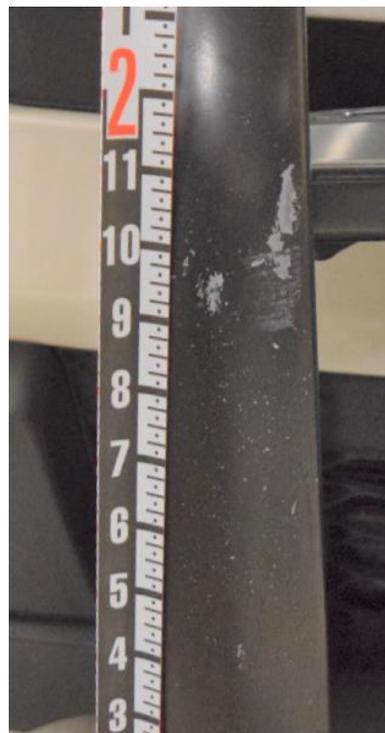
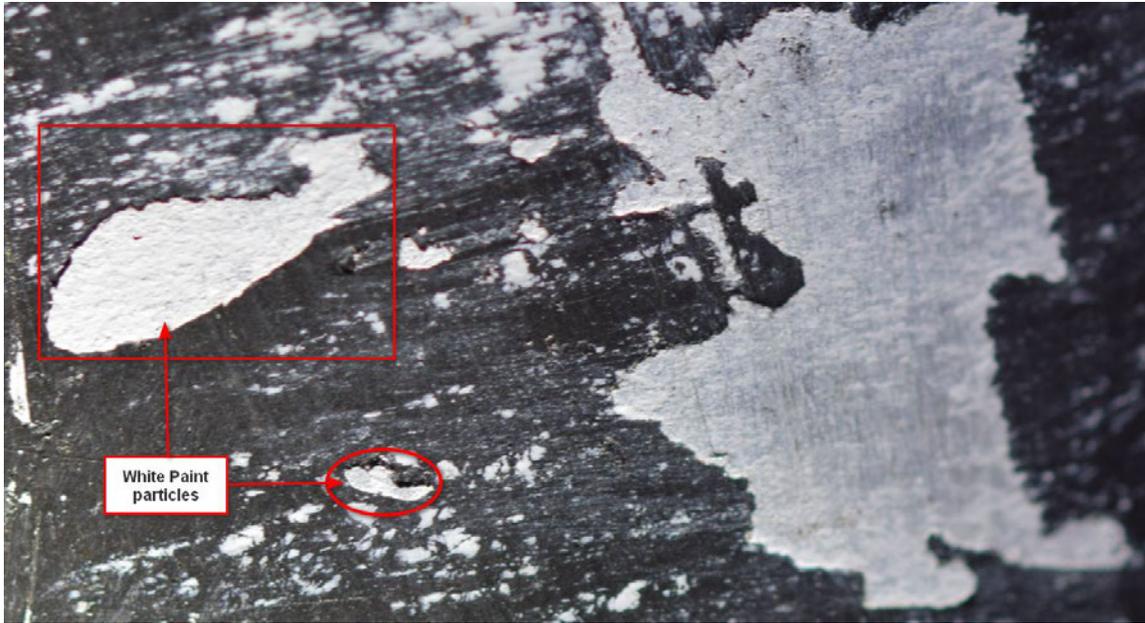
The area of the whitish scuffing and paint splatter on rubber housing around the vertical structure of the push bumper was examined. The area of the deepest scuffing was approximately one foot and nine inches (1'9") to one foot and eleven inches (1'11") above the ground – on the damaged and slightly out of alignment push bumper. There were also numerous areas of white paint splatter below. (Figures 46 & 47) Macrophotography of this area showed that there were scuffs and white latex or oil-based paint chips on the rubber itself. (Figure 48) These paint chips were consistent with a white latex paint or oil-based paint-controlled sample. (Figure 49)

When comparing this area of paint transfer to the rear of the Yamaha scooter, there was no white paint or protruding component that could have caused this contact damage transfer.

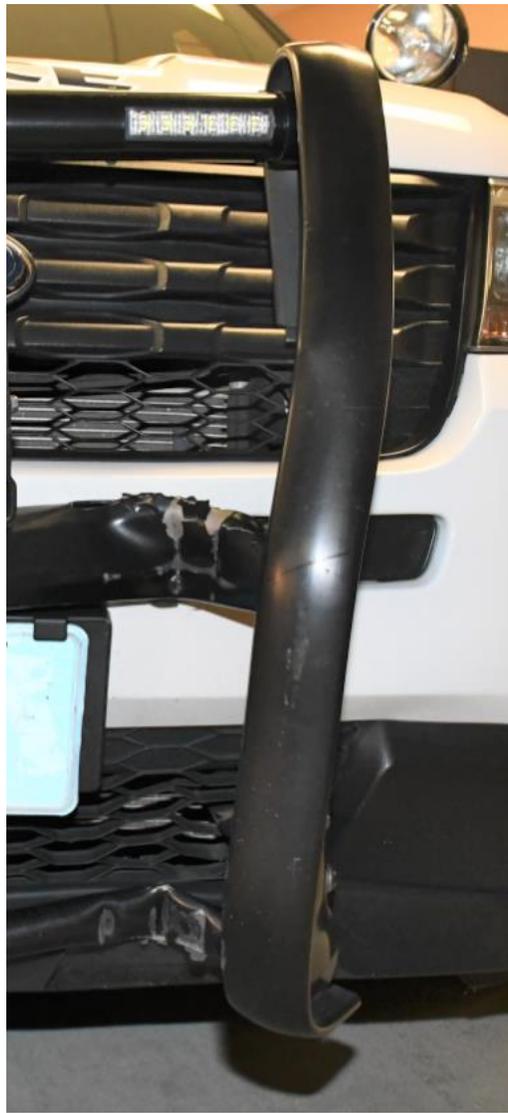
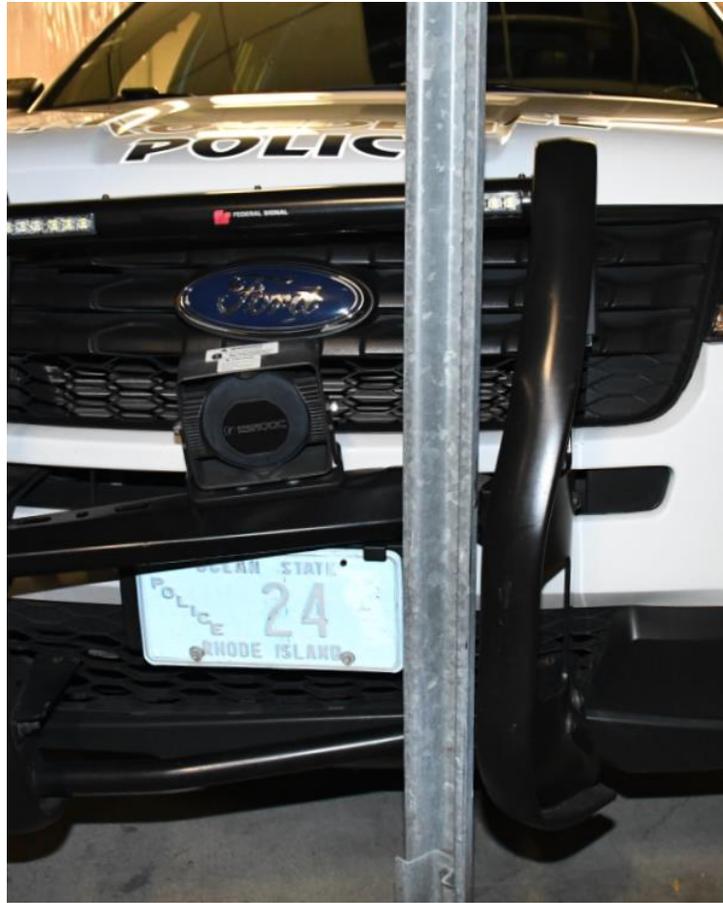
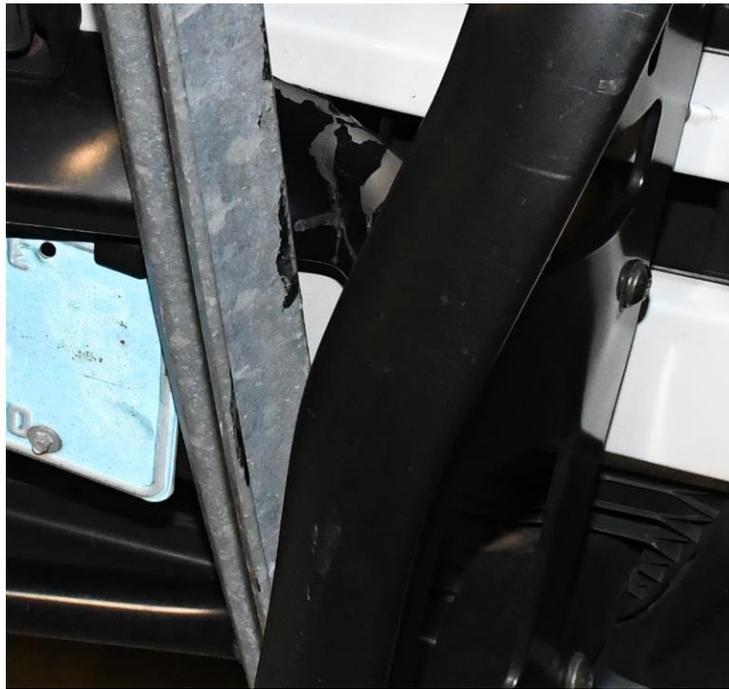
The area of the damage to the upper and lower cross rails of the push bumper were determined to be from striking the vertical stop sign post. The width and contour of the damage was consistent with this impact. The corresponding black paint and rubber contact transfer onto the signpost was also consistent with this impact. A further examination of the damage profile under magnification showed no evidence of any type of transfer evidence that was not consistent with the signpost contact. (Figures 50 – 53)

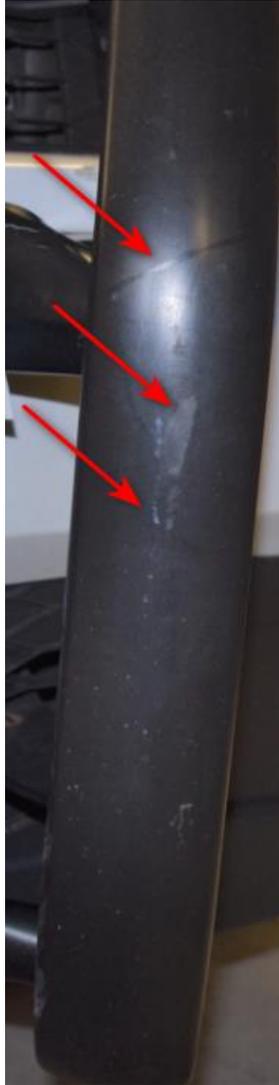
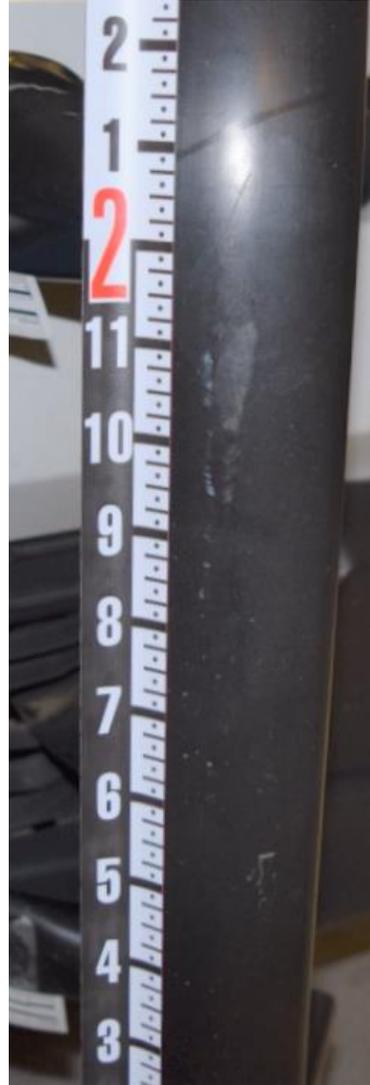
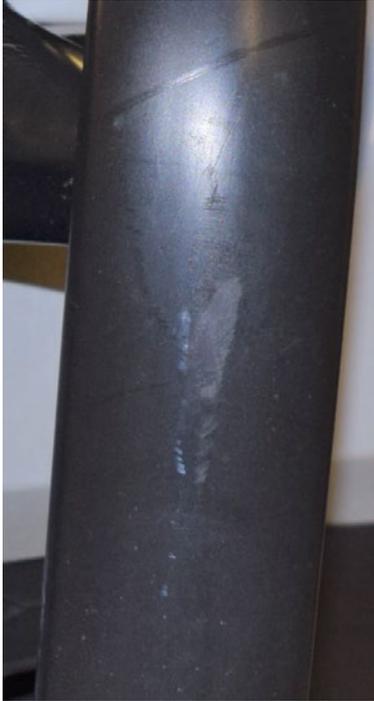
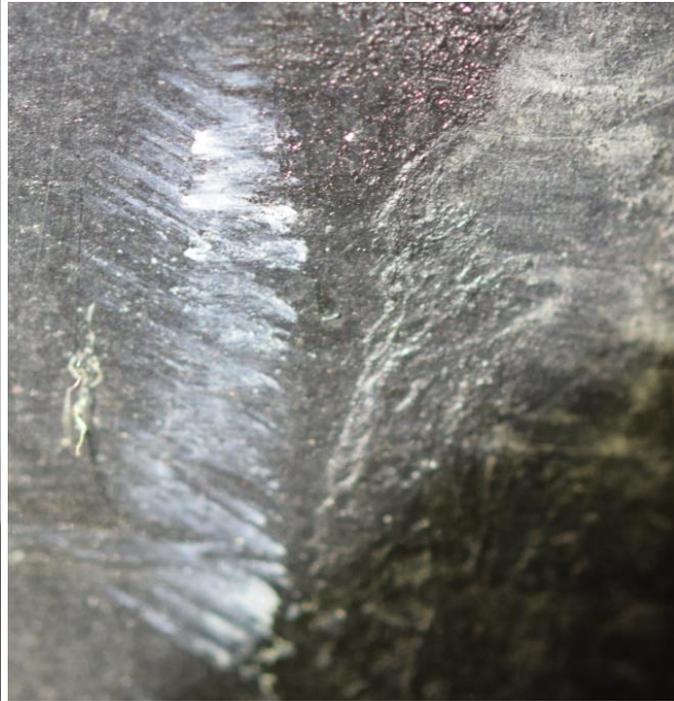
The area of the scuffing and white paint transfer on the rubber housing around the vertical structure of the driver's side push bumper was examined. The area of the deepest scuffing was approximately one foot and ten inches (1'10") to one foot and eleven inches (1'11") above the ground – on the damaged and slightly out of alignment push bumper. There was a diagonal impression scuff above this area. Below this scuff were numerous superficial scratches and additional white paint splatter – consistent with the white paint splatter on the vertical push bumper on the passenger side of the vehicle. (Figures 54 – 56) Macrophotography of this area showed that there were scuffs and white latex or oil-based paint transfer on the rubber itself. (Figure 57) When comparing this area of paint transfer to the rear of the Yamaha scooter, there was no white paint or protruding component that could have caused this damage.

Above this scuff and white paint transfer was the diagonal impression scuff. This scuff traversed the width of the push bumper and was approximately two feet and one inch (2'1") to two feet and two inches (2'2") above the ground. A closer examination showed no evidence of any transfer that could be associated with the rear of the Yamaha scooter. The vertical alignment of this scuff was too low in comparison to the height of the rear cargo bar of the Yamaha scooter. This alignment will be depicted in the **Vehicle Alignment** section of this report. (Page 56)

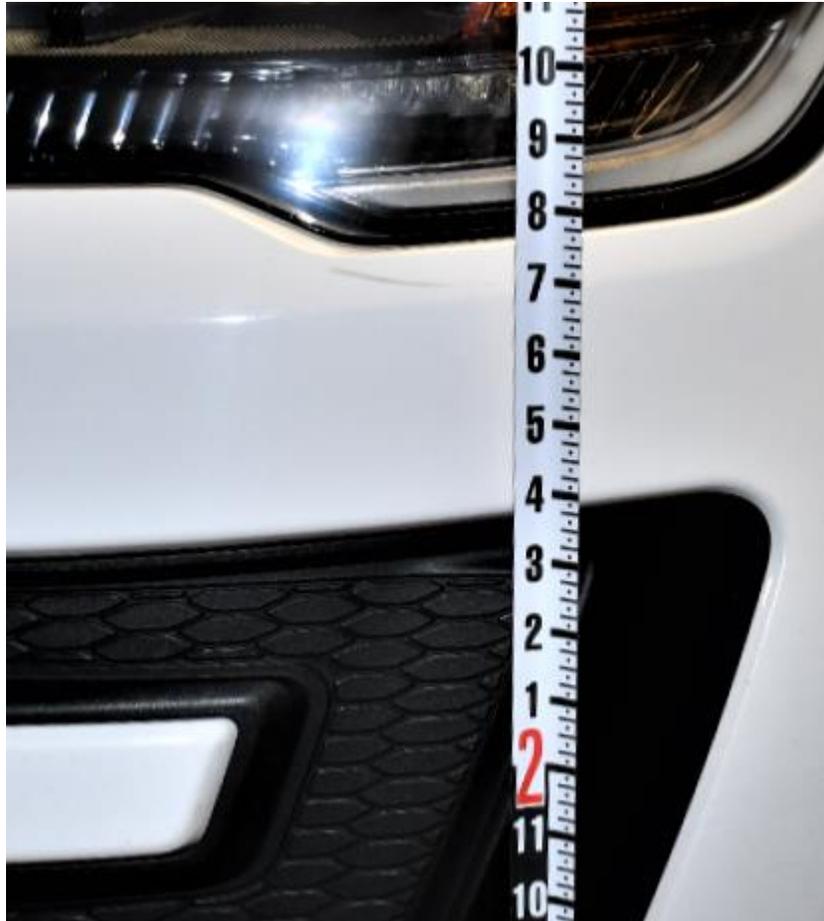
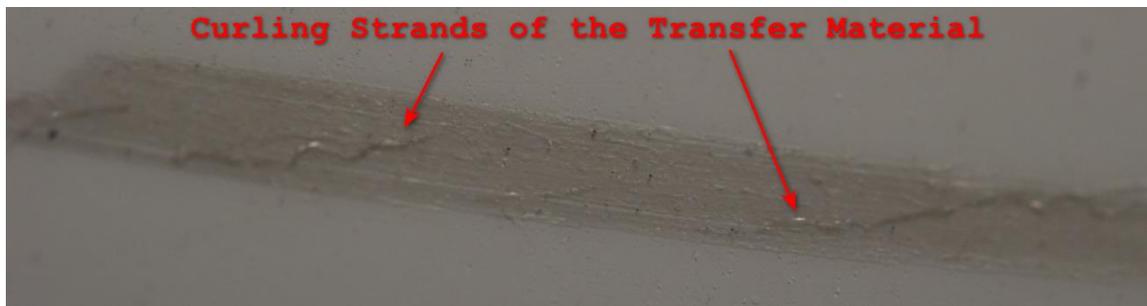
An examination of the whiteish contact transfer just below the driver's side headlight assembly was determined to be an approximate two-inch (2") horizontal scuff, approximately two feet and seven inches (2'7") above the ground. A closer examination of this transfer with macrophotography showed that there were strands of the material curling or peeling away from the plastic bumper cover. This material did not appear to be consistent with latex or oil-based paint, nor consistent with automotive paint. The composition of the substance was not identified during this investigation. (Figures 58 & 59)

A closer examination showed no evidence of any transfer that could be associated with the rear of the Yamaha scooter. The vertical alignment of this scuff was also too high in comparison to the rear of the Yamaha scooter. This alignment will be depicted in the **Vehicle Alignment** section of this report. (Page 57)

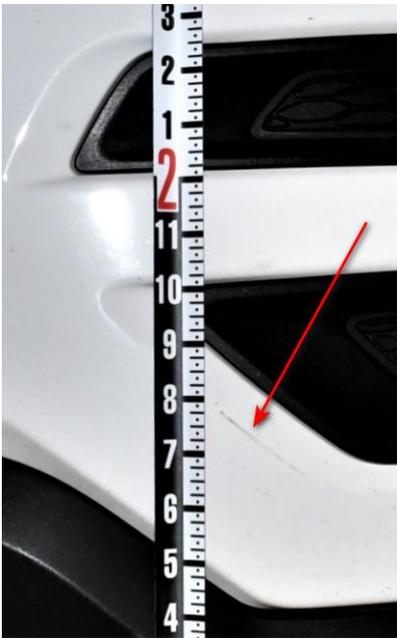
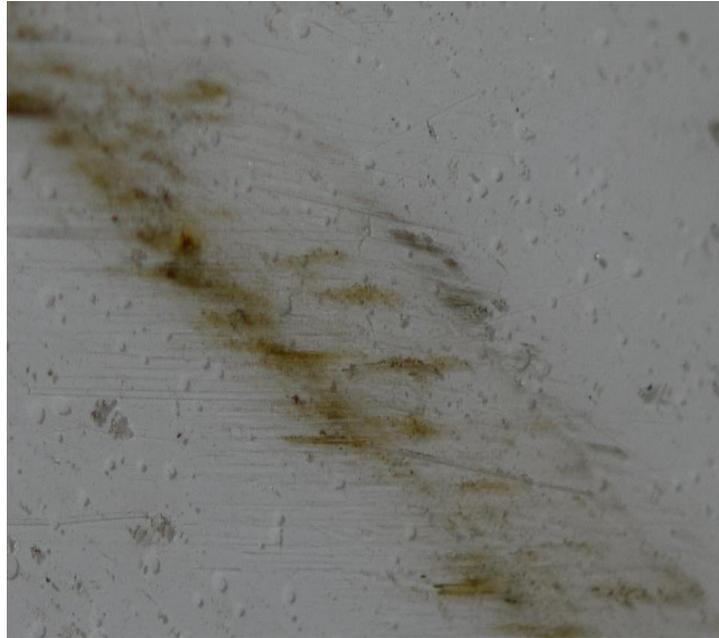
An examination of the dark transfer scuff along the edge of the molded recess in the plastic bumper cover showed it to be approximately one foot and six and one-half inches (1'6.5") to one foot and eight inches (1'8") above the ground. A closer examination of this transfer with macrophotography showed the substance to be dark brown and tan and not consistent with a plastic or rubber compound. This contact transfer was in a consistent horizontal manner across the plastic bumper cover. (Figures 60 & 61)

A closer examination showed no evidence of any transfer that could be associated with the rear of the Yamaha scooter. The vertical alignment of this scuff would have aligned with a section of the rear mud flap of the scooter; however, the cargo carrier bar would have to contact the front bumper for this to occur. This alignment will be depicted in the **Vehicle Alignment** section of this report. (Page 58)

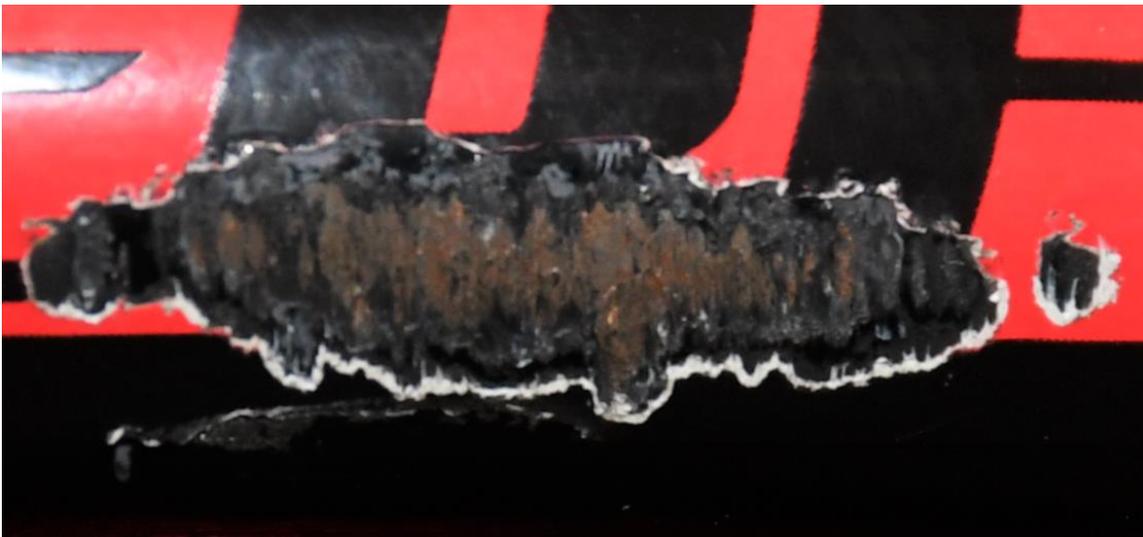
**Figure 64**

This area of contact damage to the rear cargo carrier bar was to the left of the centerline of the scooter. This contact damage was an approximate one inch (1") horizontal scrape into the metal of the cargo bar, approximately two feet and six inches (2'6") above the ground. A closer examination showed that the channels of the scrapes were in a vertical direction. Within the scrapes were significant oxidation and rusting of the metal. This level of oxidation and rusting was not consistent with this damage occurring approximately forty-one (41) hours prior to these photographs being taken. (Figures 63 & 64)

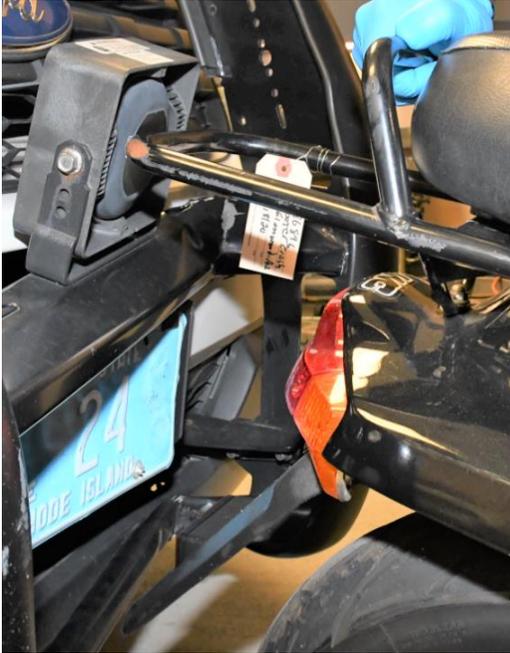
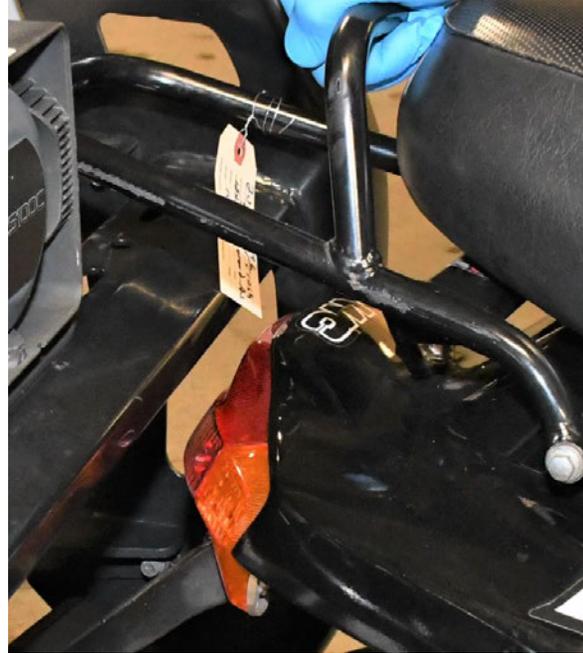
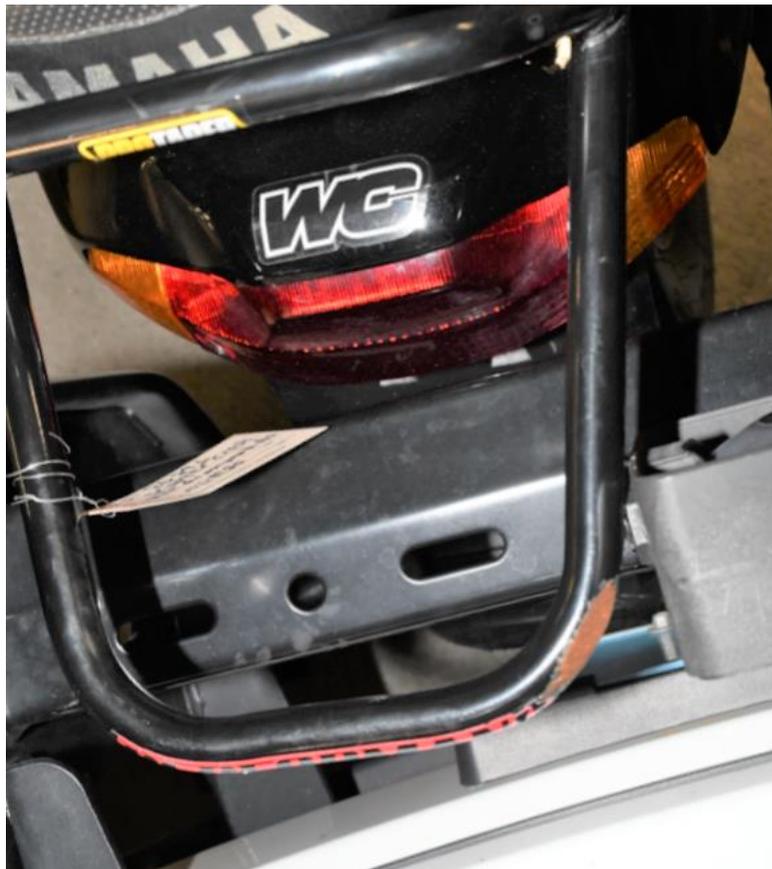
An examination of Area # 3 and the area between the two vertical rails of the push bumper was conducted. This examination showed that if the Providence Police Cruiser struck the rear of the Yamaha scooter anywhere in this area, there would have been visible contact damage somewhere along the interior vertical rails of the push bumper, the siren mounted in the center of the push bumper, the front grille of the Providence Police Cruiser, the cargo bar of the Yamaha scooter, the rear mud flap of the Yamaha scooter, or anywhere along the plastic lenses of the scooter's tail light assembly. The lack of any visible damage or contact transfer to either vehicle in these areas confirms that the Providence Police Cruiser did not strike the Yamaha scooter within the interior of the push bumper. (Figures 70 – 73)

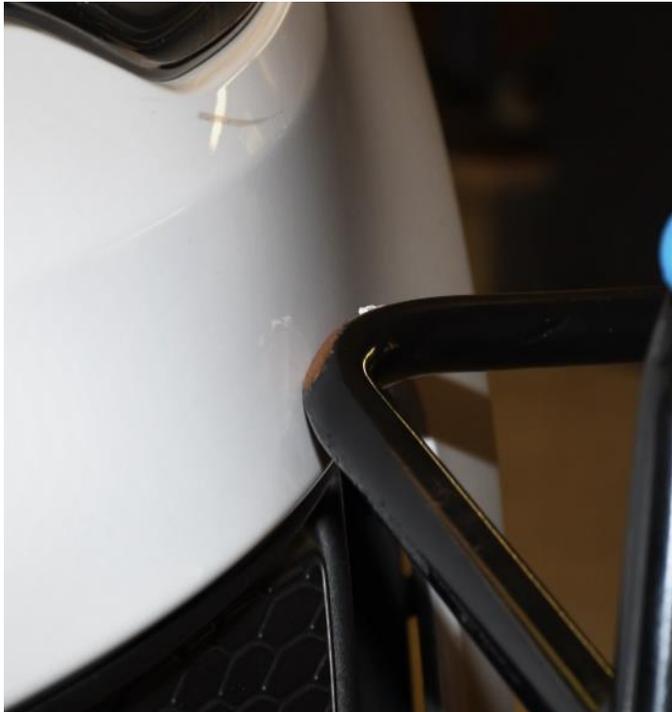
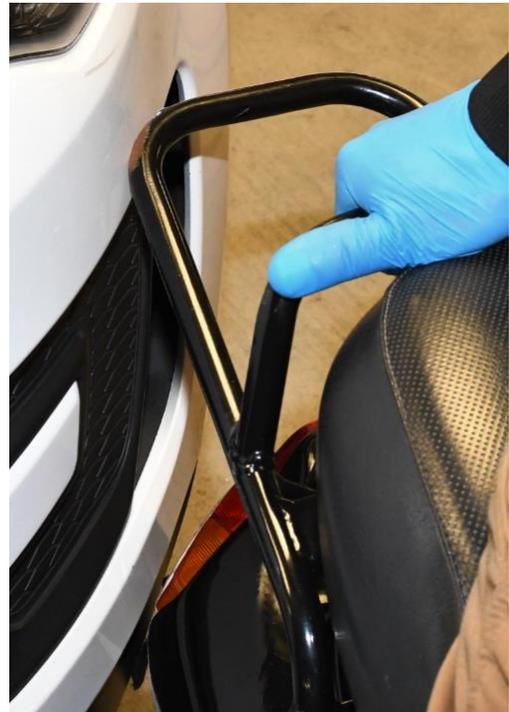
The alignment of the Yamaha scooter to Area # 5, the whiteish contact transfer just below the driver's side headlight assembly, was determined to be too high for any component from the rear of the Yamaha scooter. There were also no corresponding marks from the rear mud flap to the lower portion of the front of the Providence Police Cruiser's front bumper. The whitish substance itself was determined to not be consistent with any component on the rear of the Yamaha scooter. (Figures 75 & 76)

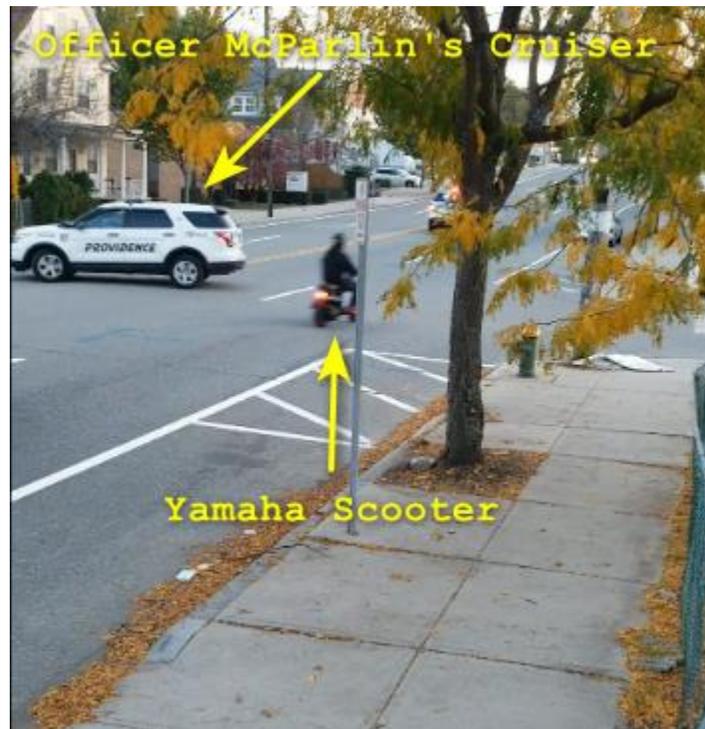
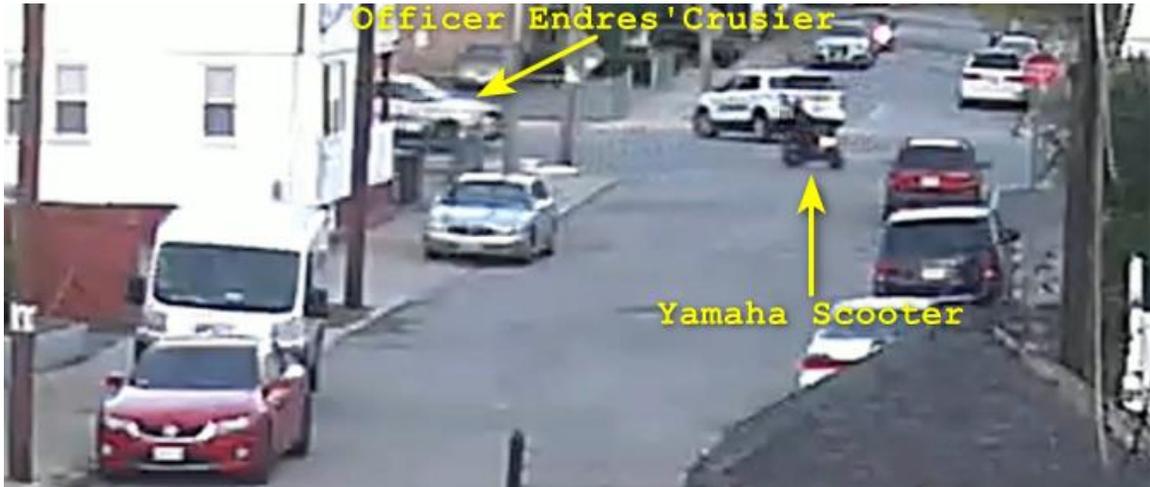
In these two images, the Yamaha scooter can be seen traveling south on Elmwood Avenue as Officer Endres' Police Cruiser follows and becomes visible in the Advanced Telesystems Group Inc. surveillance footage.

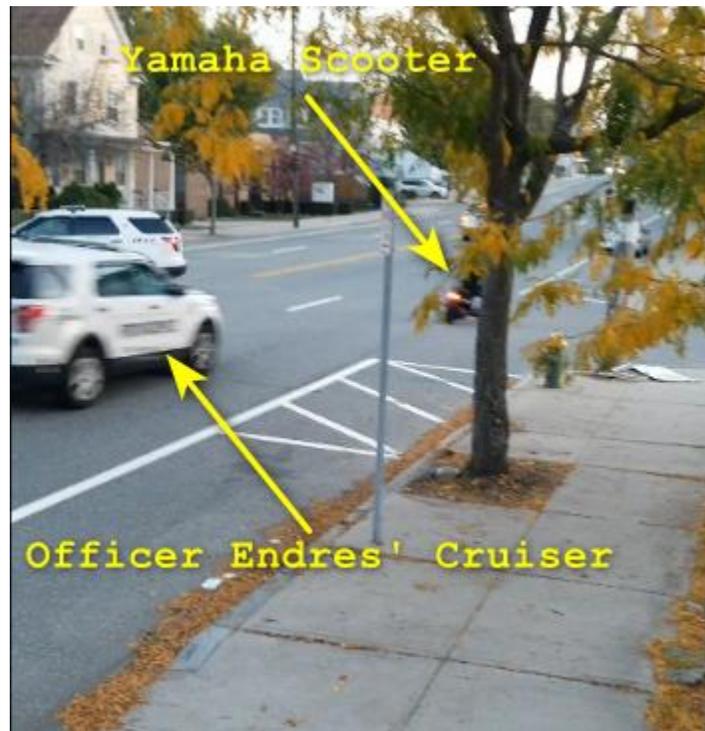
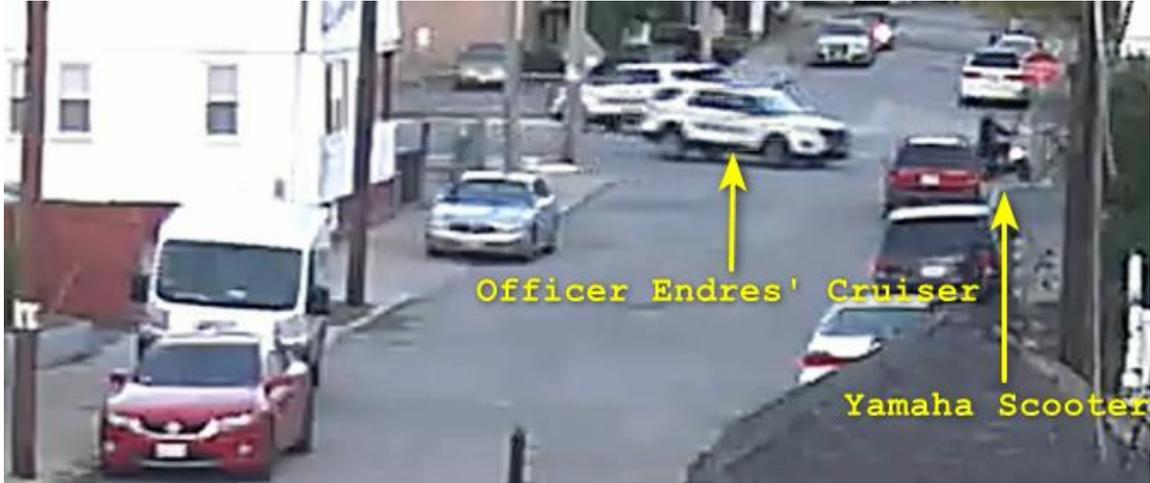
In these three images, the Yamaha scooter begins to drive onto the sidewalk along the southwest corner of Elmwood Avenue and Bissell Street. In the [REDACTED] cellular phone video, Officer Endres can be seen turning to the right while activating the brakes of the vehicle.

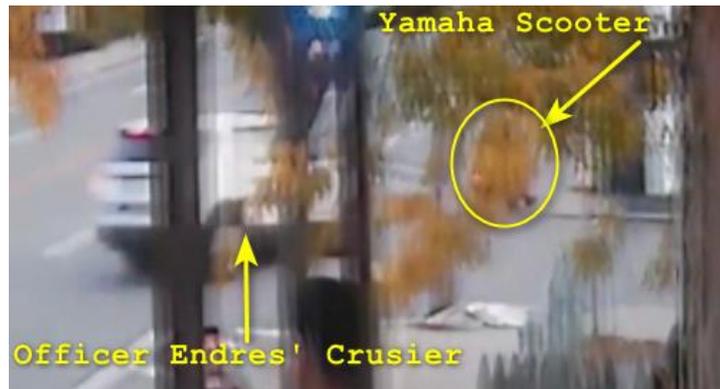
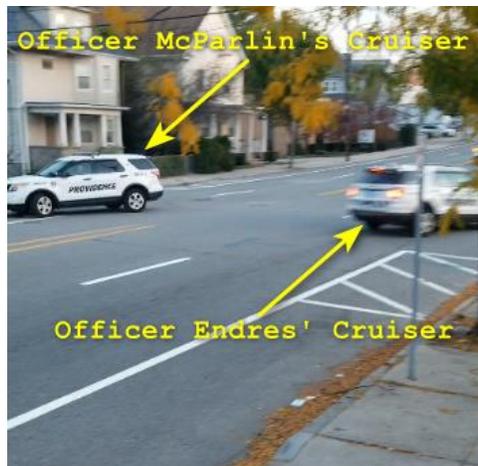
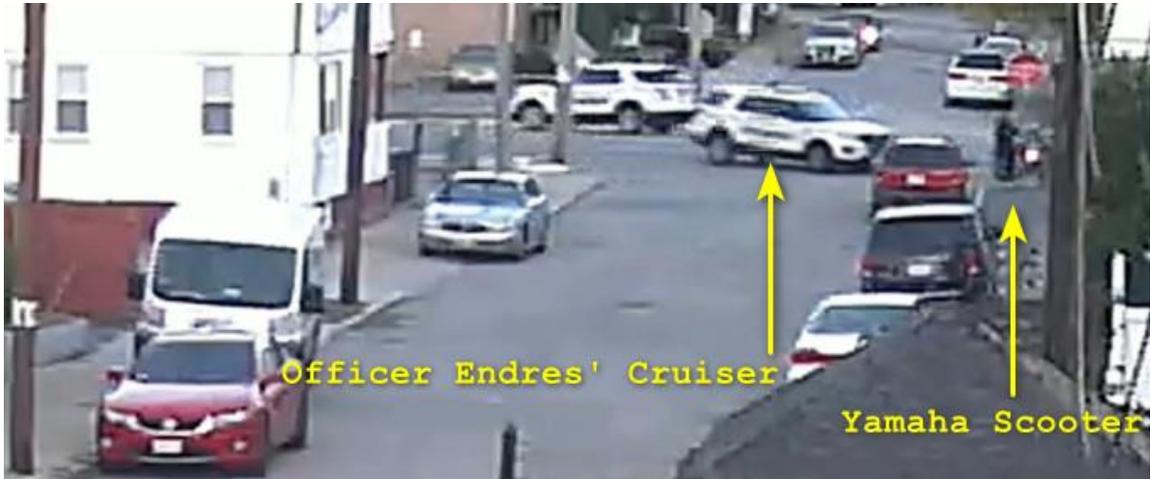
In these images, the Yamaha scooter has driven up onto the sidewalk and is to the south of the stop sign post. In the [REDACTED] cellular phone video, Officer Endres' is still activating the brakes of the vehicle as the Cruiser exits the camera view from this point.
