**Rhode Island State Police**  
**Collision Reconstruction Unit Report**

**Case Number: 20-298-CRU**

**Date: October 18<sup>th</sup>, 2020**

**Elmwood Avenue at Bissell Street**

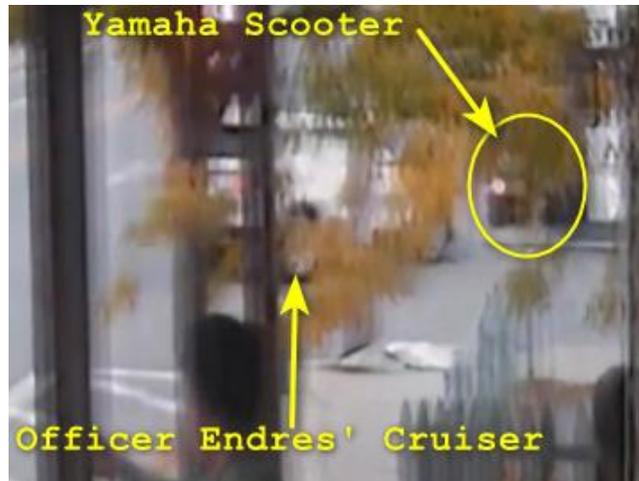
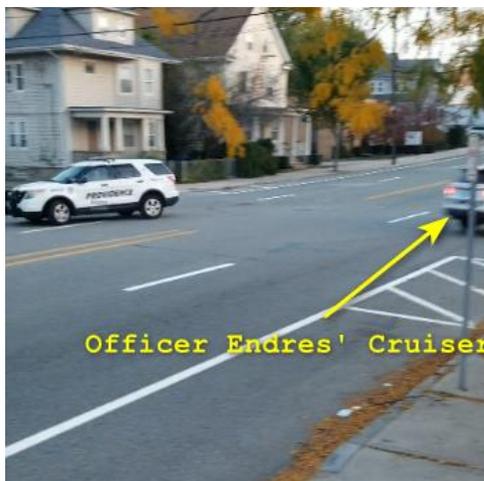
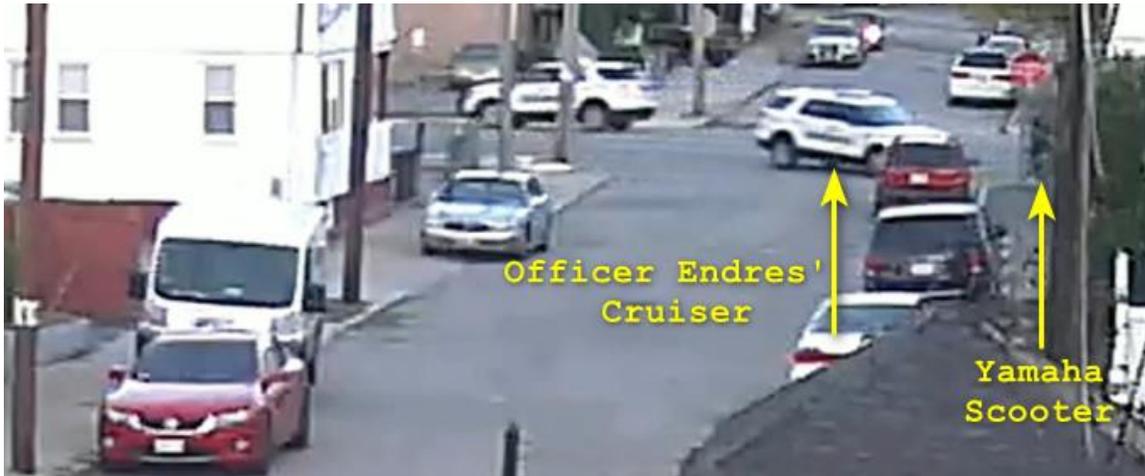
In these two images, the Yamaha scooter has driven up onto the sidewalk and is passing the stop sign post as it travels west on the sidewalk. In the [REDACTED] cellular phone video, Officer Endres's Cruiser has exited the camera view as [REDACTED] follows Officer McParlin's Cruiser.

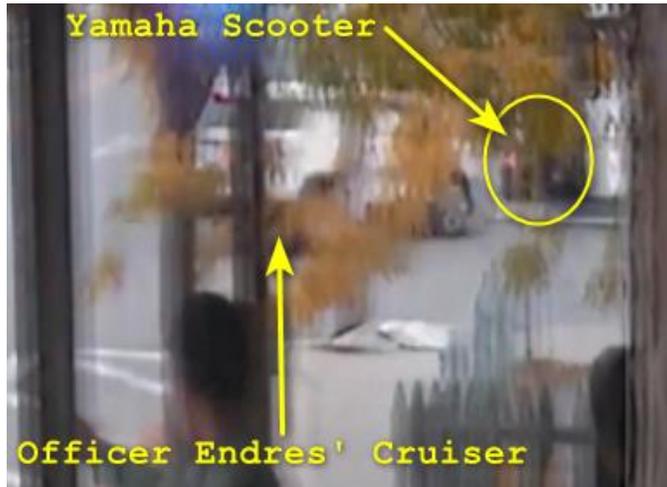
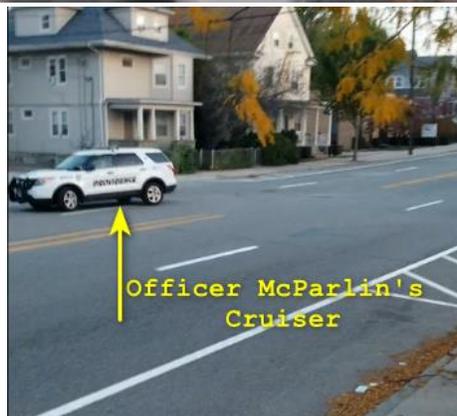
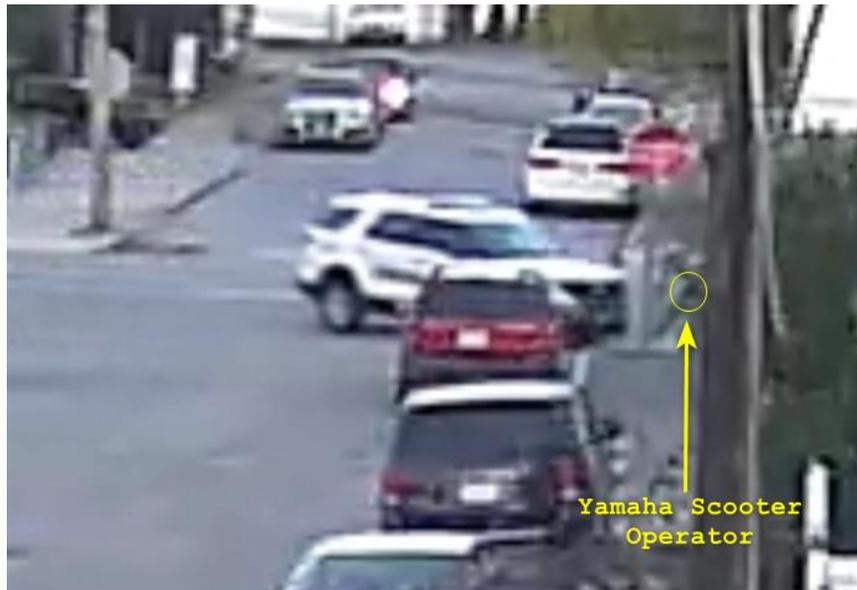
In these images, the last visible area of the Yamaha scooter / operator is captured from this angle on the Advanced Telesystems Group Inc. video. Its full view is obstructed by the foliage of a tree on Bissell Street. Officer Endres's Cruiser is just starting to drive onto the sidewalk at this point. From the perspective of the home video surveillance footage it appears as though the front of the Cruiser and the rear of the scooter are close. However, from the Advanced Telesystems Group Inc. video, we can see that the two vehicles are separated by at least the entire width of the visible sidewalk at this time. The [REDACTED] cellular phone video does not capture any of this and is not depicted below.

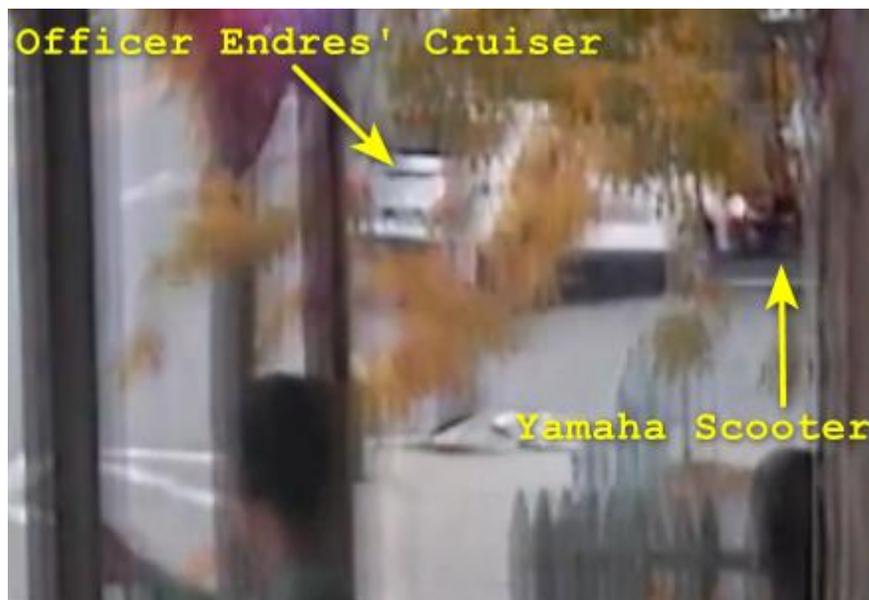
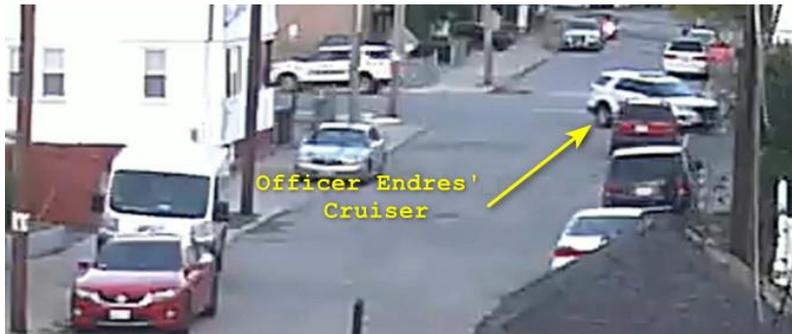
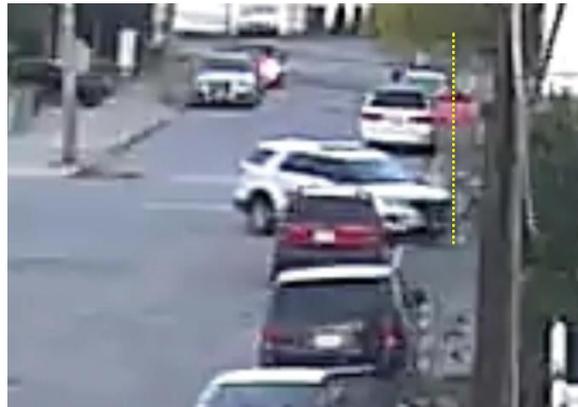
In these images, the front of Officer Endres's Cruiser makes contact with the stop sign post. These images capture the stop sign beginning to move for the first time. The second image is a magnification of the same frame of the video. From the [REDACTED] home video footage the stop sign being struck is not visible, however the below image depicts the approximate same time based upon the Cruiser's tire positions. Again from the home video perspective, the two vehicles appear very close to each other, but from the Advanced Telesystems Group Inc. video, we know that they are still separated by at least the entire width of the visible sidewalk.

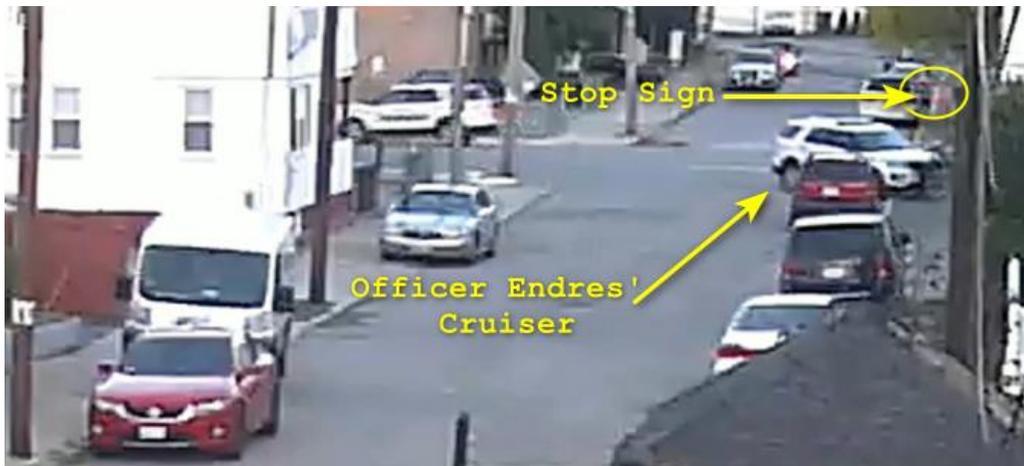
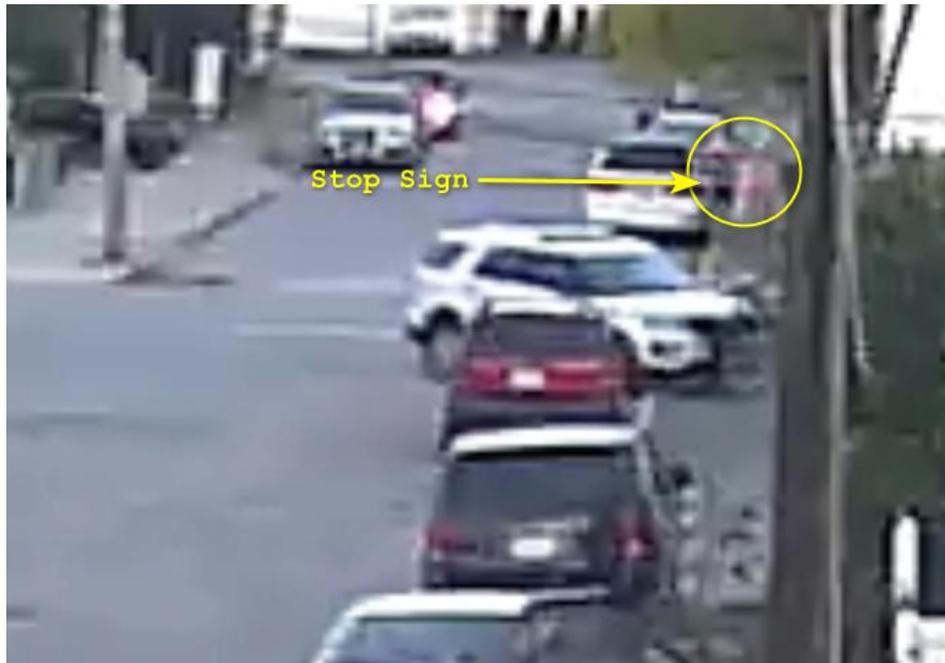
In these two images, the stop sign is being driven over and deflected downward. The images capture the red stop sign face as it is moving downward. Its motion is consistent with the ‘blurring’ of the red image. The Yamaha scooter / operator are not visible in this video frame. From these images, we can determine that the front of Officer Endres’s Cruiser struck the stop sign post and had not made contact with the Yamaha scooter – which is out of the video frame. The [REDACTED] home video footage was recorded with a different frame rate and could not be broken down to capture the stop sign moving. The next frames of the home video capture the front of the Cruiser and the entire scooter out of camera view. These frames are not depicted below.

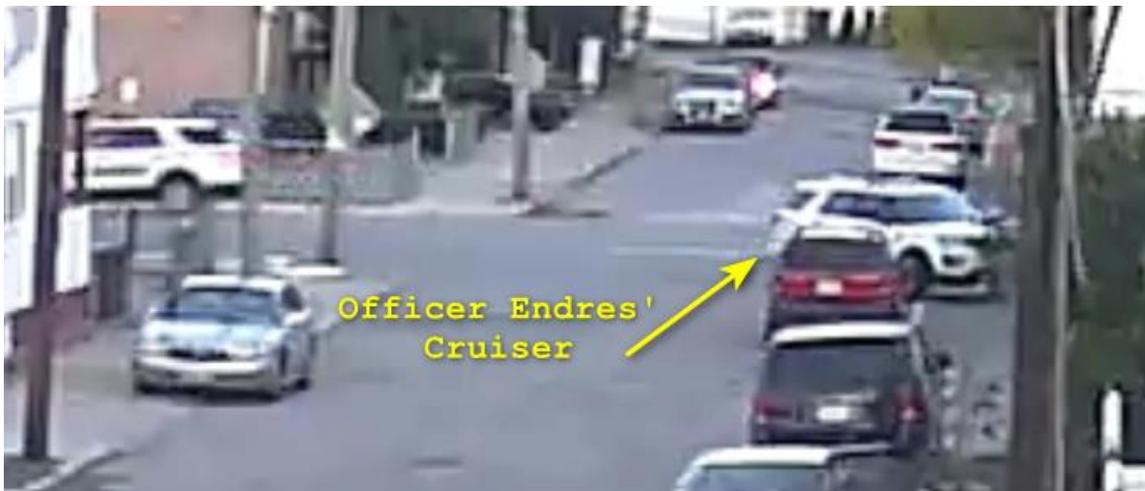
In the two images below, the elapsed time from the images on the previous page is approximately three tenths (3/10ths) of a second. The driver's side front of the Cruiser is not captured in the Advanced Telesystems Group Inc. surveillance footage, however, the [REDACTED] cellular phone video, which was panning back to Officer Endres's Cruiser and the Yamaha scooter, captured both the front of the Cruiser and the rear of the Yamaha scooter. While the image is blurred due to the motion of the camera, the rear tail light of the Yamaha scooter can be seen in the [REDACTED] image. Although it looks like the two vehicles are very close to each other in this frame, the image is only a two-dimensional view of this moment. When comparing these two images below with the previous images, we know that the Yamaha scooter drove to the south around the stop sign post and was traveling along the brick wall of 1245 Elmwood Avenue. We also know that the Providence Police Cruiser had just mounted the sidewalk and while the front of the Cruiser cannot be seen, we know the Yamaha scooter had already driven through this area of the sidewalk. From the perspective of the [REDACTED] camera, it would appear that the Providence Cruiser and the Yamaha scooter are closer than they actually are. The third image is a scaled diagram of this moment with the Providence Police Cruiser and the Yamaha scooter being placed in their approximate locations. The top-down view of this diagram illustrates the separation between the two vehicles that is not apparent from the perspective of the [REDACTED] video footage.

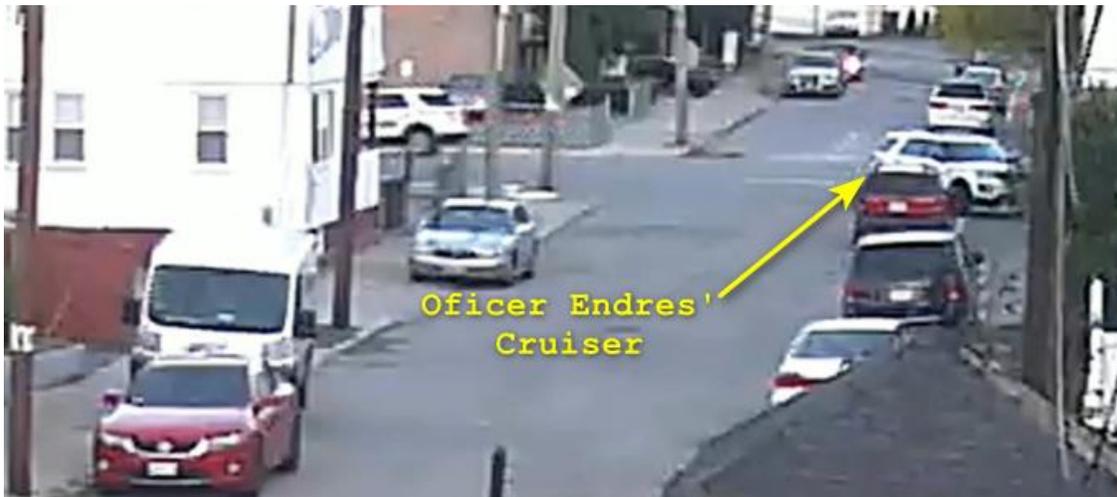
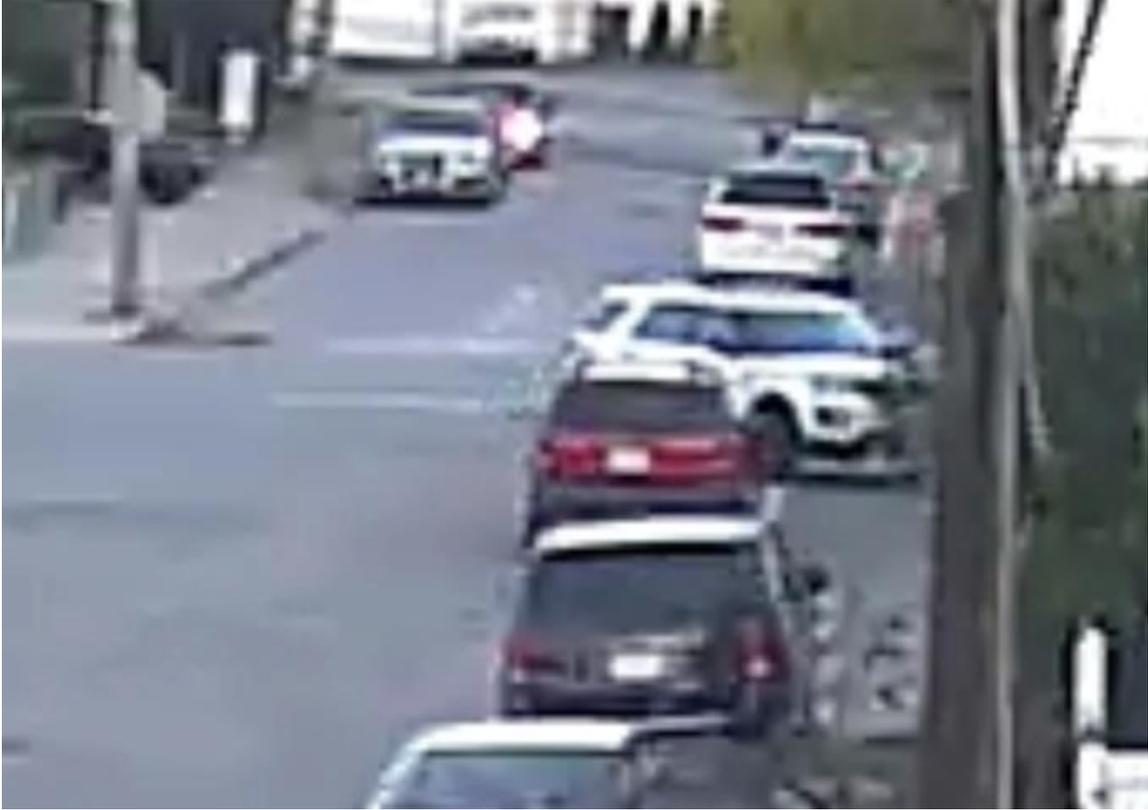
In the four images below, the stop sign has been driven over and Officer Endres' Cruiser's passenger front tire has just mounted the curbing. The rear brake lights of the Cruiser can also be seen. From the Advanced Telesystems Group Inc. surveillance footage view, the Yamaha scooter / operator are still not visible in this video frame. In the [REDACTED] cellular phone video, which has panned back to Officer Endres's Cruiser and the Yamaha scooter, we can see the separation from the front of the Providence Police Cruiser to the rear of the Yamaha scooter. Both individual video frames were magnified on the following page. With the previously identified left brake lever contact on the brick wall of the building (Figure 7), we know that the scooter at this point needs to be aligned along the brick wall. Based on the alignment of the Providence Police Cruiser at this point, these individual frames clearly show that the front of the Providence Police Cruiser could not strike the Yamaha scooter in this alignment.

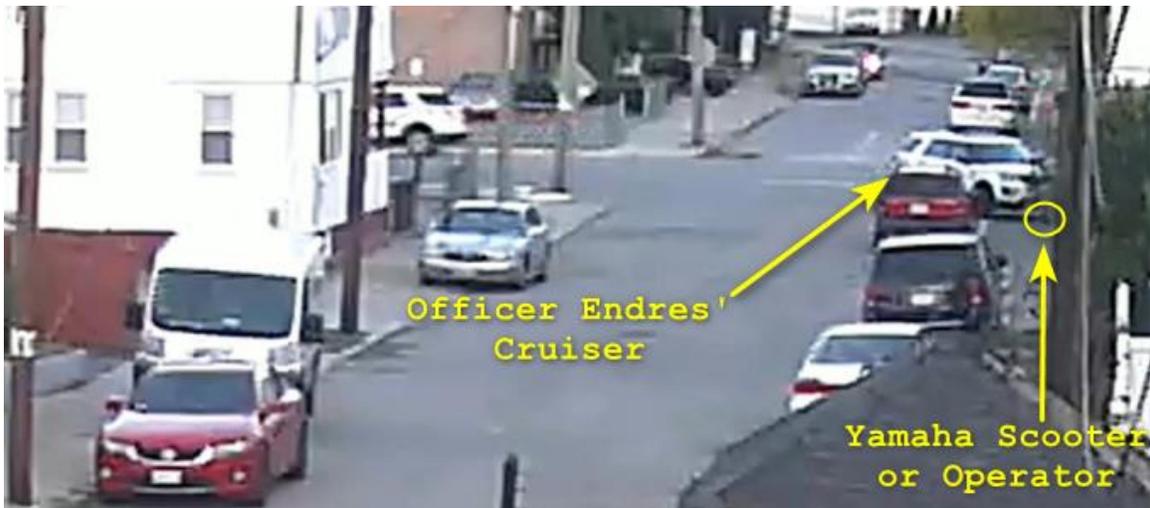
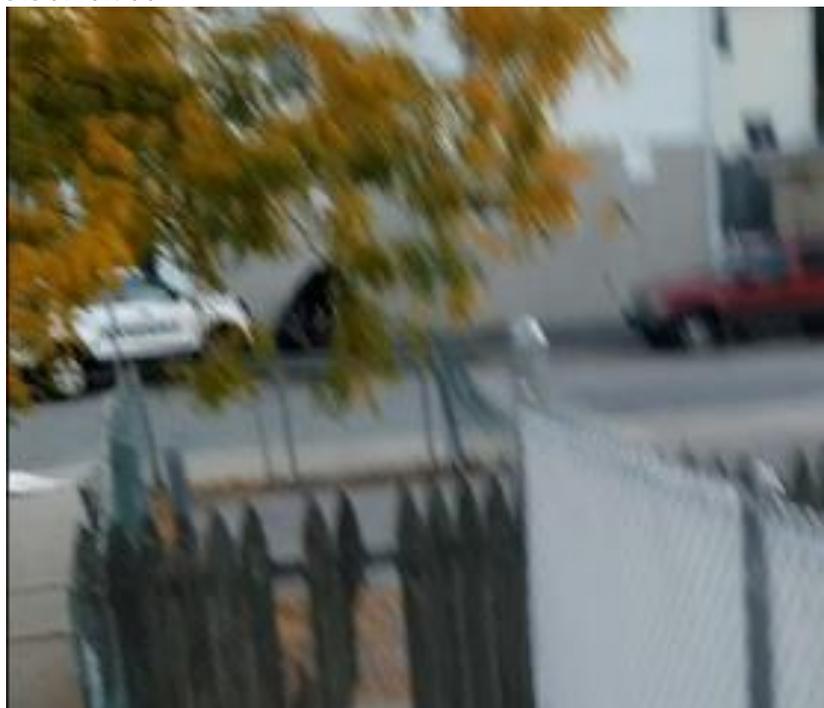
In the two images below, the Yamaha scooter / operator first comes back into the video frame of the Advanced Telesystems Group Inc. surveillance footage. In the [REDACTED] cellular phone video, the separation between the front of the Providence Police Cruiser and the Yamaha Scooter is more evident. Both individual video frames were magnified on the following page. An analysis of these individual frames clearly shows that the front of the Providence Police Cruiser did not strike the Yamaha scooter at this point.

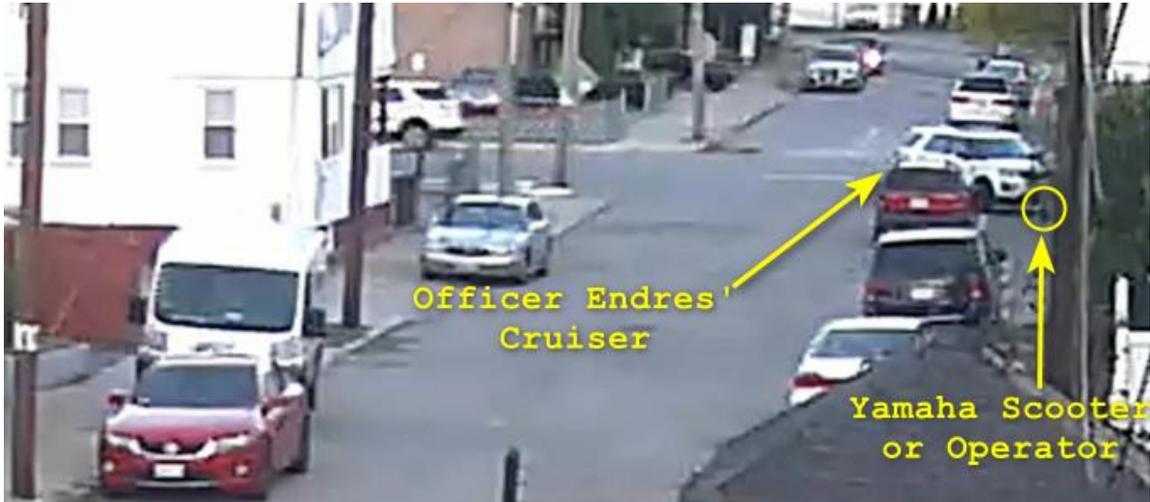
The two images below were taken thirty-three (33) milliseconds after the above images. The [REDACTED] cellular phone video clearly captures the stop sign post in contact with the operator of the Yamaha scooter.

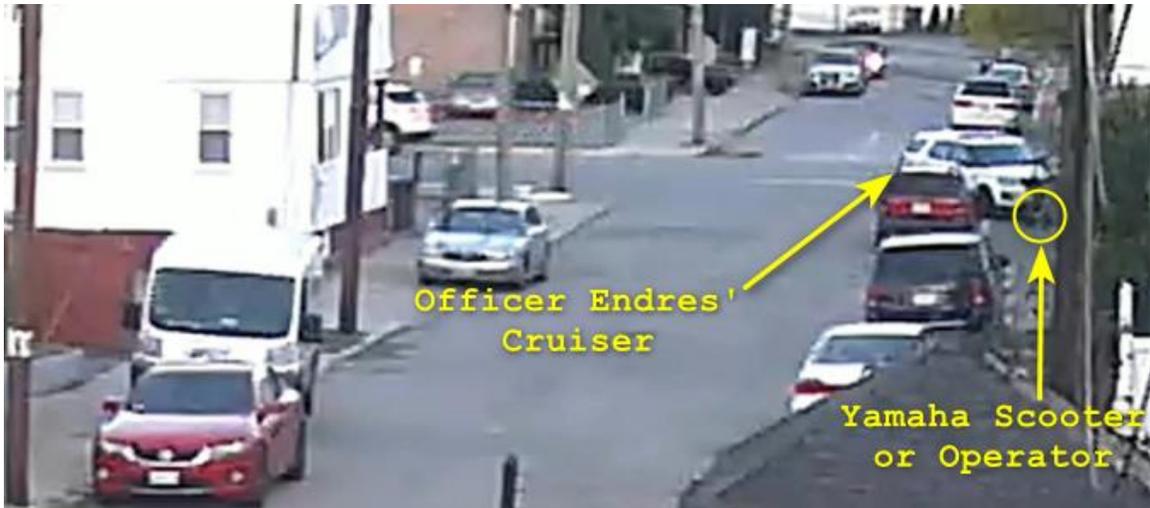
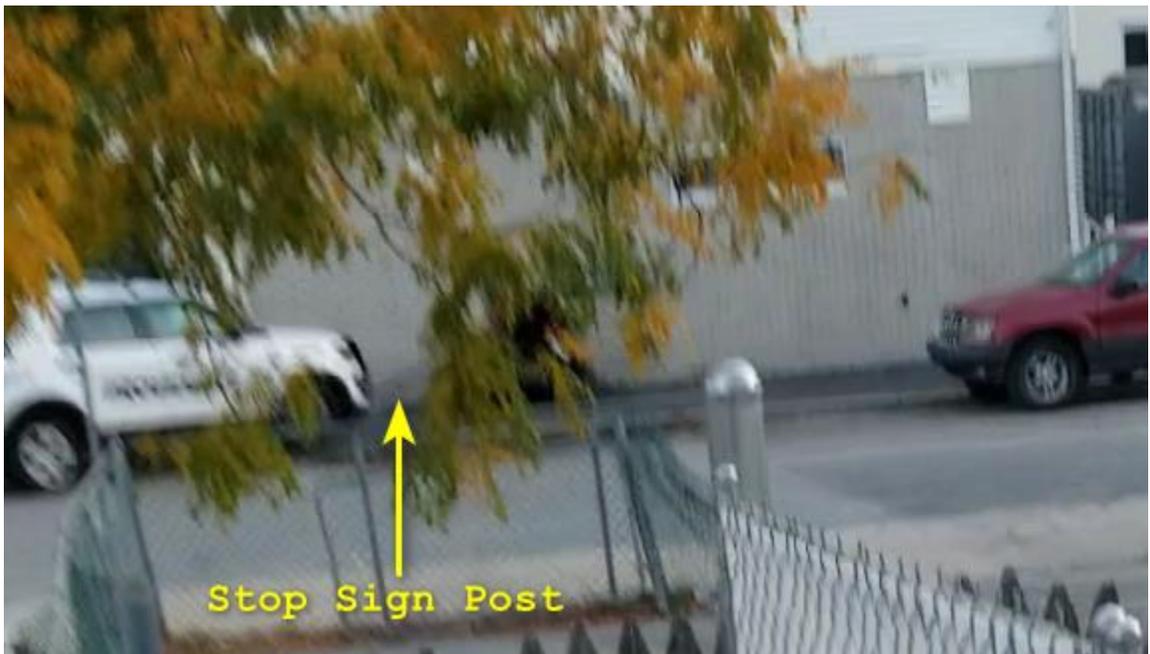
In the two images below, the Providence Police Cruiser has come to a complete stop and the Yamaha scooter and its operator can be seen falling onto the sidewalk in the Advanced Telesystems Group Inc. surveillance footage. In the [REDACTED] cellular phone video, the stop sign and post can be seen still falling as the Yamaha scooter is obscured by a tree branch.

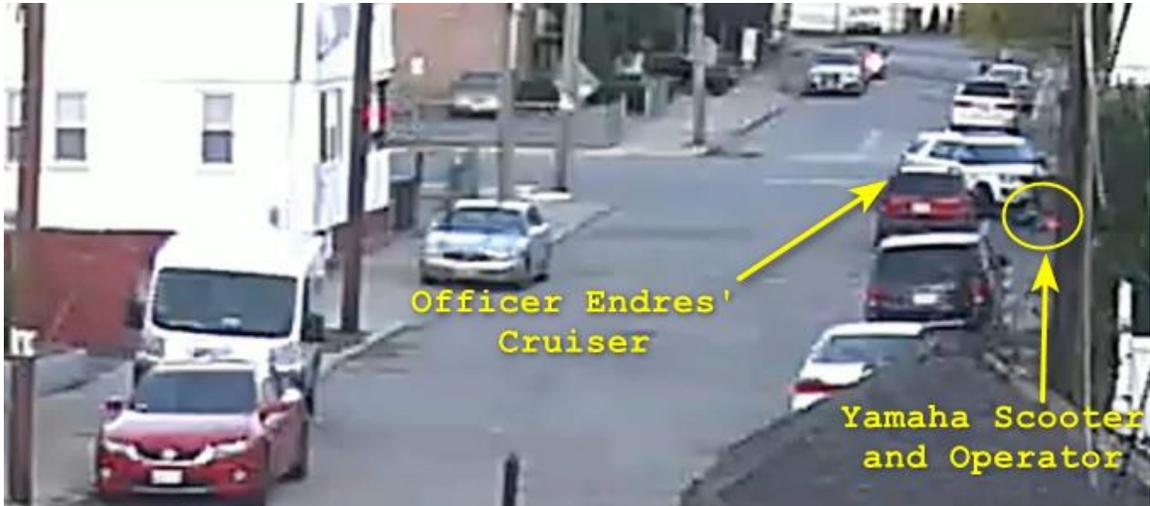
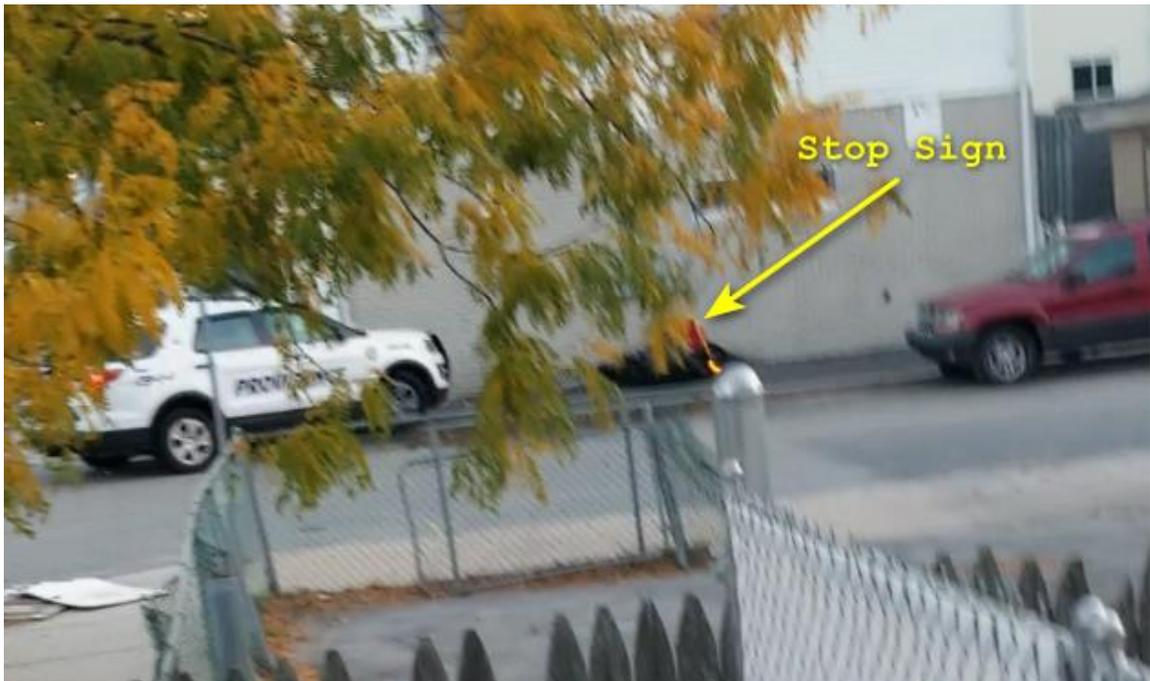
In the two images below, the Providence Police Cruiser remains at a complete stop and the Yamaha scooter and its operator continue to fall over onto the sidewalk in the Advanced Telesystems Group Inc. surveillance footage. In the [REDACTED] cellular phone video, the stop sign face is clearly visible alongside the fallen Yamaha scooter and its operator.

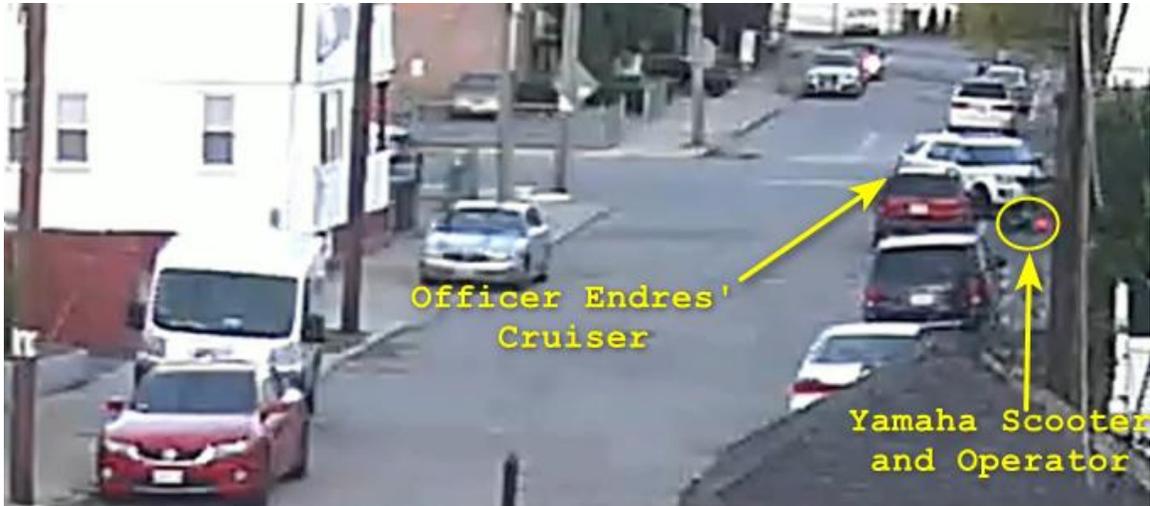
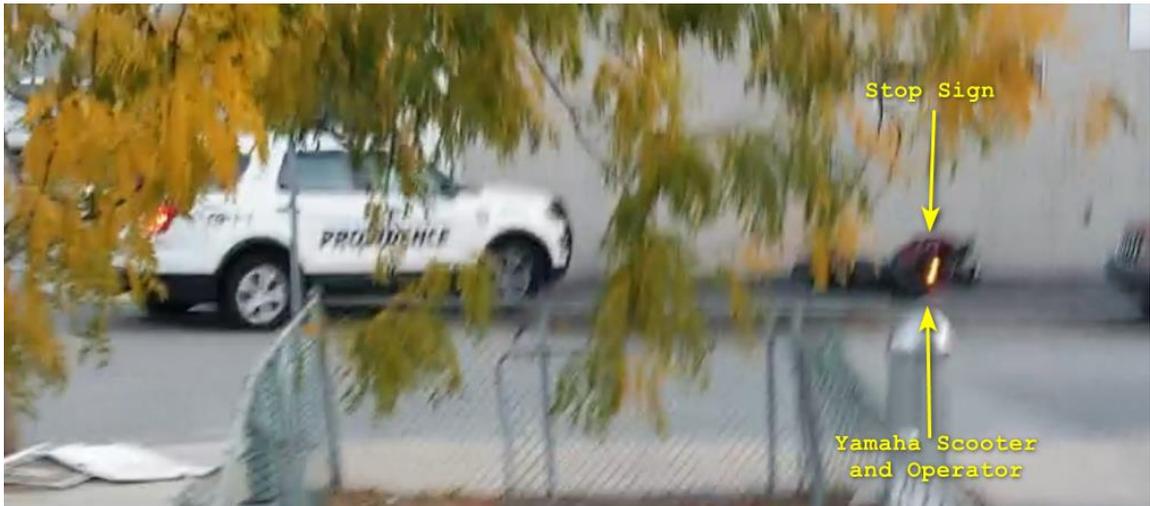
In the two images below, the Providence Police Cruiser remains at a complete stop and the Yamaha scooter and its operator both come to a complete stop as well.

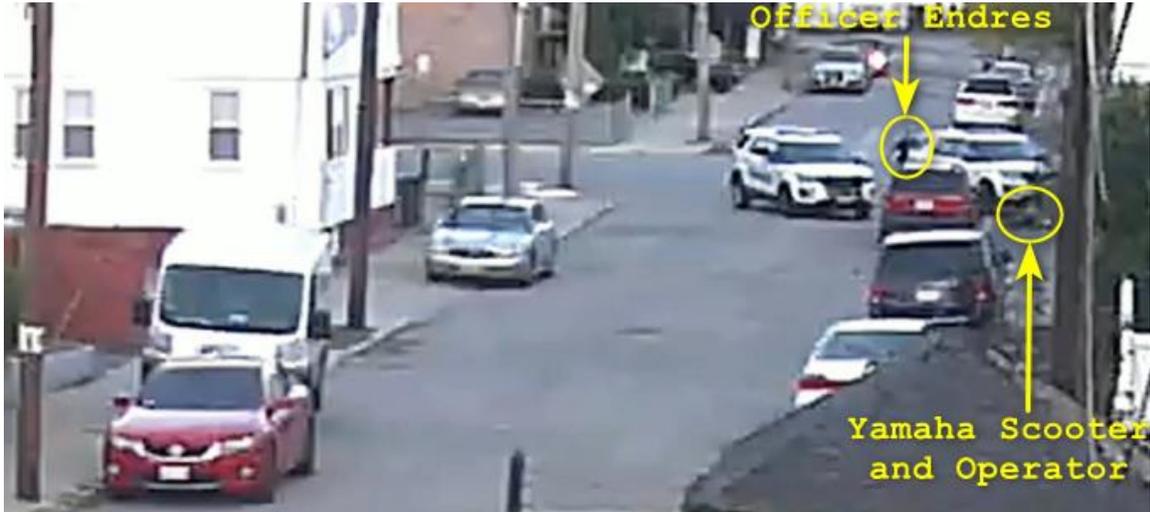
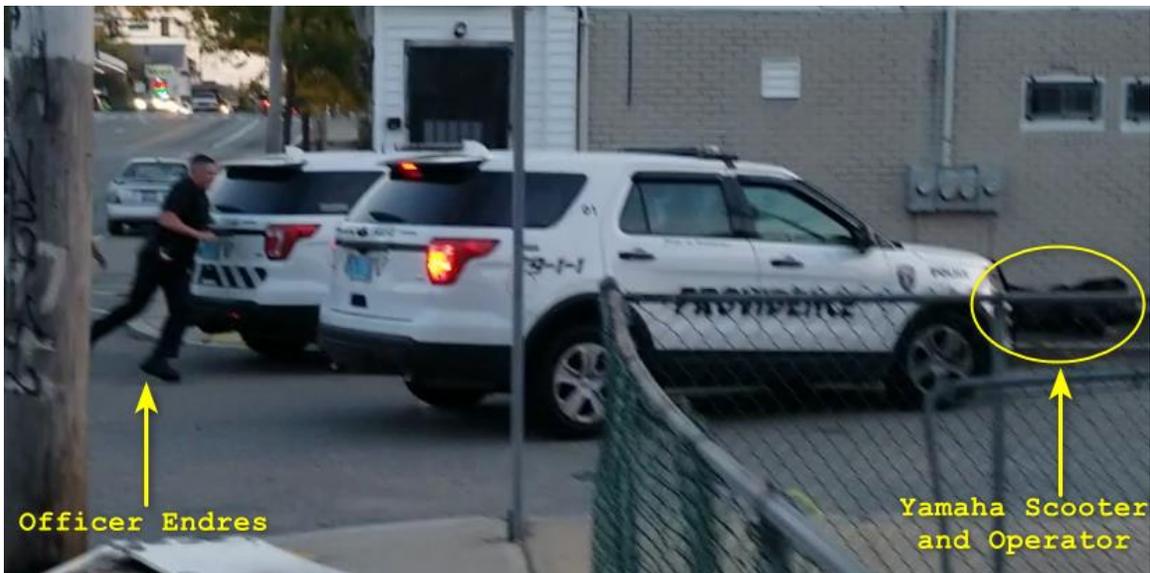
In the two images below, Providence Police Officer Endres has exited his Cruiser and run around the back of it, towards the Yamaha scooter and its operator. The operator of the scooter, Jhamel Gonsalves, remained at rest on the sidewalk. Additional Providence Police Cruisers began to arrive on the scene from this point forward.

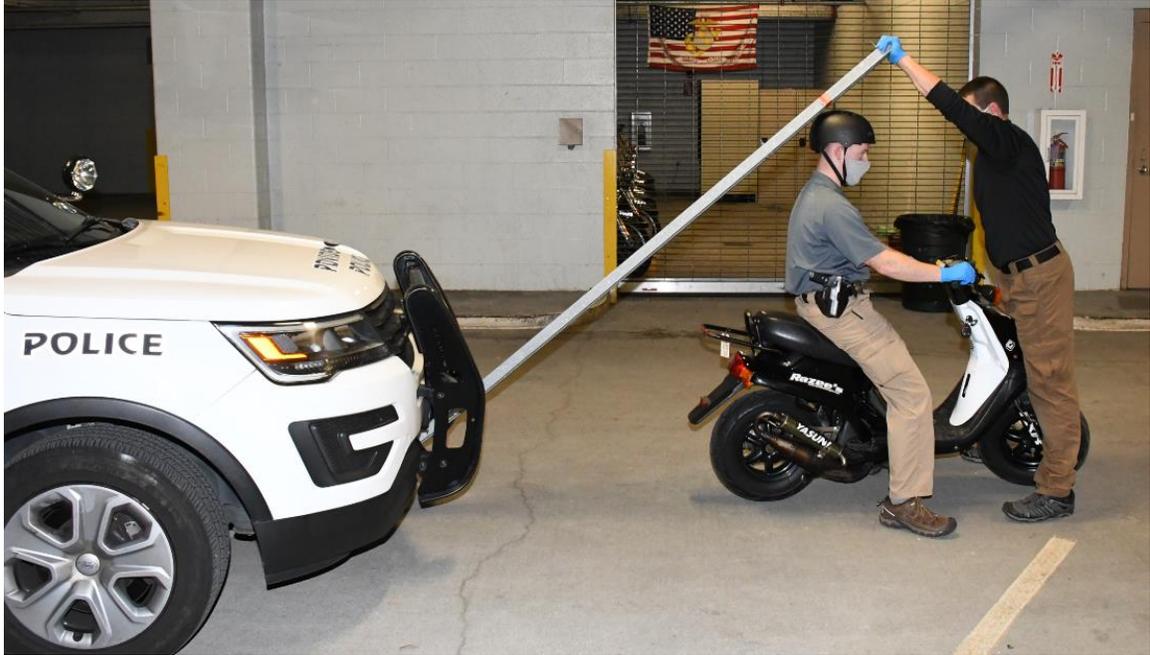
Figure 82

To conduct the examination, we drove the Cruiser forward into contact with the stop sign post. We then lowered the signpost down from this area and aligned the scooter and operator with the marked area of the post where the contact occurred. We continued to drive the Cruiser closer to keep the push bumper rails in direct contact with the stop sign post. This examination of this alignment showed that the closest the Cruiser could be to the rear of the Yamaha scooter was thirty-eight (38”) inches. When we drove the Cruiser any closer, the post continued to be deflected downward to ride under the bottom push bumper rail. As the Cruiser advanced, the lowered height of the post became too low to strike the Yamaha operator in the helmet. (Figures 82 – 84)

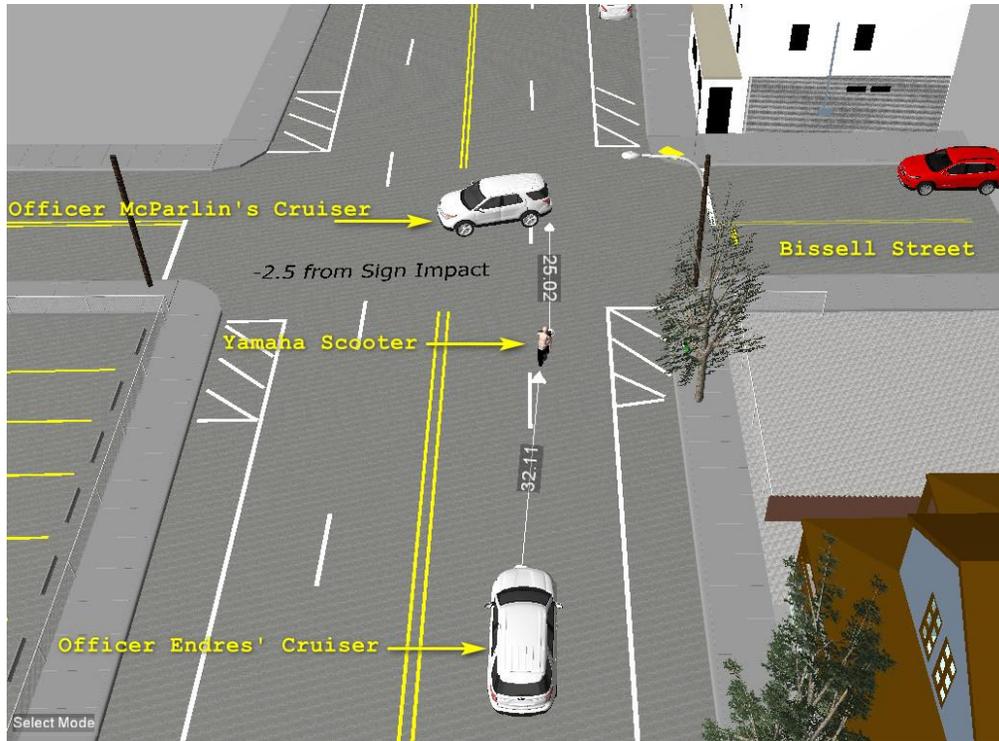
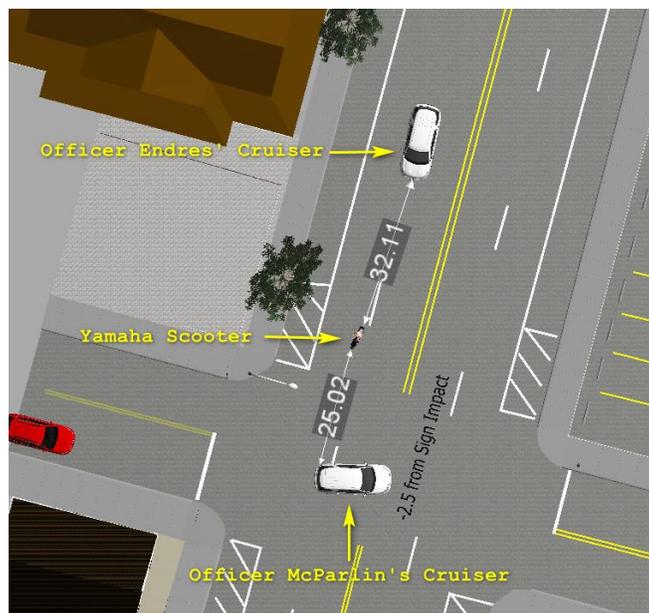
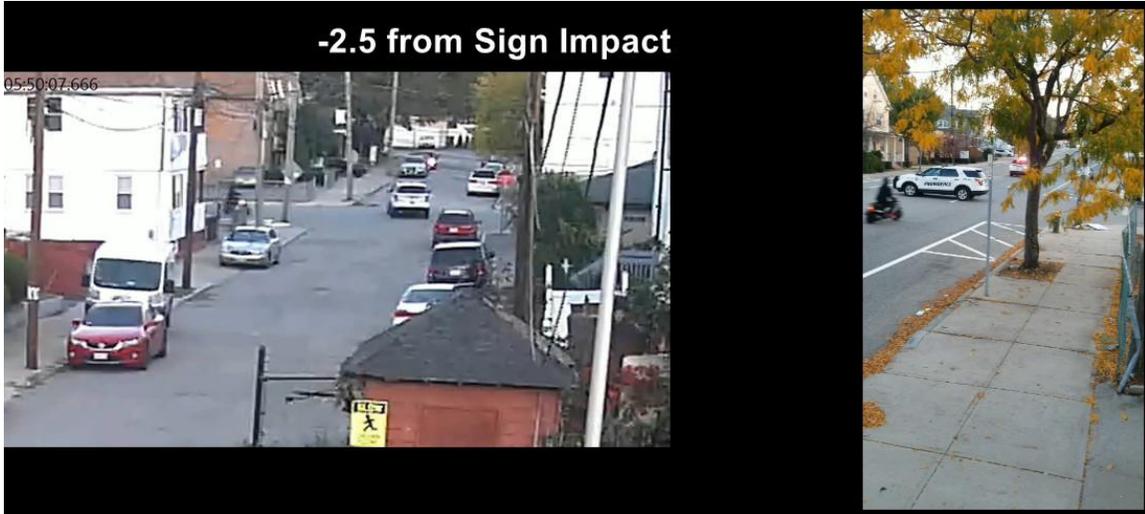
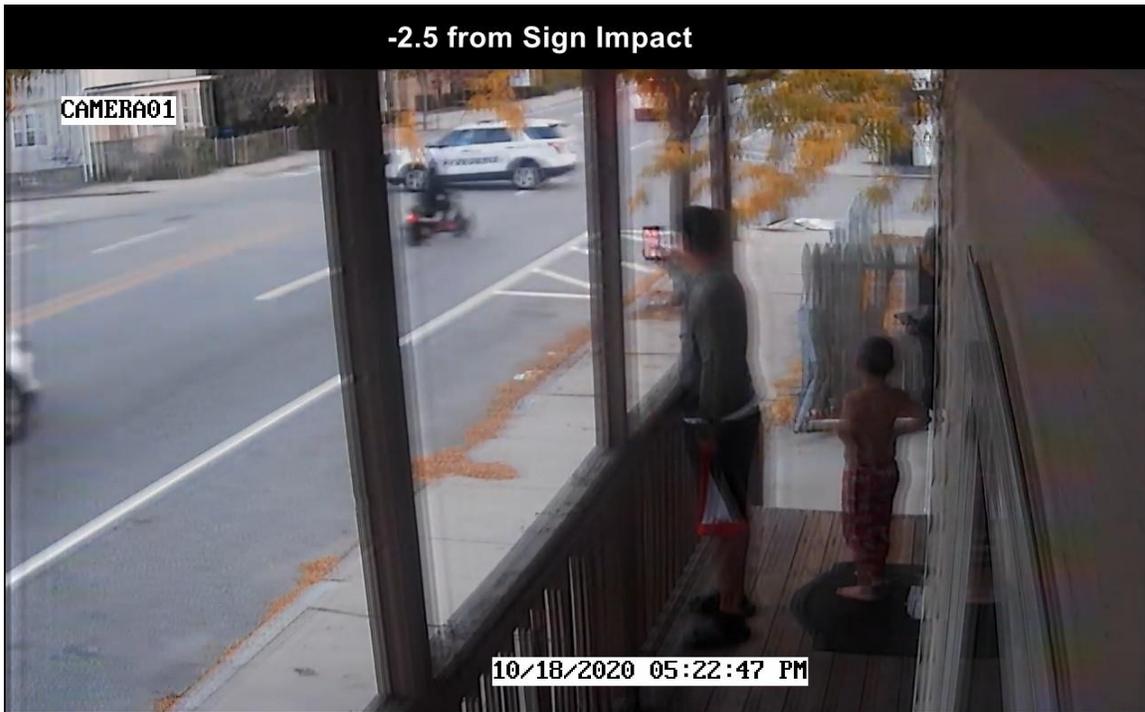
The following scaled diagram depicts the top-down view of the approximate locations of Officer McParlin's Cruiser, Officer Endres' Cruiser, and the Yamaha scooter approximately two and one-half (2.5) seconds prior to the impact with the stop sign post. (Figures 94 – 97) At this point, Officer Endres' Cruiser was traveling at approximately 28.3 miles per hour and was approximately thirty-two (32') feet from the rear of the Yamaha scooter.

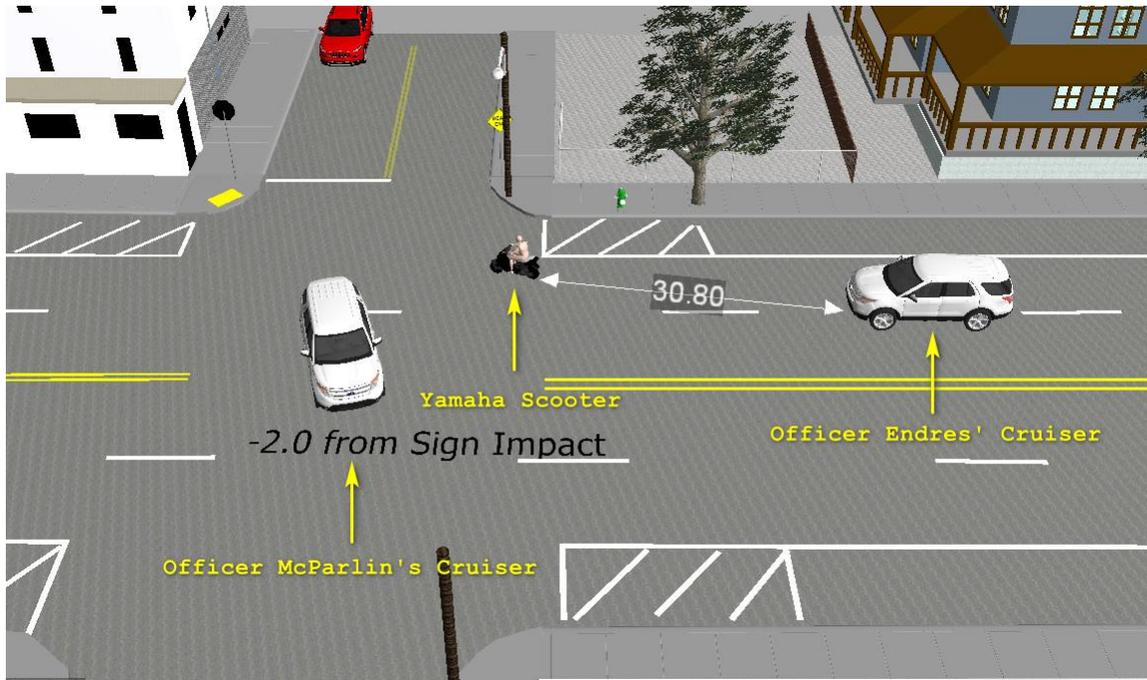
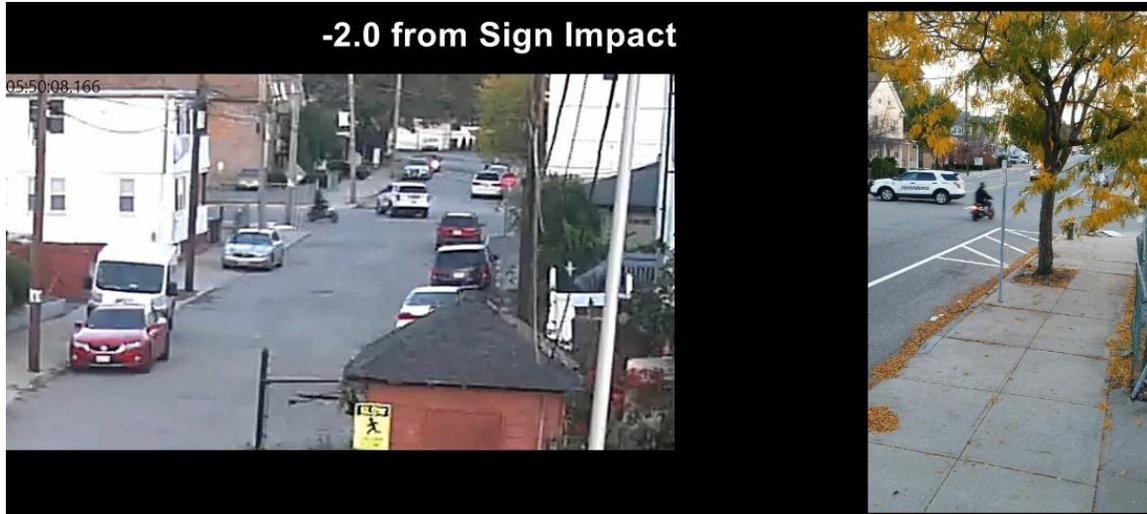
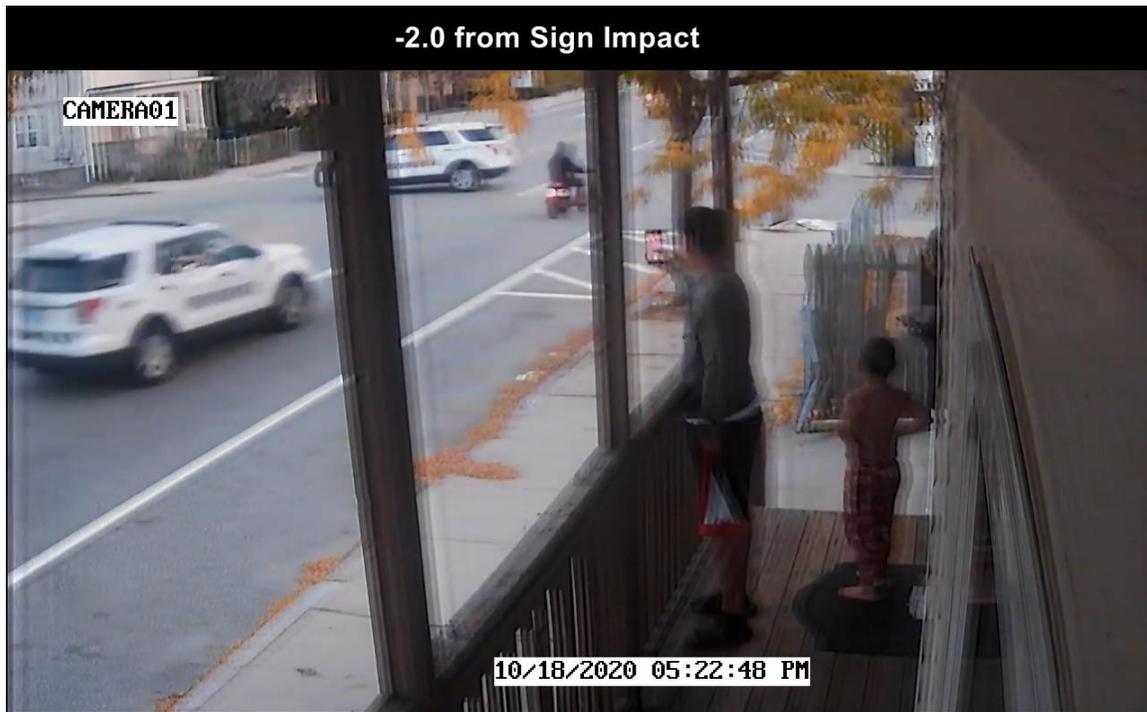
The following scaled diagram depicts the top-down view of the approximate locations of Officer McParlin's Cruiser, Officer Endres' Cruiser, and the Yamaha scooter approximately two (2.0) seconds prior to the impact with the stop sign post. (Figures 98 – 100) At this point, Officer Endres' Cruiser was traveling at approximately 27.7 miles per hour and was approximately thirty (30') feet from the rear of the Yamaha scooter.
