**Rhode Island State Police**  
**Collision Reconstruction Unit Report**

**Case Number: 20-298-CRU**

**Date: October 18<sup>th</sup>, 2020**

**Elmwood Avenue at Bissell Street**

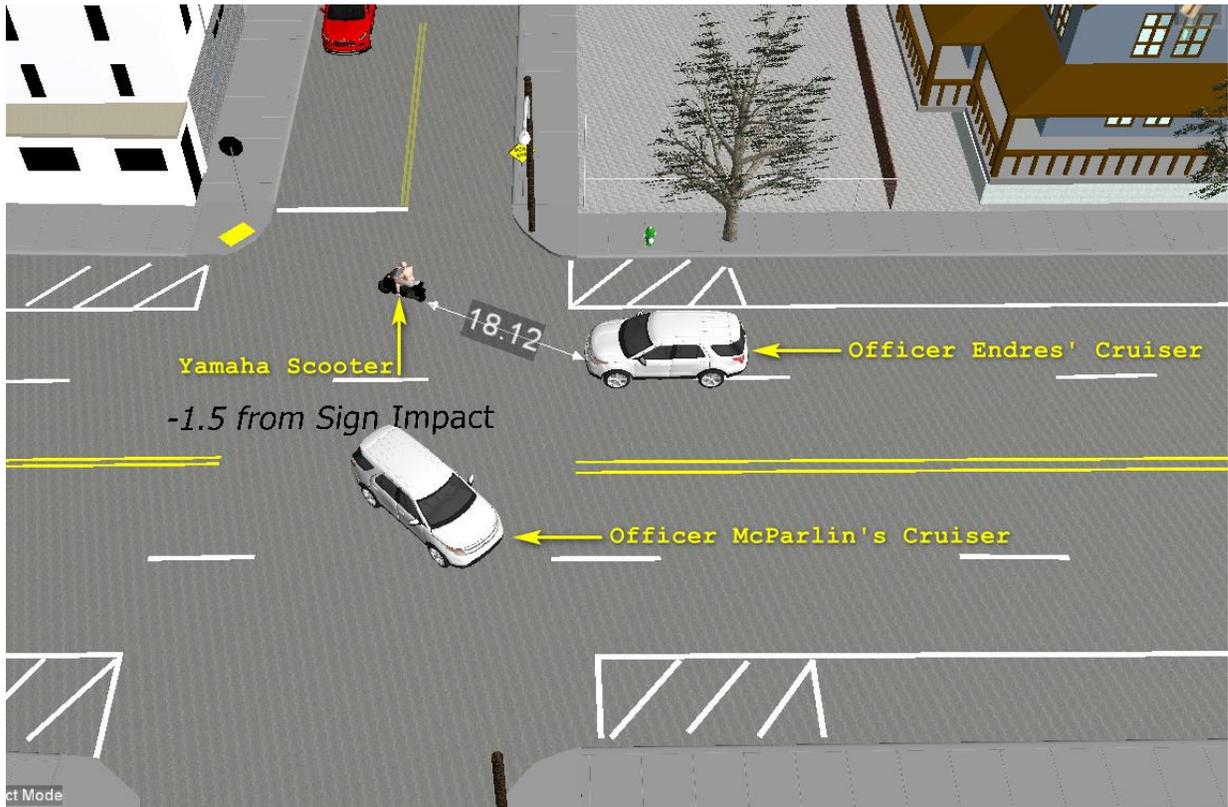
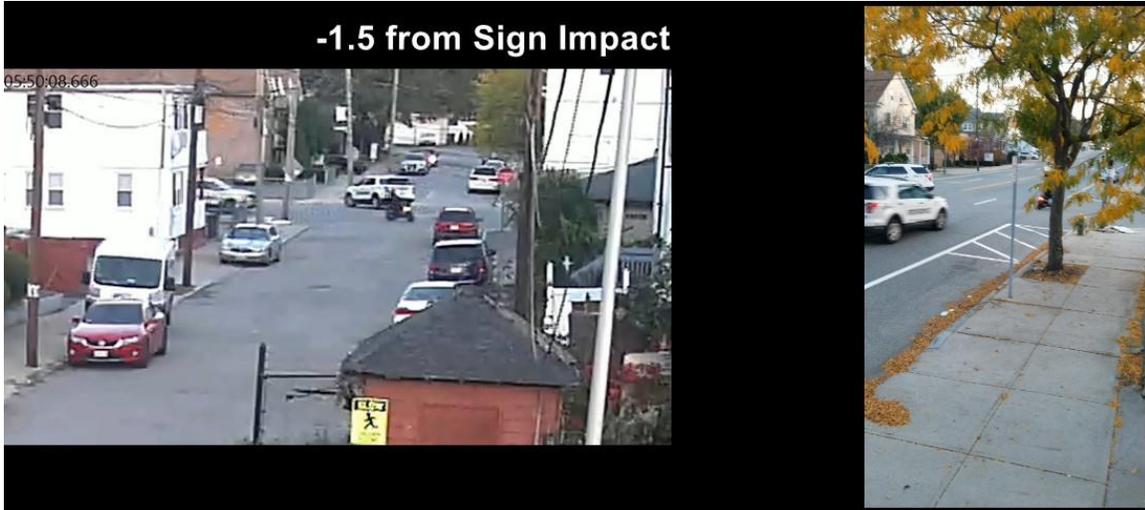
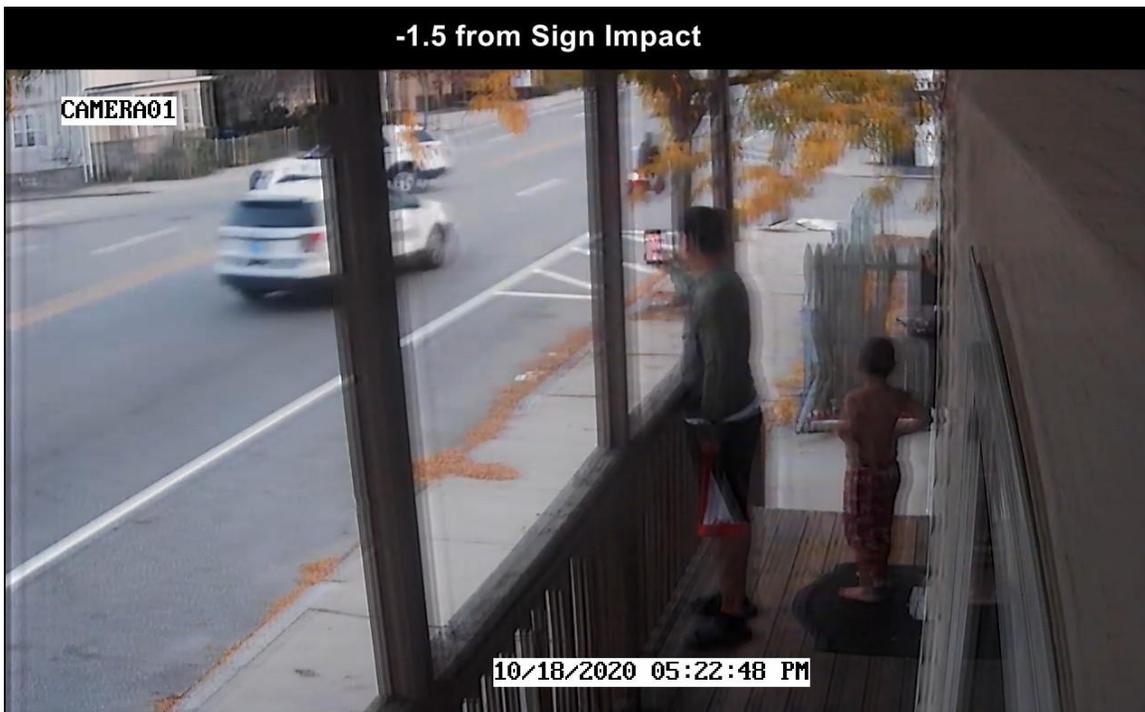
The following scaled diagram depicts the top-down view of the approximate locations of Officer McParlin's Cruiser, Officer Endres' Cruiser, and the Yamaha scooter approximately one and one half (1.5) seconds prior to the impact with the stop sign post. (Figures 101 – 103) At this point, Officer Endres' Cruiser was traveling at approximately 27.4 miles per hour and was approximately eighteen (18') feet from the rear of the Yamaha scooter.

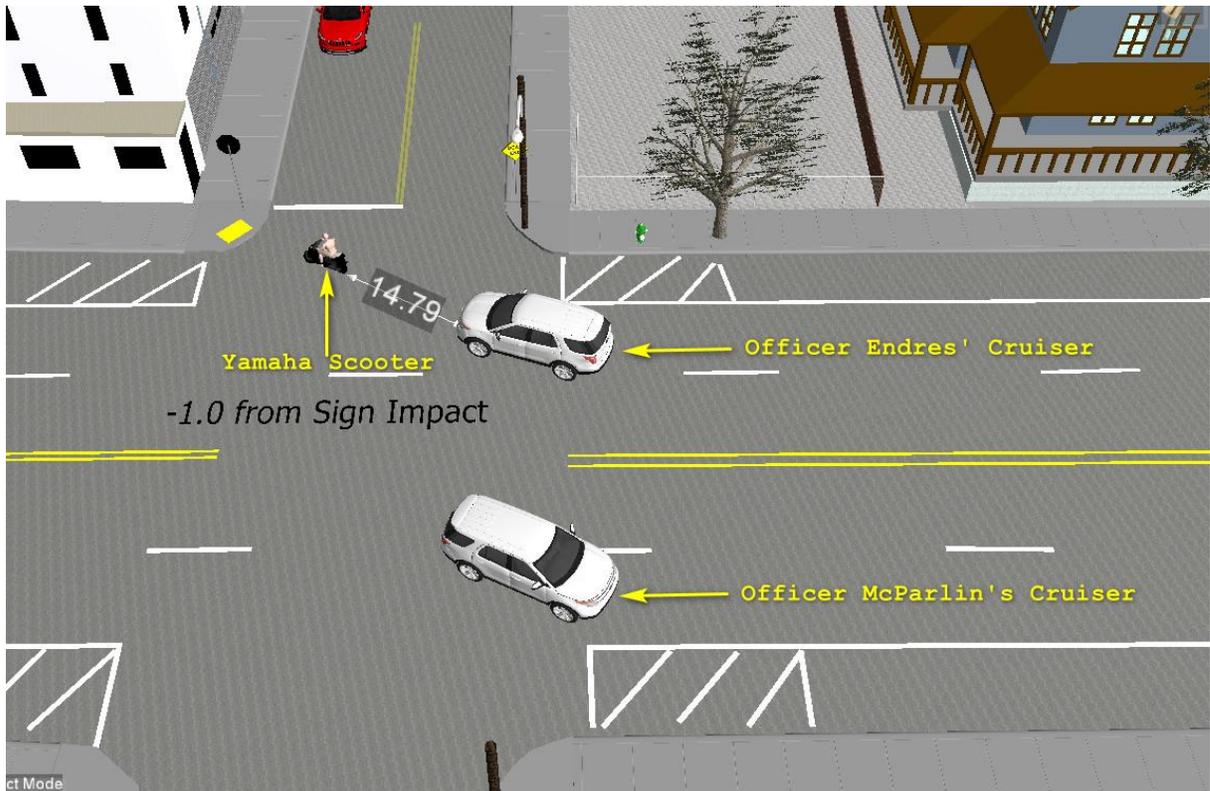
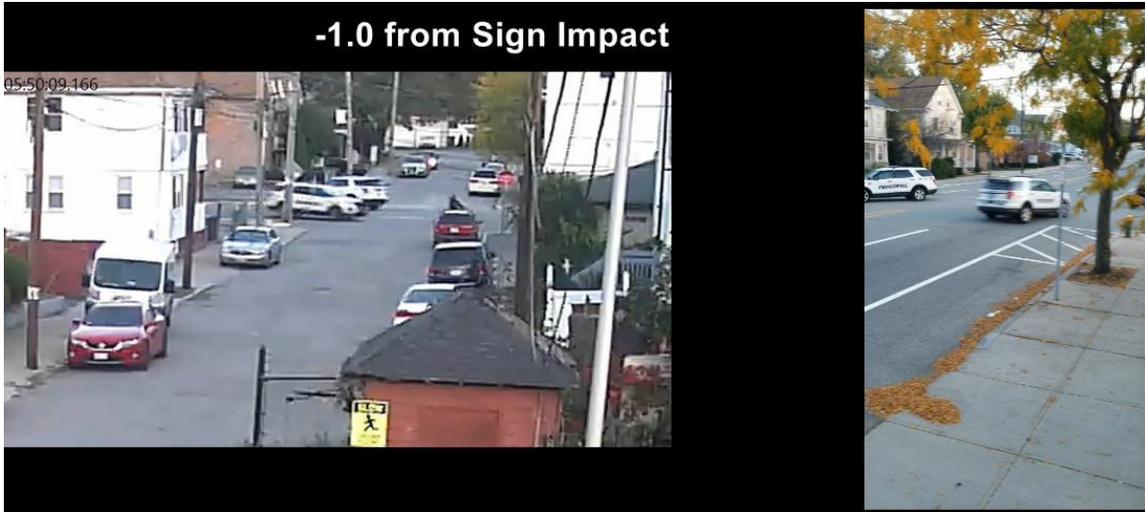
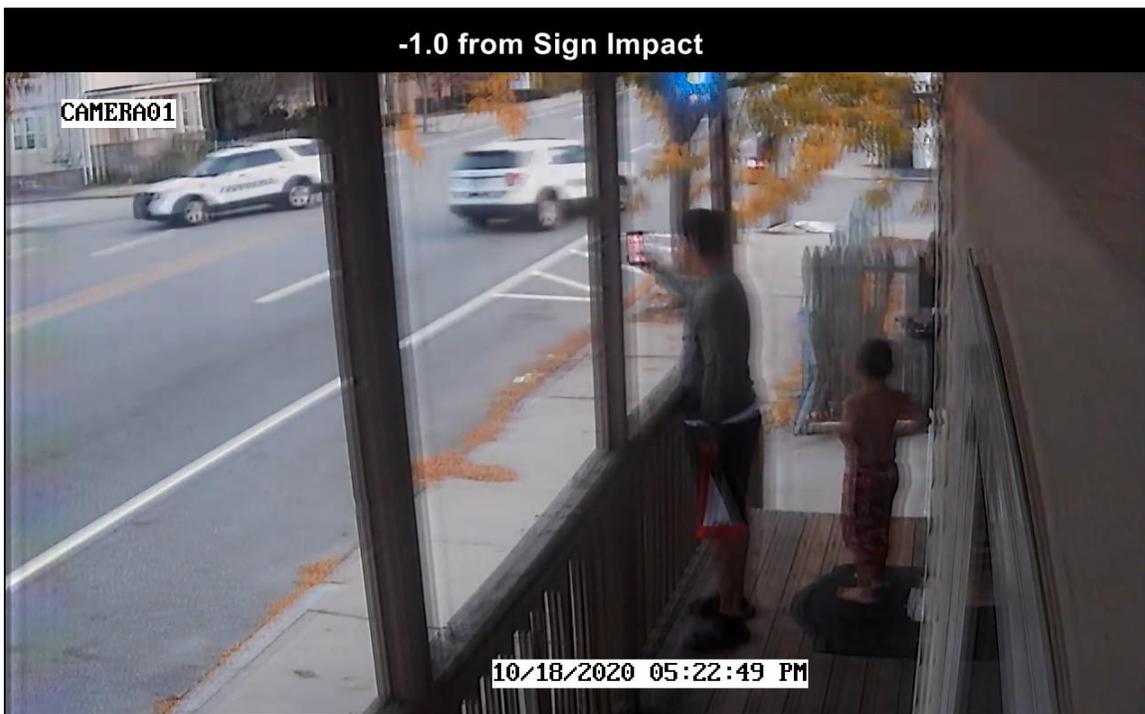
The following scaled diagram depicts the top-down view of the approximate locations of Officer McParlin's Cruiser, Officer Endres' Cruiser, and the Yamaha scooter approximately one (1.0) second prior to the impact with the stop sign post. (Figures 104 – 106) At this point, Officer Endres' Cruiser was traveling at approximately 26.5 miles per hour and was approximately fourteen (14') feet from the rear of the Yamaha scooter.

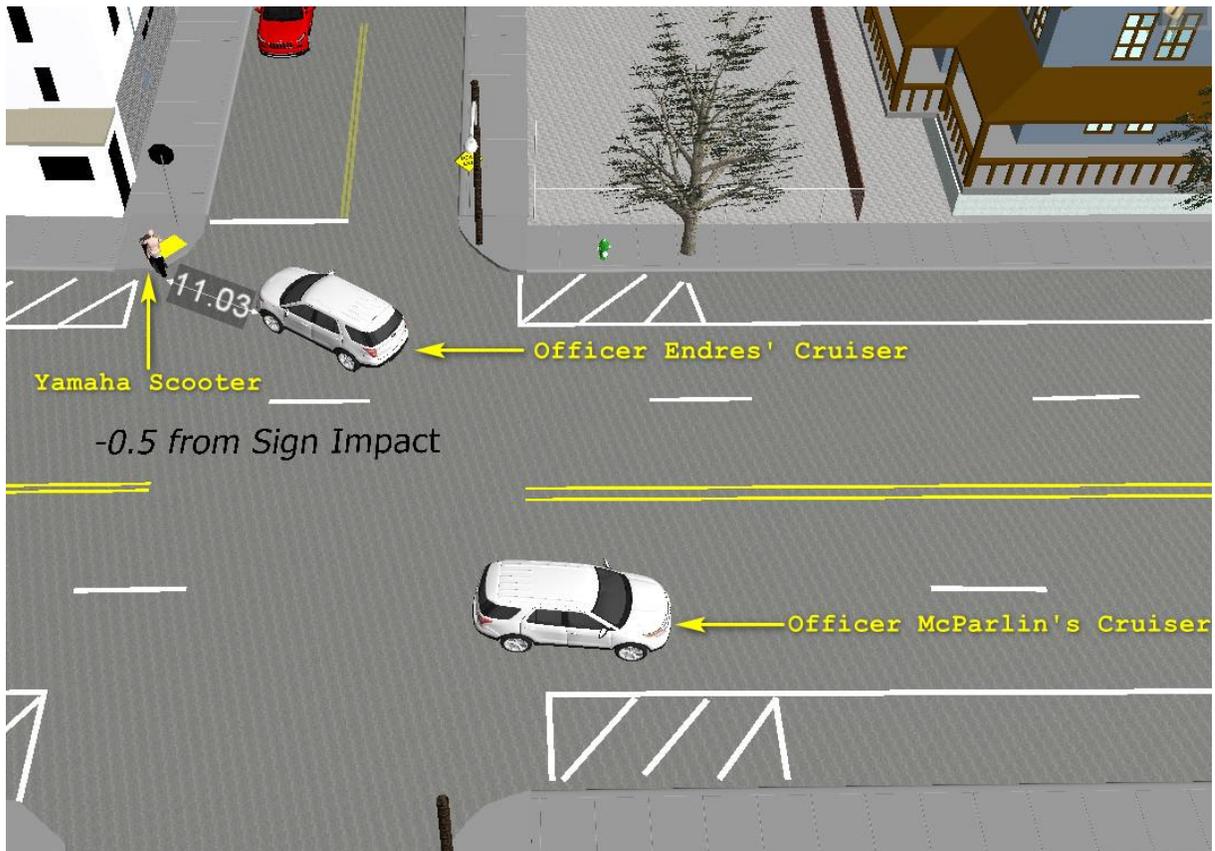
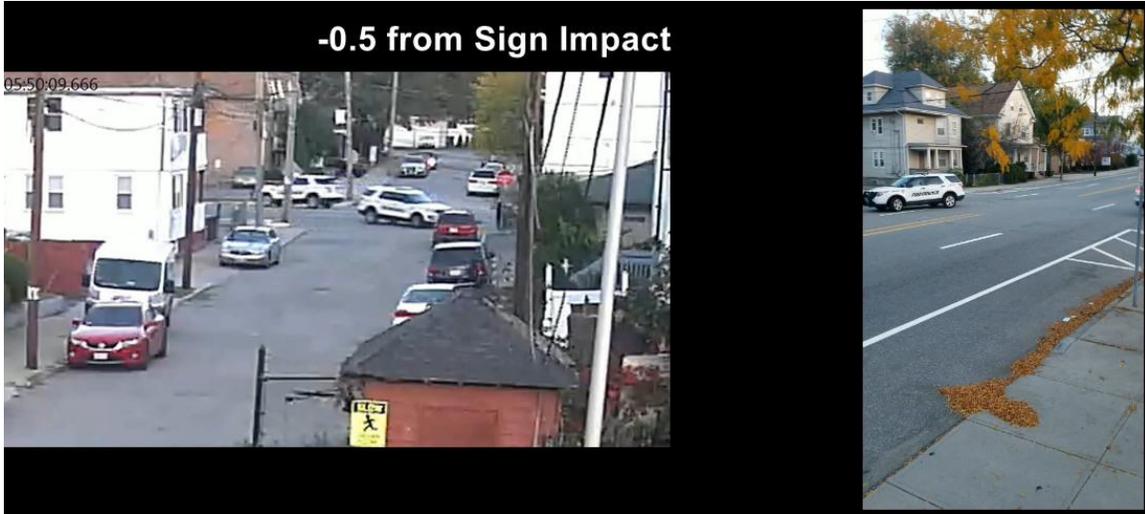
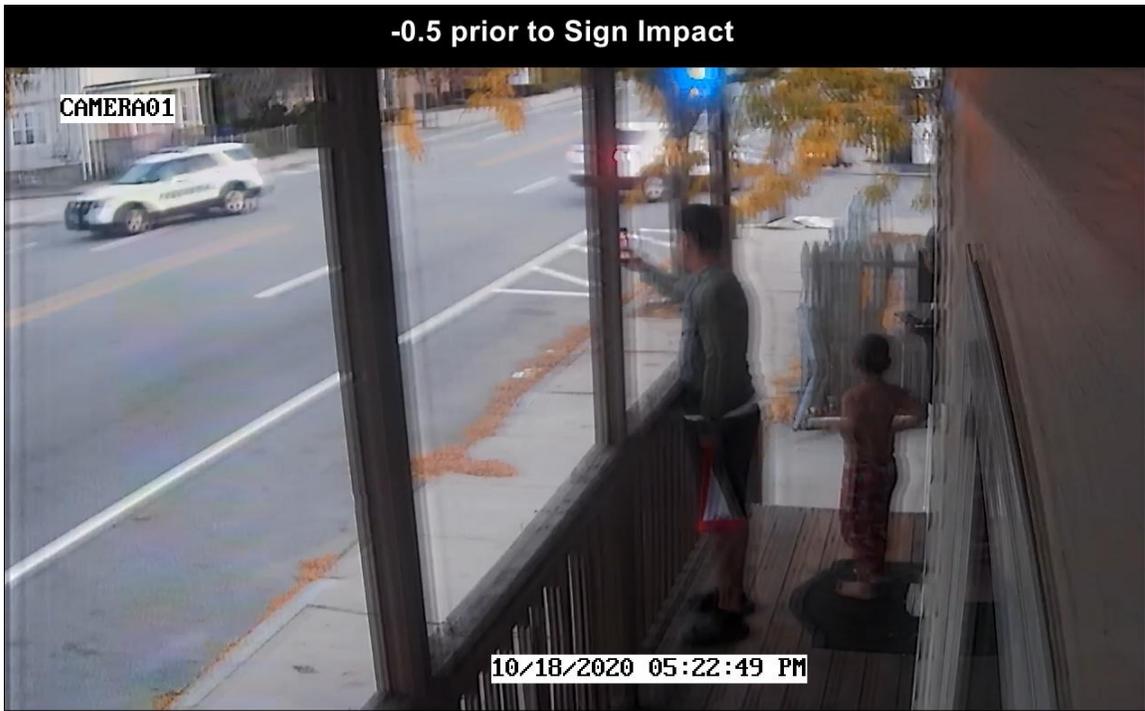
The following scaled diagram depicts the top-down view of the approximate locations of Officer McParlin's Cruiser, Officer Endres' Cruiser, and the Yamaha scooter approximately one half (0.5) second prior to the impact with the stop sign post. (Figures 107 – 109) At this point, Officer Endres' Cruiser was traveling at approximately 22.9 miles per hour and was approximately eleven (11') feet from the rear of the Yamaha scooter.

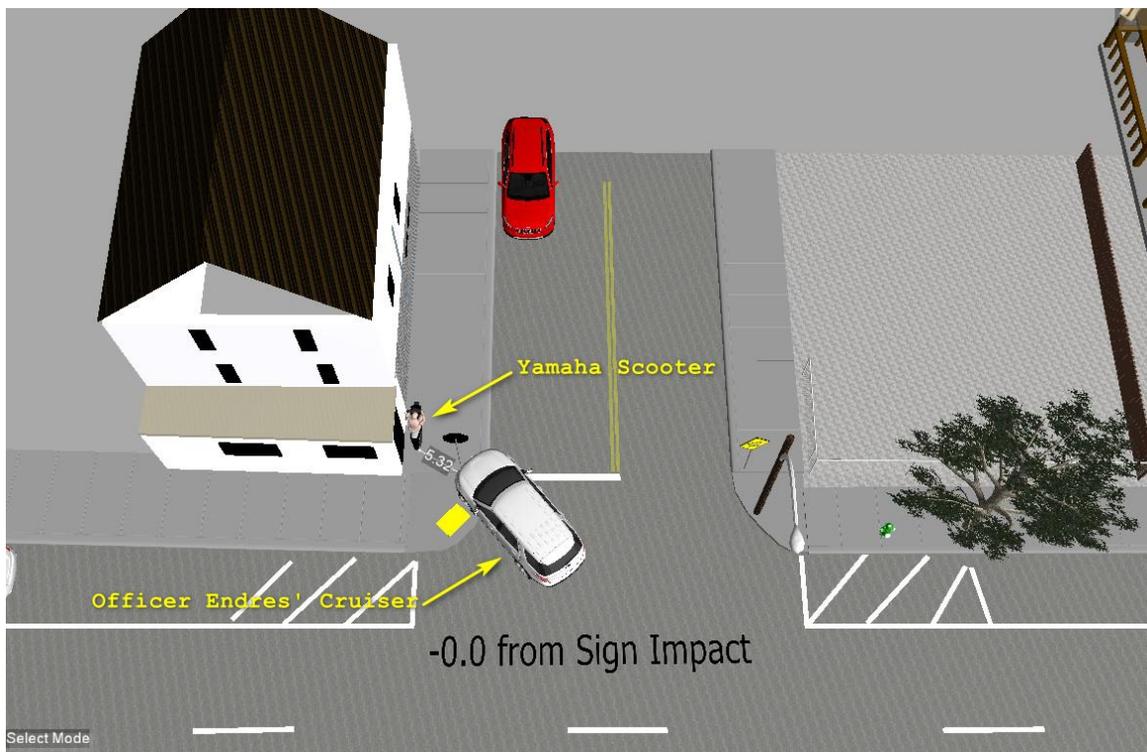
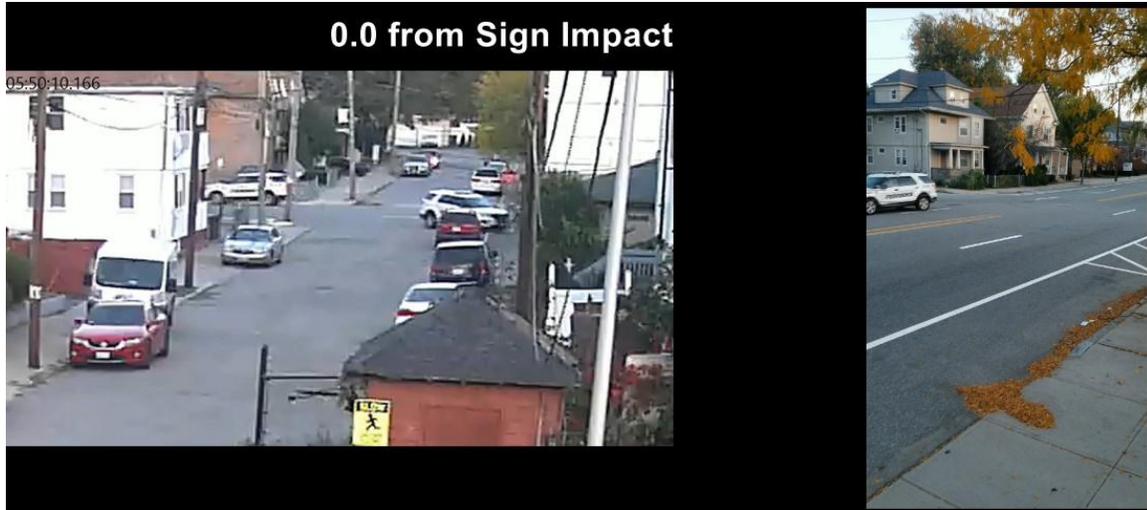
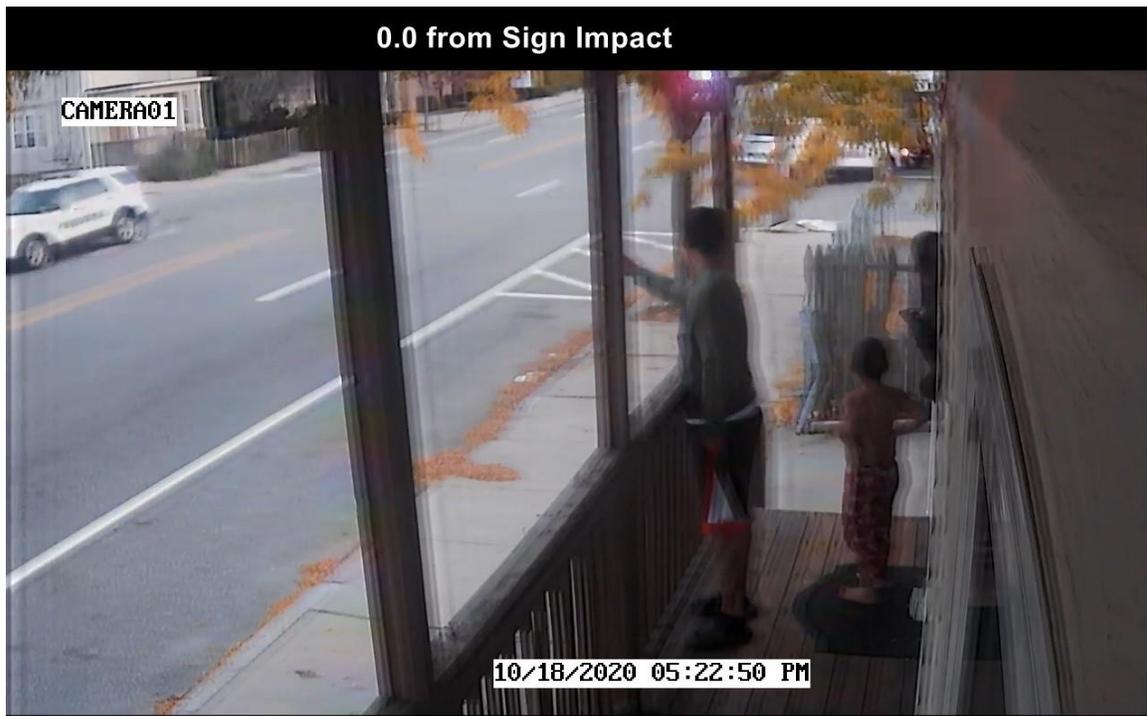
The following scaled diagram depicts the top-down view of the approximate locations of Officer Endres' Cruiser and the Yamaha scooter at the time of the impact with the stop sign post (Time Zero -0.0). (Figures 110 – 112) The location of the Yamaha scooter was estimated from the surveillance video from [REDACTED] residence and placed east of the stop sign contact and left brake lever contact with the brick wall. At this point, Officer Endres' Cruiser was approximately five (5') feet from the rear of scooter, while traveling at approximately 18.5 miles per hour with the ABS braking system engaged.

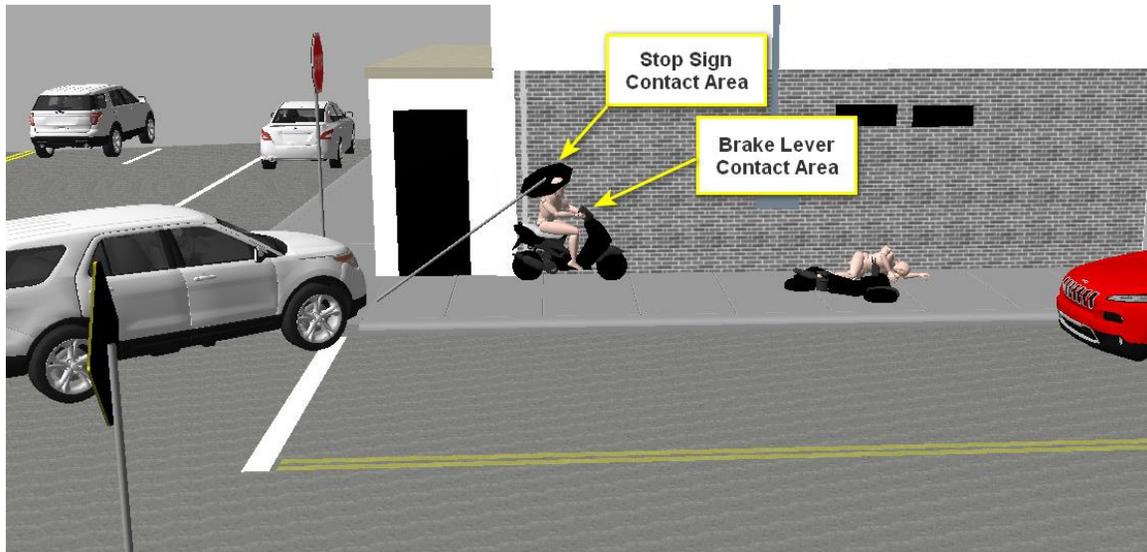
*Figure 113*

The next diagram illustrates the approximate location of the Yamaha scooter as the stop sign deflected downward and struck the wall. The sign was moved forward into contact with the brick wall at the measured height, and the left brake lever was placed along the beginning of the measured impact scuff mark in the brick wall. Both the stop sign and the brake lever appear to be striking the wall at nearly the same time. In this diagram, the Providence Police Cruiser was left at the area of first contact with the stop sign post to better illustrate the post moving away from its base in the sidewalk. The diagram also illustrates the final rest area of Mr. Gonsalves and the Yamaha scooter after the impact. (Figure 113)

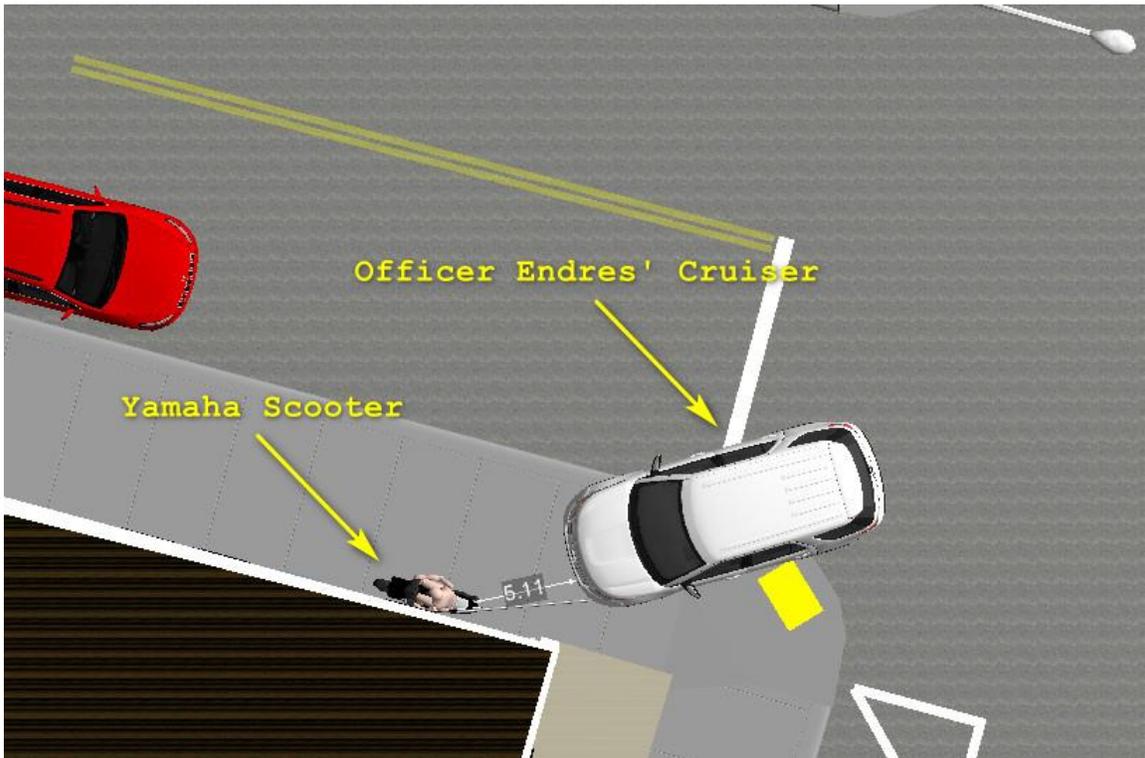
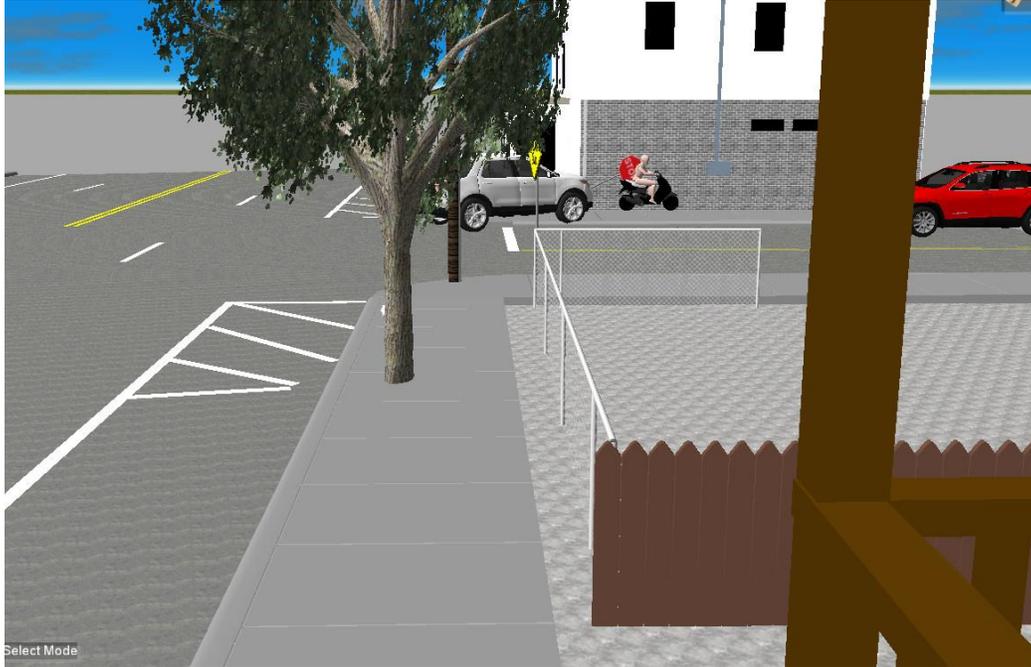
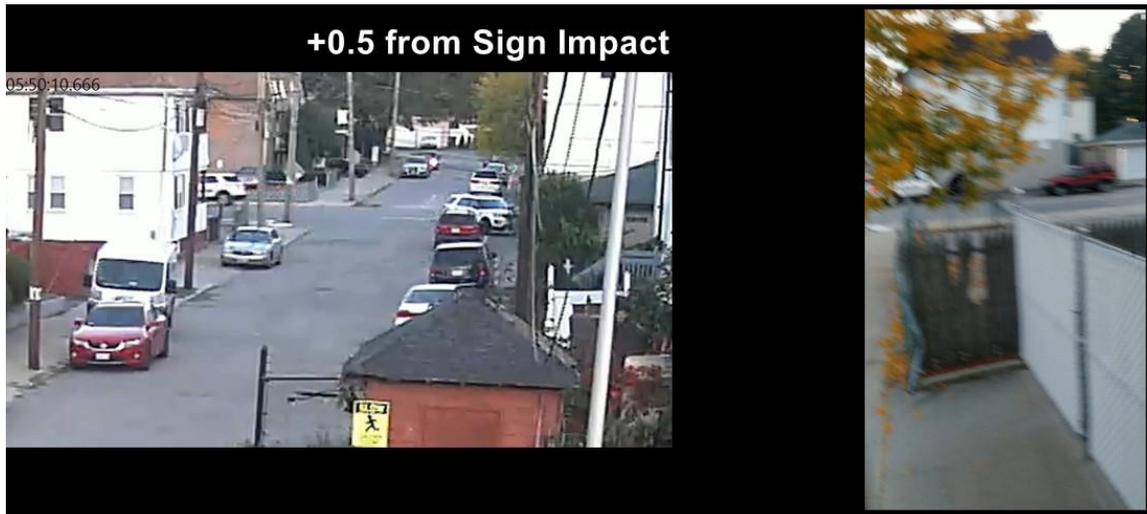
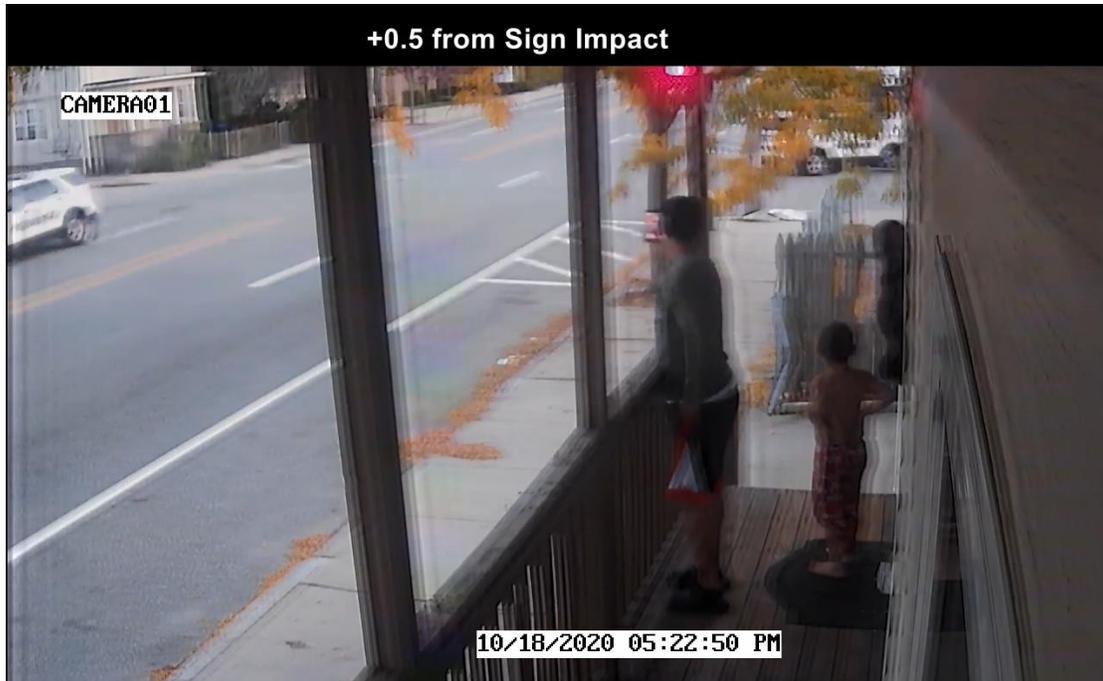
The following scaled diagram depicts the top-down view of the approximate locations of Officer Endres' Cruiser and the Yamaha scooter approximately one half (+0.5) second after the impact with the stop sign post. (Figures 114 – 117) At this point, Officer Endres' Cruiser was coming to a complete stop as the stop sign can first be seen in [REDACTED] cellular phone video. The estimated distance from the front of Officer Endres' Cruiser to the rear of the Yamaha scooter was over five (5') feet and increasing.

After viewing the scaled diagrams from a top down perspective, it was again evident that the front of the Providence Police Cruiser did not strike the Yamaha scooter at any point during this crash sequence.
